Seismic strengthening of churches as a part of earthquake renewal in the Posočje region, Slovenia

M. Uranjek, B. Dolinšek & S. Gostič

Building and Civil Engineering Institute ZRMK, Slovenia

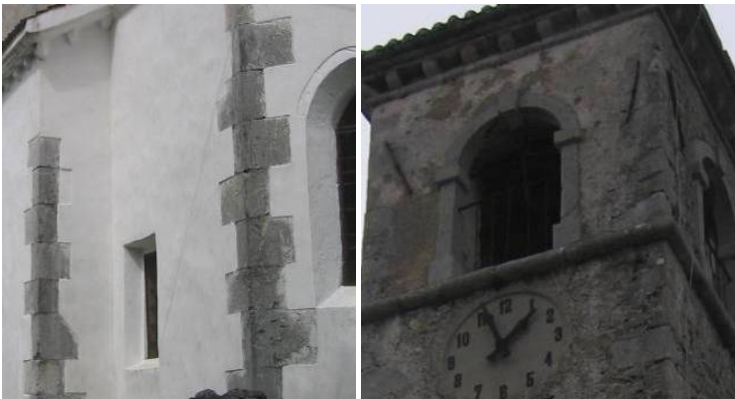
Figure 1: Sewn corners of a St. Michael church in Ljubinj and iron wall ties of the church of St. Andrew in Svino.

Although churches were mostly built by experience without detailed calculations, structural elements such as “sewn” corners of walls and iron wall ties (fig. 1) are proof that the builders of the past were familiar with the principles of improving the structural integrity of buildings subjected to seismic loads.

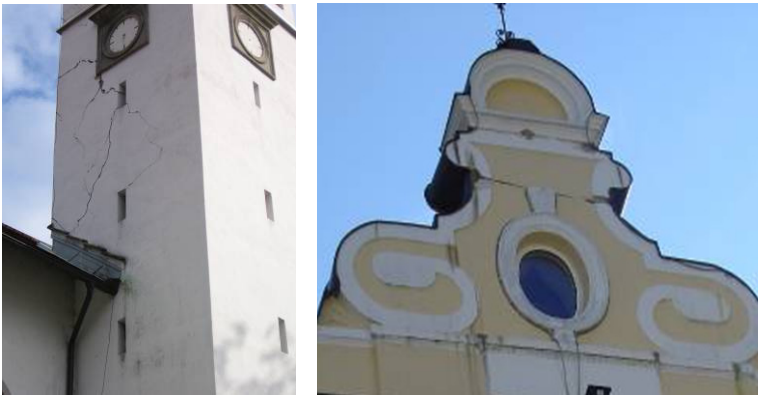
Figure 2: Typical damage on bell tower of a church and console structure of a historical building.

different response to seismic action. Nave as a central structural part of a church is characterised with high walls which are often not properly connected and anchored at floor and roof levels and in addition, most naves have no load-bearing walls in transverse direction, which makes them irregular in terms of earthquake resistant design. The irregularity of bell towers as a second most discernible part of a structural system is mainly due to its height/floor area ratio. Damage induced by an earthquake often occurs at connections and intersections of different structural parts of the church building. Usually the first elements to suffer the earthquake damage are heavy console elements e.g. campanulas and decorative elements such as jutting roof, especially if not properly anchored and connected to the base structure. Due to movements and oscillations of supporting walls, cracks are often formed in arches and vaults, but also in supporting walls themselves. On fig. 2 damage that occurred on bell tower of a church of St. Anton the Hermit and the console structure of a historical building in Bovec is presented.

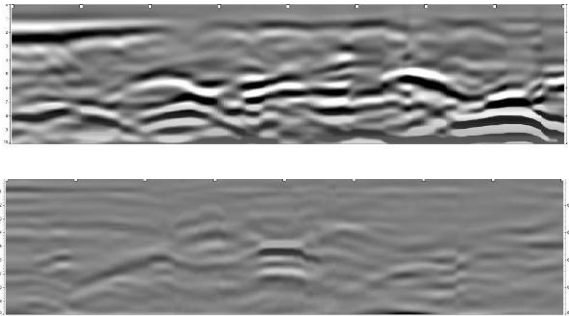
Figure 3: GPR profiles before (above) and after (below) grout injection.

GPR (Ground Penetrating Radar) measurements can be used to assess the morphology of the structure. The method is based on the emission and reflection of very short electromagnetic impulses by an antenna system. Reflection of the emitted impulses occurs at the interfaces between materials with different permittivities or conductivities, such as the interface between air (i.e. the voids) and the building material. Because the propagation velocity and the signal penetration depend on the electric and dielectric properties, the boundaries between different materials can be distinguished. GPR can be performed before and after grout injection to evaluate the quality of this strengthening technique (fig. 3).

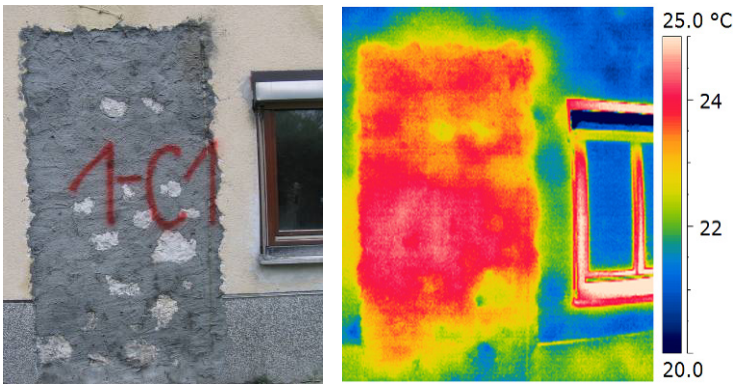
Figure 4: Digital and thermo-graphic photography of the wall 28 hours after grouting.

Thermo-graphic measurements are usually used for detecting hidden mistakes in building envelopes, but the method can be successfully applied in the monitoring of the grout injection quality (fig. 4). Thermo-graphical measurements enable us to identify the wall areas with increased surface

temperature during a given time interval after injection when, because of the hydration process, heat is released. It has to be emphasized that the measured temperature of the wall depends not only on the hydration but also on the external temperature. This is why the results need to be interpreted with knowledge of the external temperatures at the time of measurement, and a comparison of the measured temperatures between the injected and non-injected parts of the wall.

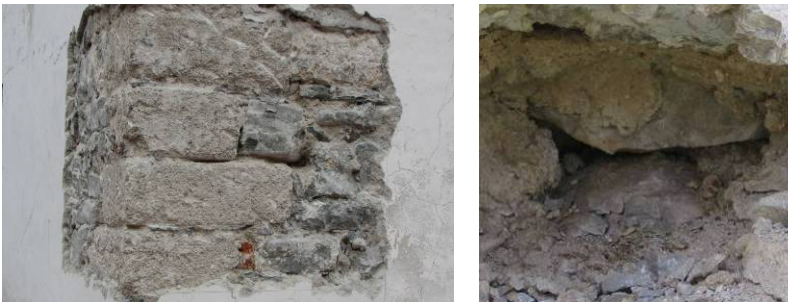
Figure 5: Surface and in-depth probing of the walls.

MDT investigation techniques such as surface and in-depth probing (fig. 5) and coring (fig. 6) on selected areas of the investigated building's structure (walls, foundations), reveal the morphology of the structure at tested positions.

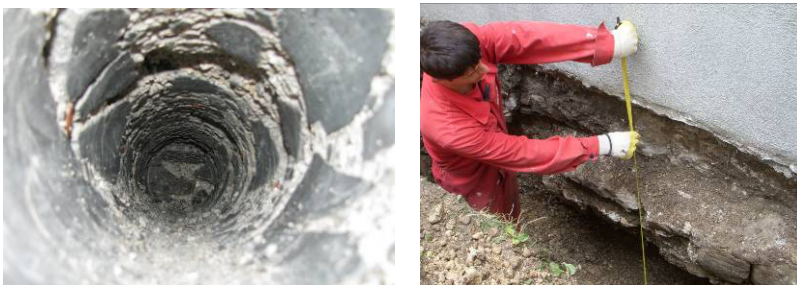
Figure 6: Coring of the walls and in-depth probing of foundations.

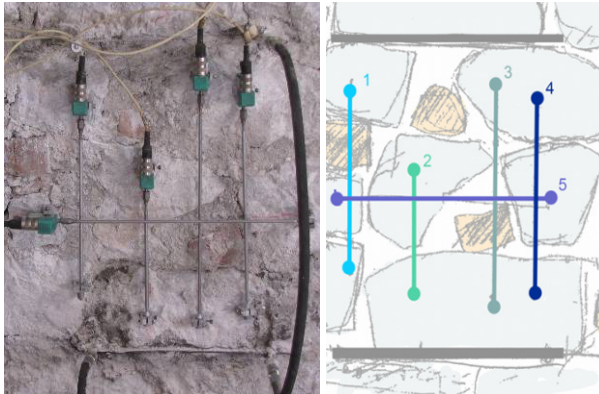
Figure 7: Set up of the measuring equipment for the double flat jack test.

Occasionally, more demanding MDT methods such as **double flat jack test** are used. Flat jack tests enable us to determine the deformability characteristics of the tested wall area. At first, two parallel cuts are made, after which a thin flat-jack is placed inside each of the cuts, and the oil pressure operating the jack is

gradually increased. LVDT's placed between the two cuts enable the monitoring of vertical and lateral deformations during the test (fig. 7).

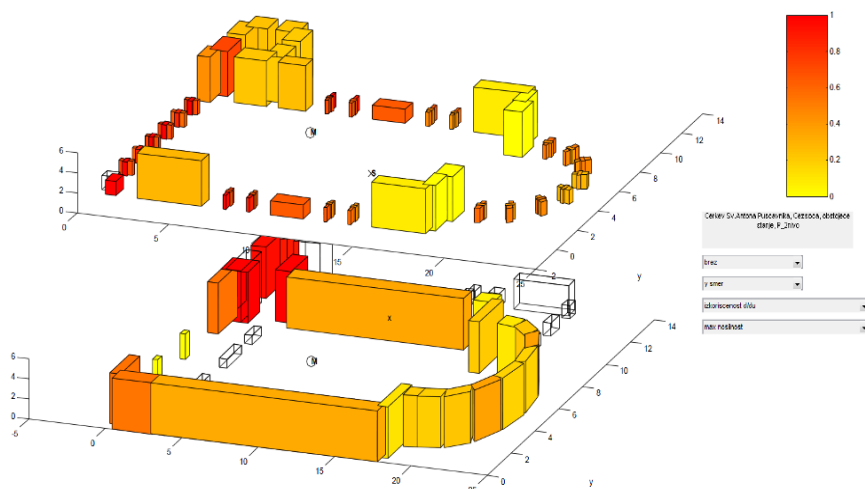
Figure 8: Actual/ultimate displacement ratio for limit state of a structure at two levels.

wooden floors, the drawbacks of the method become more obvious. Therefore, in order to determine the critical failure mechanism of the structure during an earthquake, the method can be used by performing seismic analysis at different levels, depending on geometric characteristics of the structure (fig. 8). The division of structure into macro elements correspond to the observed crack patterns after an earthquake.

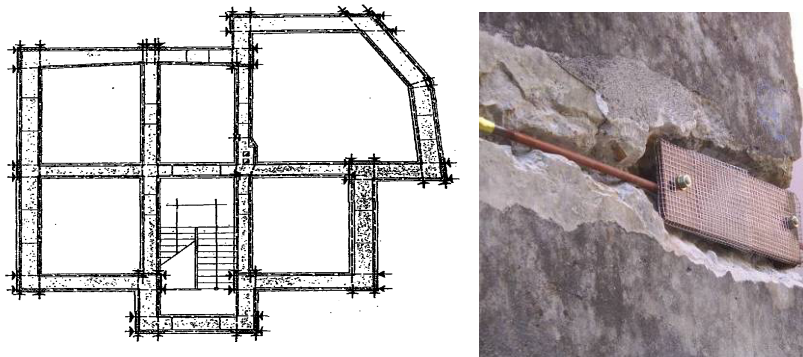
Figure 9: Tying of walls with steel ties.

Tying walls with steel ties (fig. 9) can be applied at the level of individual inter-storey floor structures. In this way the integrity of a structure is improved, the horizontal load is distributed to the walls according to their stiffness, and the walls are better protected against excessive rocking and possible failure in the out-of-plane direction.

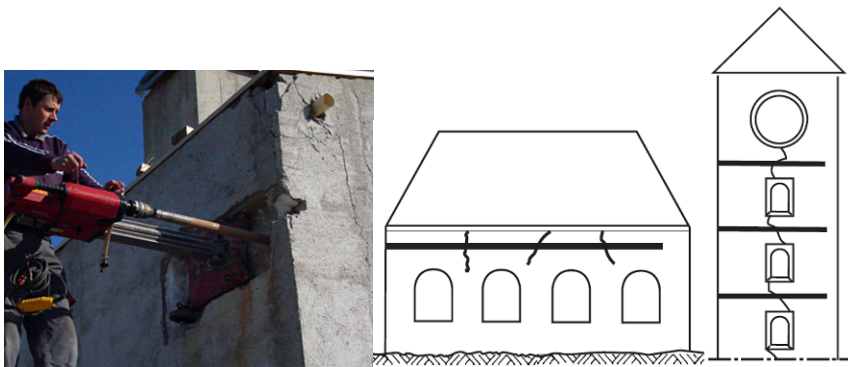
Figure 10: Application of injected anchors [3].

Injected anchors applied at the middle of the wall's cross section can, if properly designed and executed, successfully replace steel ties or reinforced tie-beams. This solution is similar to method used by the old builders. Namely connecting walls with ties, installed in the middle of the wall, has been prescribed even after the 1895 earthquake in Ljubljana [4]. Injected anchors can perform either as untensioned steel reinforcement or prestressed tendons. The execution of a borehole and examples of application are shown on fig. 10.

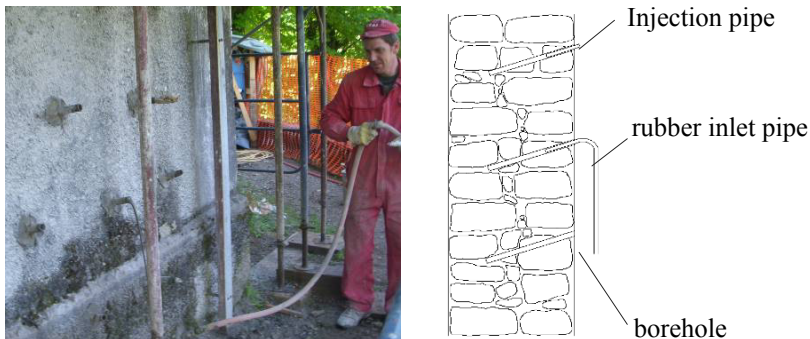
Figure 12: Injection grouting.

Injection grouting can be used to improve the mechanical properties of two or three-leaf stone masonry walls. Because of inadequate connections between separate stones, voids and poor quality of used mortar, the load bearing capacity of such walls, especially towards horizontal loading, is not sufficient. With grout injection technique, grout (liquid mixture made of water, binder and additives) is injected into a masonry wall (fig. 12) under moderate pressure (2-3 bars). The aim of the technique is to achieve better bonding between separate stones and leafs after the hardening of the injected material, and consequently to improve mechanical properties of the masonry. Work on site showed, that it is best to carry out injection grouting of all load-bearing walls, over their whole height of the structure. Damage that occurred in the buildings after strengthening and repeated earthquake has shown that grouting only parts of walls is not a good solution.

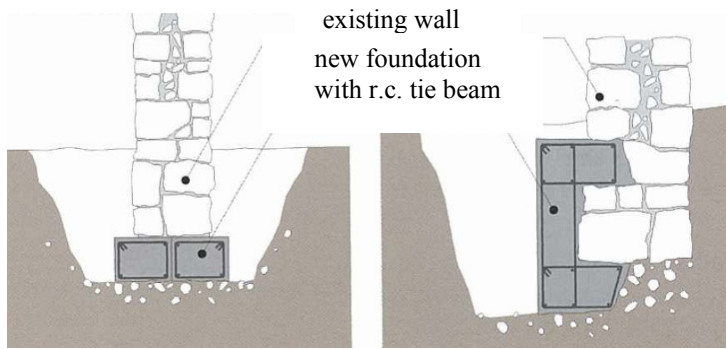
Figure 14: Strengthening of foundations [2].

Strengthening the foundations. In the case of weak or shallow foundations it is necessary to widen or deepen them. That is achieved by constructing a reinforced concrete tie-beam along the outside edge of the foundations (fig. 14). New tie-beam should be anchored into the existing foundations by transverse anchors.
