Flexible soils amplified the damage in the 2010 Haiti earthquake

R. O. de León

Sciences Academy of Dominican Republic

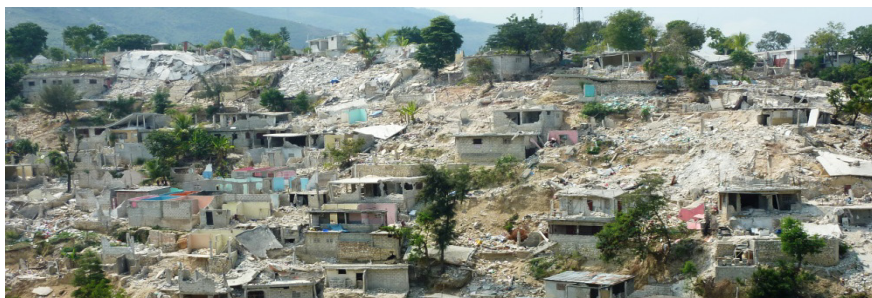
Figure 1: Small village destroyed in the south area of Port au Prince.

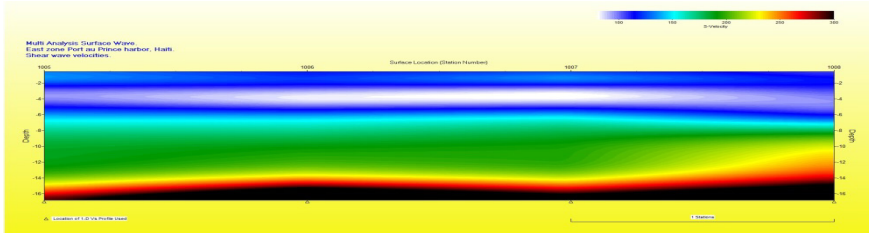
Propagation velocities of seismic shear waves (V_s) were analyzed using the multichannel analysis of surface waves approach (Park *et al.* [3], Xia *et al.* [4]) across the east side of the Port-au-Prince harbor (Figures 2, 3 and 4). The profile image shows a horizon from around 2.0 m to 4.5 m deep is a soft and flexible soil horizon, with a V_s of approximately 75 meters per second. Relating this to shear strength, we would expect an amplification of the effects of an earthquake.

Figure 2: Vs profile showing soft and flexible soils between 2.0 and 4.5 m deep.

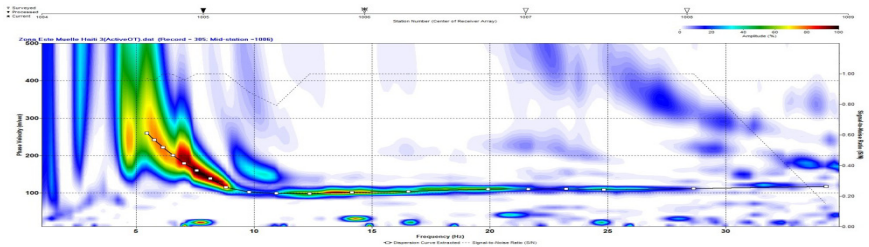
Figure 3: Phase velocity versus frequency plot collected on the east side of the Port-au-Prince harbor, Haiti.

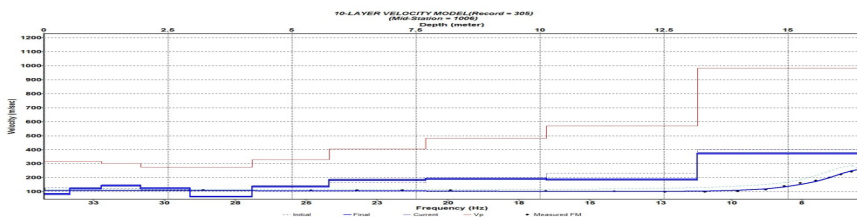
Figure 4: A representative 1D shear-wave velocity profile from the eastern section of our survey.

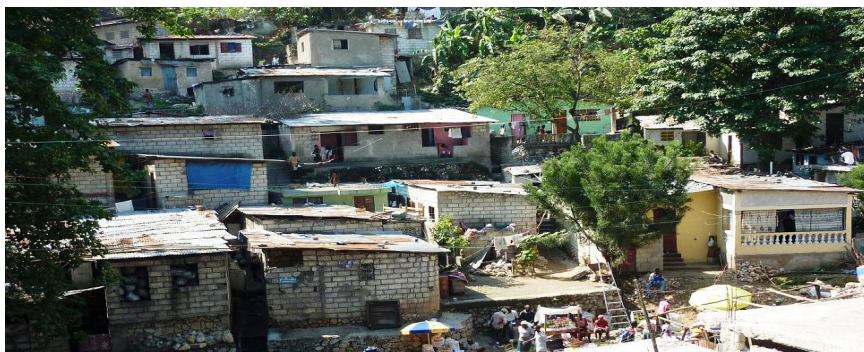
Exploring the southern mountainous area of Petionville, we found an area where buildings did not suffer any damage. These buildings were erected without any engineering criteria over an exposure of hard limestone bedrock. The citizens use a mixture of limestone cobbles and poor-quality mortar to form a foundation. Over this base, they raised block walls using similar weak mortar, without rebar reinforcement rods, and with few structural columns. Given the widespread destruction, we would expect these poorly built structures to collapse; but they did not, as we can see in figure 5. This is due to the underlying bedrock that has a relatively high shear velocity (and corresponding high shear strength) that avoided amplification of the seismic energy and reduced the shear forces transmitted to the structures (De León [5]).

Figure 5: Small village without damage, over hard limestone bedrock.

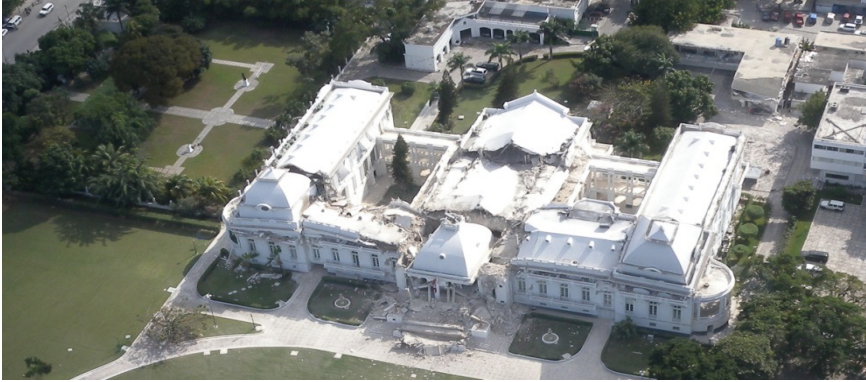
The Haitian government's palace, raised on the clay soils of the western plain of Port-au-Prince, and next to the point defined by the coordinates 0780935mE/2052405mN, collapsed in their upper stories (figure 6). The remodeled domed roof constructed with modern concrete was destroyed. Nobody could say this super structure, where the President meets with his ministers, was built without engineering criteria.

Figure 6: Haitian Government's palace, raised on the clay soils of the city.

Project engineers would probably have responded that the building structure was safe before the earthquake hit the area. This again promotes the necessity of incorporating seismic response criteria into any engineering assessment. Figures 7, 8 and 9 show another shear-wave assessment for a site with low shear wave velocity in the vicinity of the Haitian national palace.

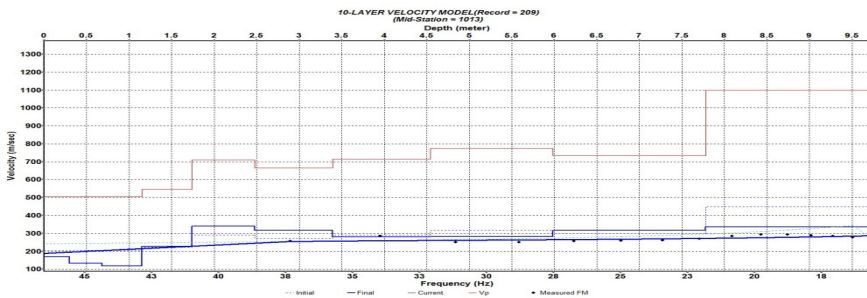
Figure 7: Representative 1D shear-wave velocity profile from the north area of the Haitian national palace.

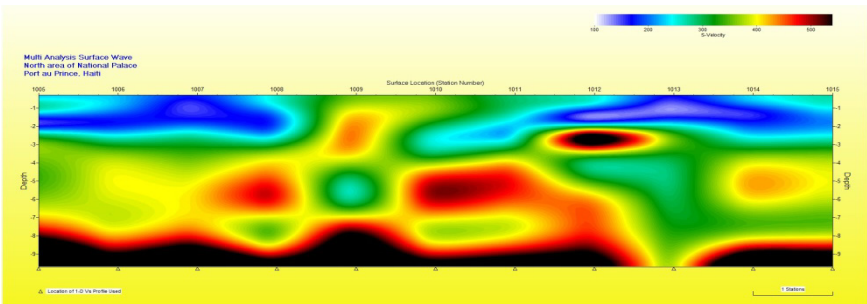
Figure 8: Pseudo 2D shear-wave velocity profile from the north area of the Haitian National Palace.

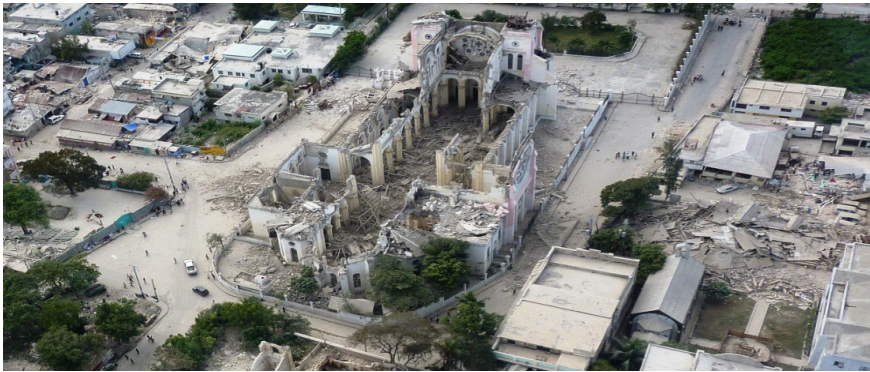
Similarly, the Cathedral of Port-au-Prince suffered the total collapse of its roof (figure 10), causing the death of several Haitian church leaders.

Figure 10: Cathedral of Port-au-Prince, built on clay soils. Note the destruction of the roof.

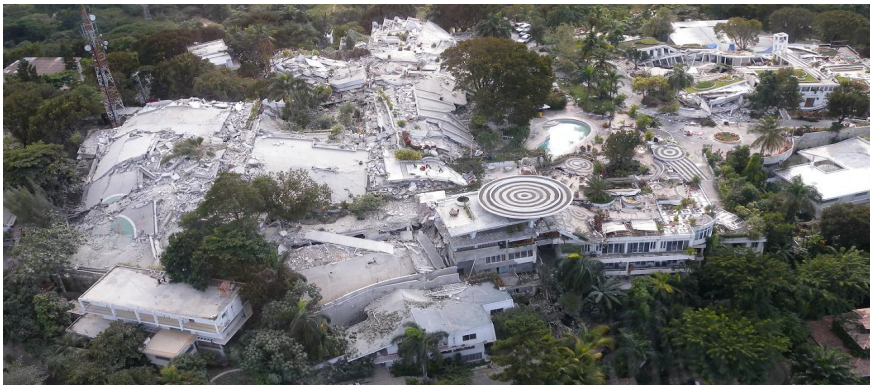
The majestic Montana hotel, built to the North of Pétionville, and next to the point defined by the coordinates 0785280mE/2050620mN, is a special case. The high eastern part, built on marly clay, collapsed completely. In contrast, the central part, housing the conference room, was raised on limestone bedrock, and

suffered no damage. Moreover, the west side, opened on December 21, 2009 and built on marl, collapsed almost completely, although the damage was not comparable to that seen on the east side. Structural engineers must analyze the diverse effects seen at this site (figure 11) and incorporate these experiences in future designs.

Figure 11: Famous Montana Hotel, over marl and clay, destroyed.

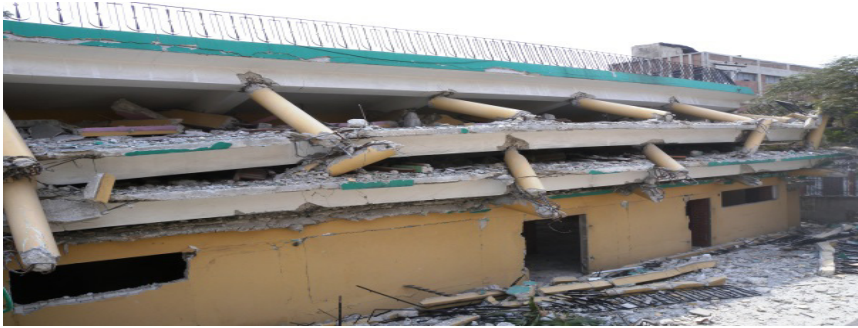
Figure 12: Salesian school of Haiti, located on clay soil.

The Salesian school of Port-au-Prince was built across four blocks, on the clay soils of the west area of the city, next to the point defined by the coordinates 0781200mE/2052750mN. The first level was supported by load-bearing walls and the three higher levels were supported by circular columns. Looking at figure 12, we can see that the load-bearing walls remained intact, while the columns were completely compromised.

Evidently the load bearing walls were able to absorb the shear stress, while the isolated columns were not able to withstand the strong shear forces generated by the earthquake (De León [7]).

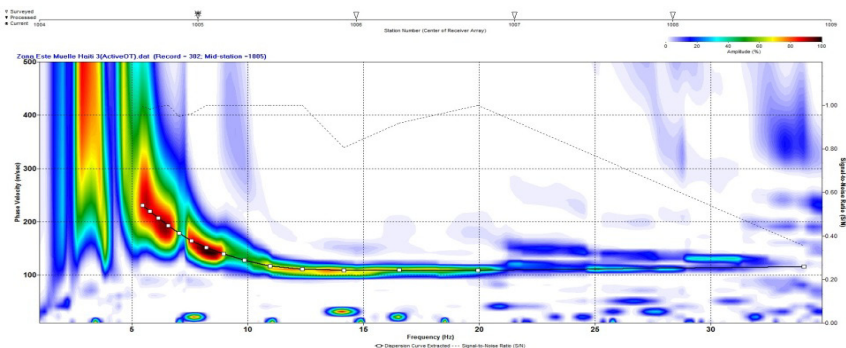
Figure 13: Phase velocity versus frequency. East side of the Port-au-Prince harbor, Haiti.

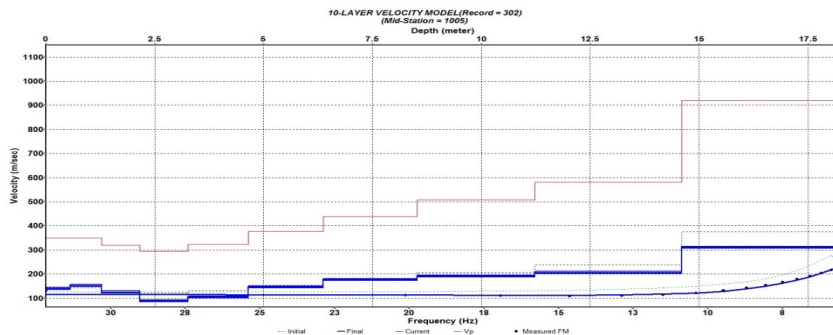
Figure 14: P and shear waves with very soft soils between 1.3 and 4.5 m deep. Haiti.

Propagation velocities of shear seismic waves (V_s) on the east side of the Port au Prince harbor, shows that a horizon from 1.3 m to 4.5 meters deep has a shear-wave velocity (V_s) of approximately 75 meters per second. We may infer that this material has low shear-strength, and therefore, would cause amplification of strong ground motion.

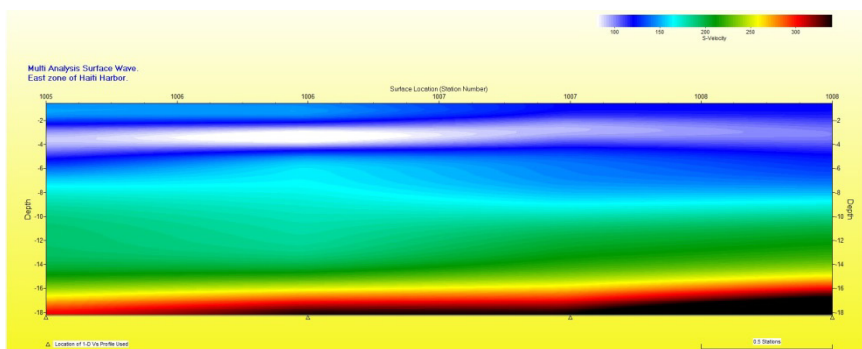
Figure 15: Shear waves showing very soft soils between 1.3 and 4.5 m deep.

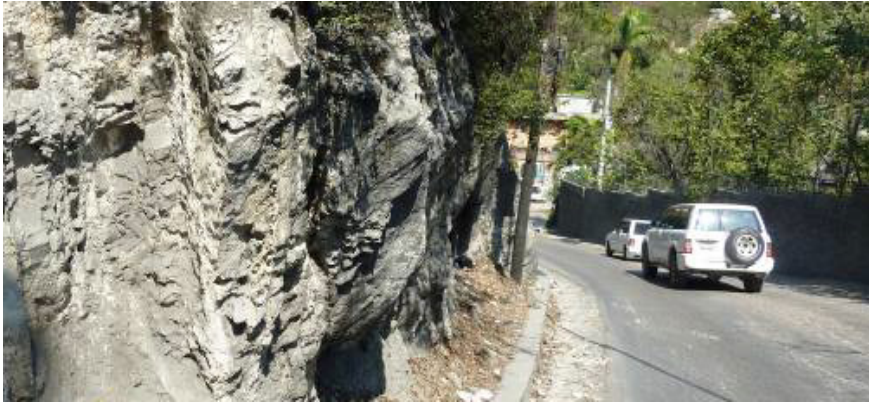
Both Haiti and the Dominican Republic must immediately revise building codes to incorporate earthquake resistance criteria, giving priority to the seismic microzonation of all population centers. These zones would be based on seismic propagation velocities of shear waves, which would correlate to different levels of structural integrity and seismic-resistant building codes. Taking into consideration the experience of the Haiti earthquake, we have seen many buildings erected on soft and flexible soils to be sensitive to strong ground motion, and an opposite response for the buildings erected on the hard limestone outcrops on the road from Pétienville to Fermate (figure 16).

Figure 16: Very hard limestone rock of south hills of Port au Prince.

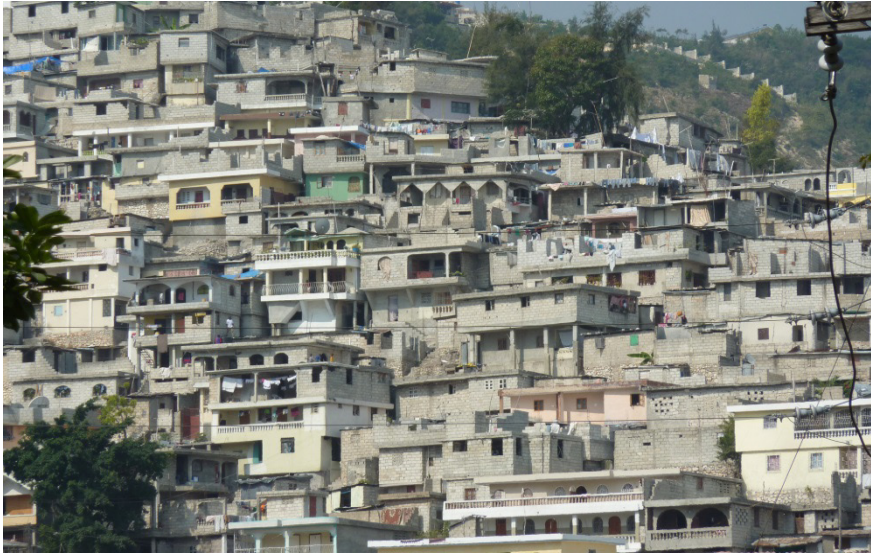
In the southern mountainous area of Pétionville, where limestone bedrock is present at the surface, the buildings did not suffer any type of damage, not even cracks, in the poorly built structures erected without any engineering forethought, as we can see in figure 17. Conversely, we see another site, built on limestone, that saw little damage.

Figure 17: Picture of a dense village compound, in the hard limestone rock of south hills of city. Note the lack of damage.

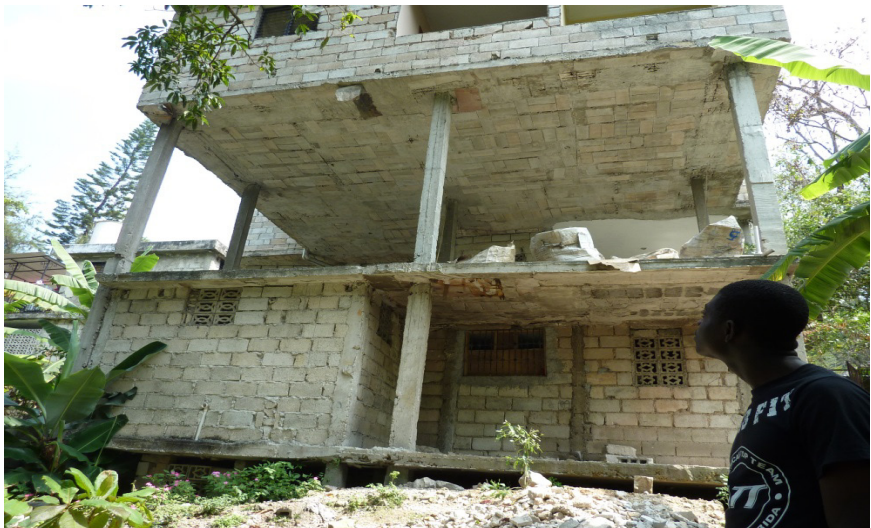
Figure 18 shows a building, with more than soft two floors, constructed over limestone bedrock, in the south area of Pétionville, with no damage after the Haiti earthquake.

Figure 18: House with second soft level, built on the limestone bedrock.

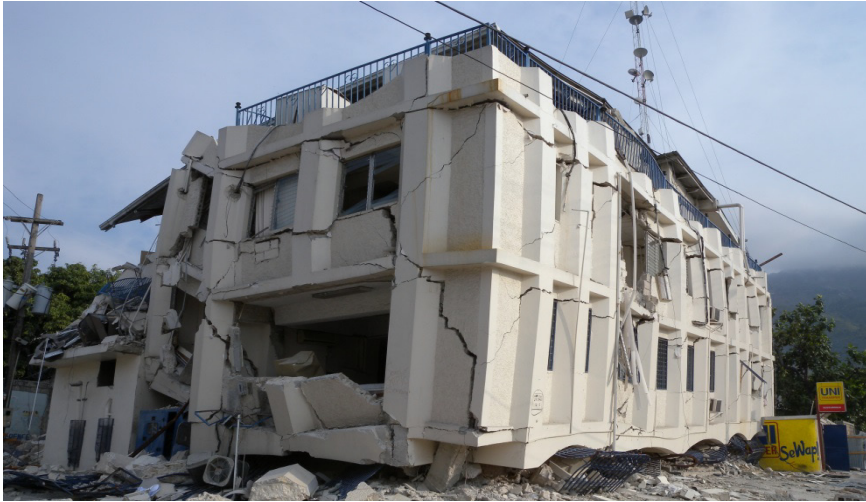
Figure 19 shows the UNI bank building, placed over the soft clay of Port au Prince Plain. The first floor was destroyed during the Haiti earthquake.

Figure 19: UNI bank building, over soft clay, with first level collapsed.
