ASSESSMENT AND PERFORMANCE-BASED DESIGN OF THE STRENGTHENING OF EXISTING STRUCTURES FOLLOWING THE 2015 NEPAL EARTHQUAKES

TIMOTHY SMALL
Arcadis Asia Pacific, Australia

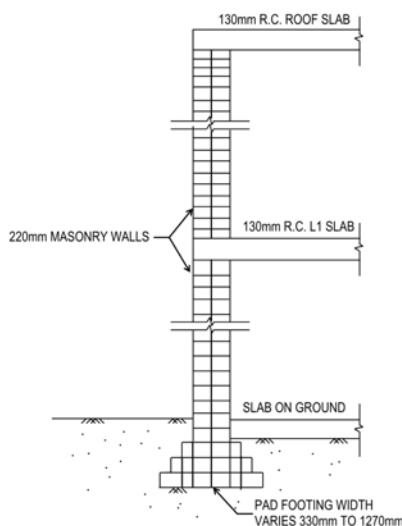
Figure 1: Typical structural framing.

The four assessed buildings had similar structural systems – reinforced concrete slabs and beams supported predominantly by load-bearing unreinforced masonry walls or (in some locations) supported by reinforced concrete or unreinforced masonry columns. Many of the upper-level masonry walls were supported on reinforced concrete beams and did not continue to the foundations. No evidence of piling was apparent for any of the buildings. Three of the buildings had car ports at the front of the buildings which acted largely as stand-alone structures. Fig. 1 shows typical structural framing of the buildings.

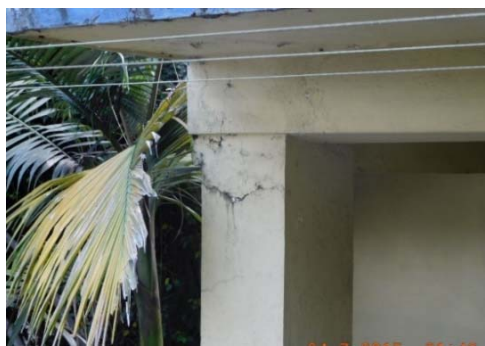
Figure 7: Crack in column.

- Minor cracking in arches or at the top of columns, and
- Cracks of approximately 5mm width at the tops of columns supporting concrete carport roofs.

Figs 6 and 7 show typical damage that was observed.

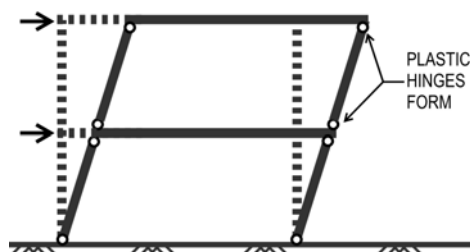
Figure 8: Behaviour of inspected structures under seismic loading.

The observations, combined with our analysis, confirmed that under seismic actions, hinges were forming at the top and bottom of vertical elements. Fig. 8 shows a diagram of the effect of earthquake actions on the structures.

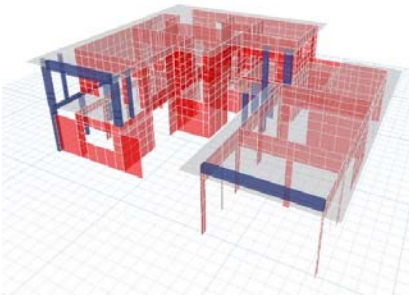
Figure 10: Building 3 analysis model.

1. Each building was modelled in the analysis program ETABS, modelling all major structural elements.

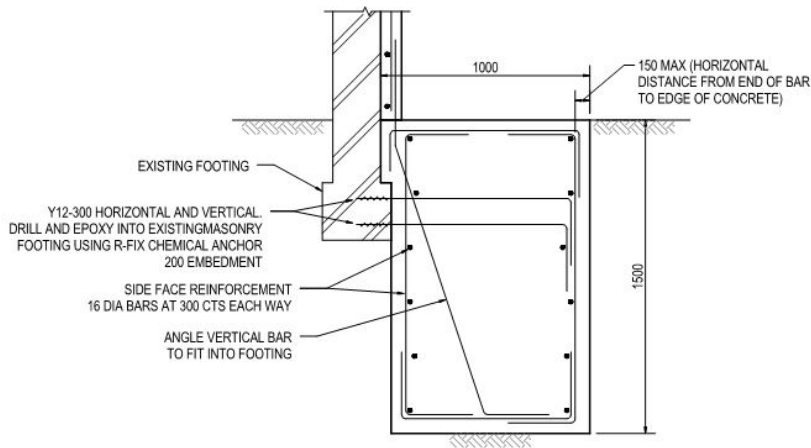
Figure 13: Foundation enlargement.

One of the most onerous parts of the strengthening process was increasing footing sizes. It was calculated that uplift loads of around 200kN/m might be experienced in some locations. Reinforcement from wall jacketing was anchored into the footings, and dowels were installed into the masonry walls. We decided against excavating under foundations as this would necessitate underpinning of the structure which would be complicated and would introduce risks both in terms of the quality of the finished product and safety of workers. Fig. 13 shows a typical footing strengthening detail.

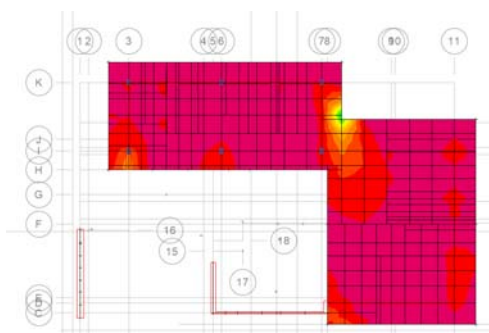
Figure 15: Plan view of in-plane loads in slab.

The survey team confirmed that there was no continuity of slab reinforcement across building joints. Stitch plates were therefore designed to join the buildings together. Tie forces were read out of the analysis model and stitch plates were designed for in-plane loads.

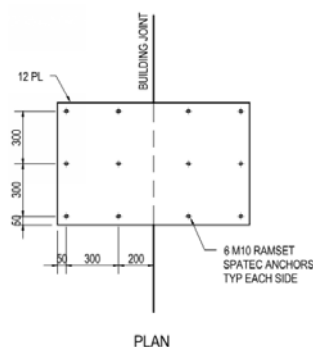
Figure 16: Stitch plate detail.
