Silica sand slope gullying and mining in Central Spain: erosion processes and geomorphic reclamation of contour mining

Abstract

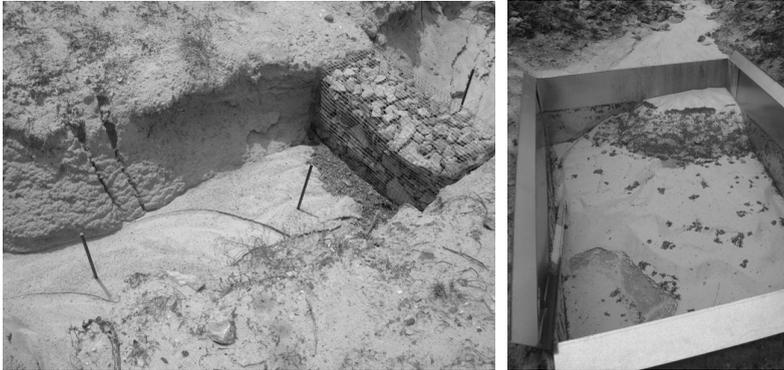
Figure 2: (A) left, gabion sediment trap in an entrenched channel; (B) right, pit sediment trap located at the footslope collector of a silica sand gully.

Based on this principle, we have used in our study: (a) gabion check-dams built *ad hoc*, in suitable entrenched channels (Segovia Province) (Fig. 2(A)); (b) gabion check-dams in which the dikes have been raised, once they were silted (Ribagorda gully, Guadalajara Province). Figure 3 shows the starting point of the Ribagorda sedimentation monitoring setting, installed in January 2007.

Additionally, a 1.5 x 2.25 x 0.75 galvanized sheet box has been installed as a pit trap [4] at the mouth of another silica sand gully main collector channel, at the Segovia Province (Fig. 2B).

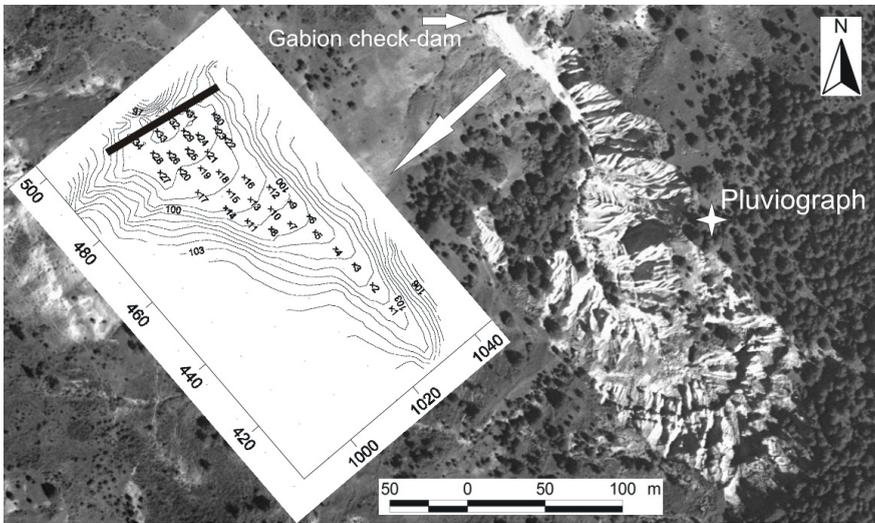
Figure 3: Orthophoto of the Ribagorda gully catchment. The contour map to the left shows the topography of the first sedimentation platform behind the new raised check-dam, where the sediment yield is monitored. Within the platform, position and numbers of rods are shown.

In both cases, a series of 16 mm iron rods were driven into the soil of the sedimentation platforms, with washers located at the land surface which mark the starting point of the filling process. Once installed, detailed topographical surveys of the dam areas, including the dikes, were carried out. Thus, after each precipitation event, recorded at any of the pluviographs installed, the exposed length of the rods is measured, and a record of the sediment yield for that event is obtained.

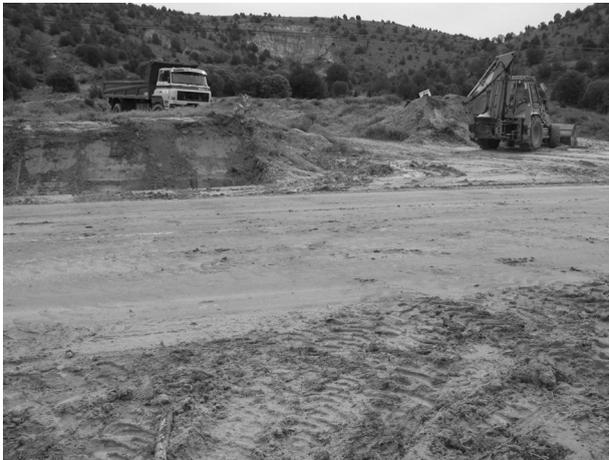
Figure 4: After intense storms, the fillings of local roads with sand, which make necessary the cleaning of this sand, allow a quantification of the sediment yield from the silica sand gullies.

On May 25th, 2007, a convective storm triggered intense erosion on a small area of the Segovia silica sand gully slopes. As a consequence, some local roads were filled with sand, as the one shown on Figure 4, buried at this point with 31.5 cubic metres (44.1 tons) of sand. The gully catchment had one hectare of surface, and the precipitation event was recorded with 27.5 mm in 24 hours.

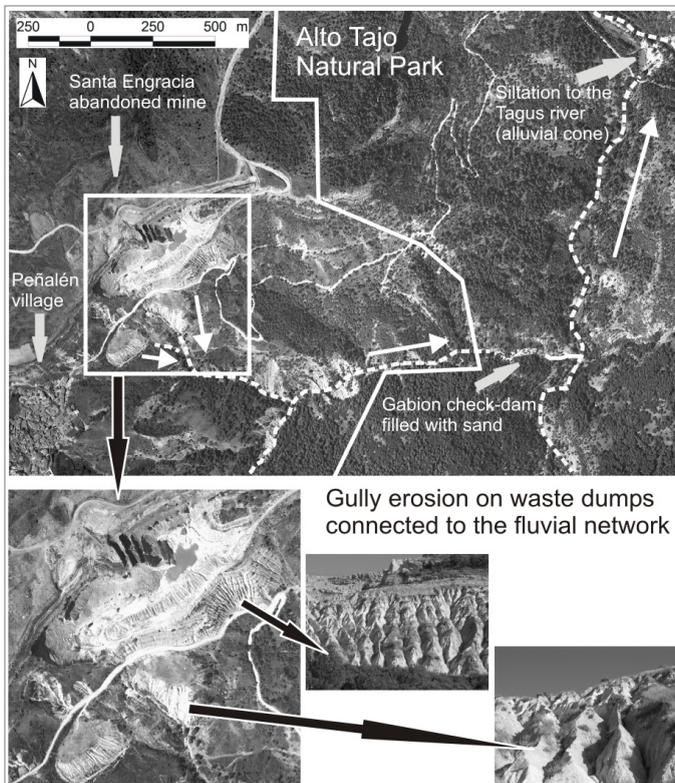
Figure 5: Hydrological impact of the Santa Engracia abandoned mine.

A geomorphic analysis of non-reclaimed silica sand mines, both at the Segovia and Guadalajara provinces, shows that they evolve towards gully and badlands landforms when no reclamation is made. The erosion of these sites produces on and off site environmental impacts, such as soil degradation and declining soil fertility (within, and at, the surroundings of the mine), sedimentation on roads, and siltation of nearby rivers, among others. The Santa Engracia abandoned mine (Peñalén, Guadalajara), constitutes an example of severe hydrological impact, since the siltation affects the Tagus River in a location which is a Natural Park (Fig. 5).

Concerning erosion rates, they are much higher in this scenario than in natural gullies. As an example, in 1984, a 4 m in height gabion check-dam was built downstream of the Santa Engracia waste dumps, in order to store the sediments eroded from them. In 1988, the check-dam was already full of sand. In 1988, the check-dam was raised 4 metres more, being full again before 1990. The volume of this sediment wedge has been estimated to be of 6.000 cubic metres, having been deposited in only 5 to 6 years, and being their main sediment source the spoil heaps of Santa Engracia (Fig. 5). This data, along with field surveys of the Segovia silica sand abandoned mines, make evident that the reclamation of these degraded sites which constitute the abandoned mines is a priority.

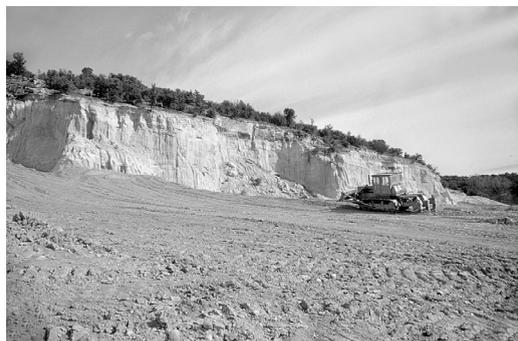
Figure 6: Reclamation of a silica sand mine in the Segovia Province. Former quarry face, white color at the background; the reconstructed pediment with original carbonatic colluvium on it (dark-colored), being extended by a bulldozer, at the foreground.

The existence of a 1995 reclaimed silica sand mine in the study area (Segovia province) allowed us to analyze a 13 year geomorphic evolution of the site, and to compare it with natural gullies and non-reclaimed sand quarries. The reclamation project of this mine was designed by us [8], based on a geomorphic approach. The geomorphic rehabilitation of this silica sand slope mine established two domains well defined. The former quarry face was left to evolve naturally, in order to allow it to acquire a natural appearance, and to reach a geomorphic equilibrium. For that, a trench was built at the highwall foot, in order to retain the eroded material by hydric erosion and mass movements. At the former quarry platform, a pediment (concave shape) was built, resembling the original one, including its surficial deposits (carbonatic colluvium) (Fig. 6).

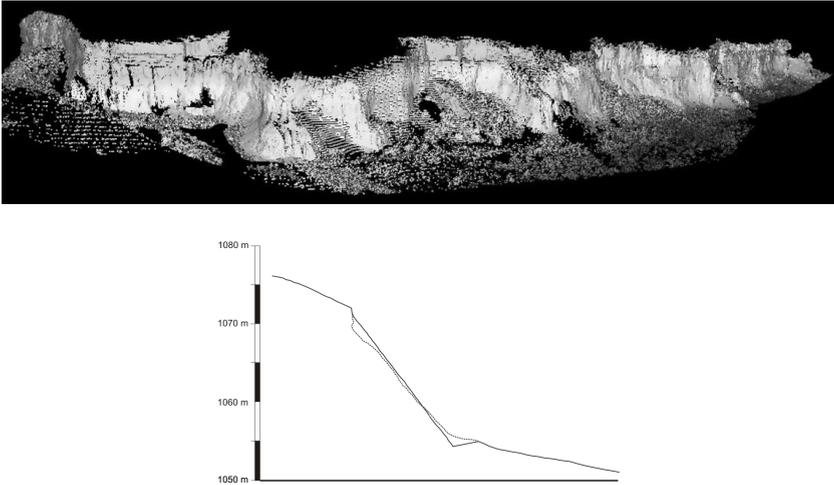
Figure 7: Upper, detailed topography of the former quarry face (laser scanner technology); down, profiles comparison: 1995 (dark line), 2007 (dotted line). The difference of the stroke is due to the fact that the 1995 profile was obtained with total station and the 1997 one with laser scanner technology.

A comparison between the detailed topography of the former quarry face, as it was in 1995, and the one existing in 2007, shows how the slope is acquiring a 'naturalized' profile. At the same time, the eroded material is being accumulated at the trench, without interfering with the recovery of the pediment (Fig. 7).

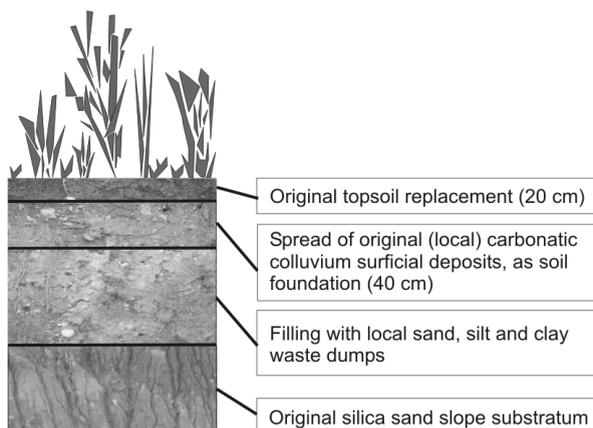
Figure 8: Proposal of surface structure for the reclamation of El Machorro mine. Its design is based on the original structure of the surficial geology of the silica sand slopes in which the mine is located.

3) To adopt a reclaimed terrain structure based on the original structure of the surficial geology of the silica sand slopes in which the mine is located (Fig. 8). For that, the collection of the original carbonatic colluvium and soils, previously removed for the mining activities are considered to be essential for the success of the reclamation.
