Multi-technique investigation of calcium hydroxide crystals at the concrete surface

Abstract

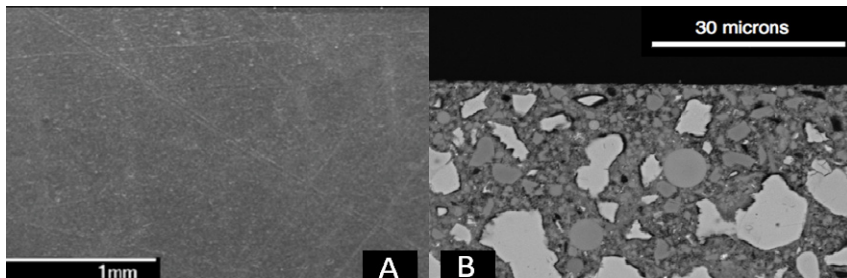
Figure 1: SEM observations of a standard high-performance concrete surface in secondary electron mode (A) and in back-scattered electron mode on a polished section (B).

Figure 1 shows observations of both the surface (A) and the cross-section (B) of a standard high-performance concrete. No specific features are visible on the surface, except for a couple of scratch due to the formwork defects. As for the polished section, it reveals a classical concrete microstructure, with dark grey aggregates and light grey un-hydrated cement grains surrounded by cement paste.

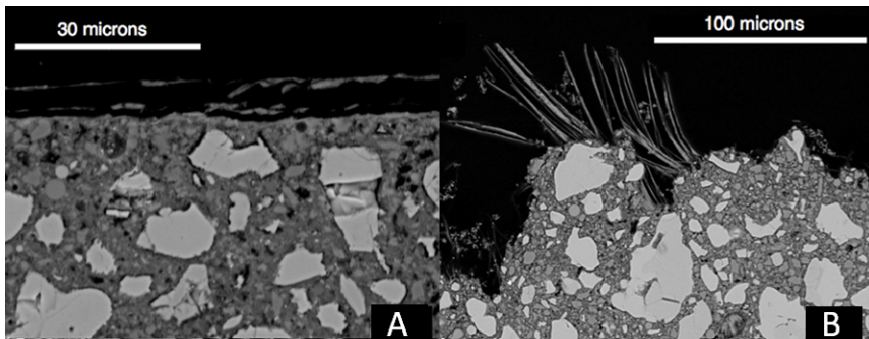
Figure 2 shows SEM observation of two cross-sections from two different samples. These observations reveal the presence at the concrete surface of a thin layered structure presenting various orientations and organization, sometimes well-aligned parallel to the surface (A), sometimes arranged in a more chaotic way in the first micrometers of the surface (B). At this level of observation, it is not possible to clearly indentify the nature of this unexpected phase. The limited magnification in back-scattered mode, the thin structure of the hydrates and the surface damages due to the polishing all complicate the interpretation. This is why it is necessary to make complementary observations of the surface itself.

Figure 2: SEM observation in back-scattered electron mode of two polished sections from two different concrete samples from the study.

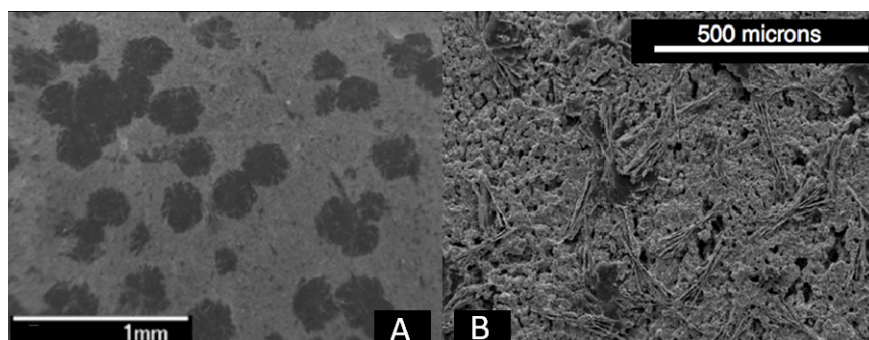
Figure 3 shows the same samples as figure 2 observed from the surface in secondary electron mode. These micrographs allow a better understanding of the structure of the crystals. All of them share the same layered and flaky structure with different orientations. In all cases, the crystals are composed of thin leaves that grow around the nucleation point. For some crystals, these leaves are strictly parallel to the surface and grow as ‘flower petals’ around the central point, reaching sometimes a perfect hexagonal shape. For other crystals, the leaves are strictly perpendicular to the surface, forming a very regular spherulitic structure. This very organized structure was not visible on the polished sections, where the leaves appeared randomly implanted in the surface. This is due to the polishing, which damaged the first micrometers of the surface and disturbed the structure.

The characteristic hexagonal shape of the crystals, as well as their layered organization, allow identifying them as calcium hydroxide – no other concrete phase would present this morphology. This is confirmed by EDS analysis, where mostly calcium is detected in these areas (spectrum not showed).

Figure 3: SEM observation in secondary electron mode of the surface of two different samples from the study.

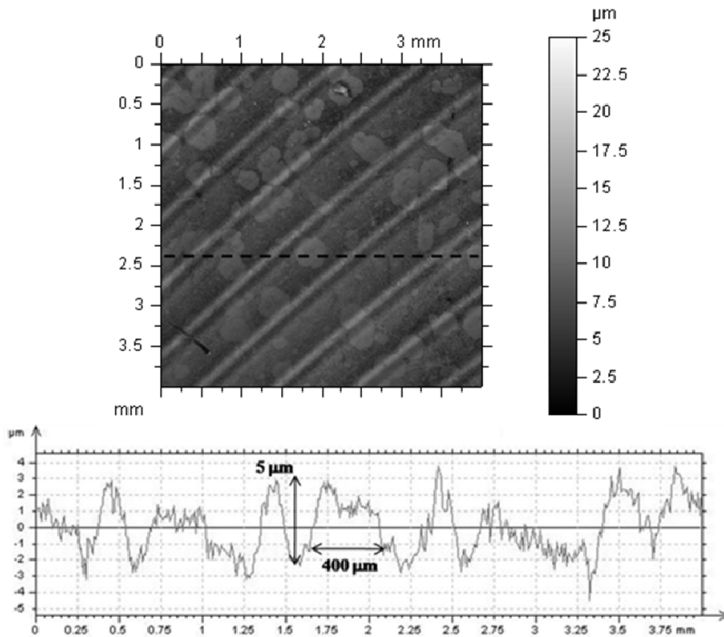
Figure 4 shows an example of profilometry on a sample where the crystals are oriented preferentially parallel to the surface. Two patterns appear on the 2D mapping: regular and slightly curved lines, which are due the formwork texture, and irregular spots, which are the CH crystals. Below the mapping is a roughness profile extracted along the dotted line. The narrow peaks correspond to the lines, the larger one at 1.7 mm corresponds to the CH crystal in the middle. The profile allows measuring the size of the crystal (400 micrometers) and the height between the concrete surface and the top of crystal (5 micrometers).

Figure 4: Example of a mapping of the concrete surface. The profile was extracted from the mapping along the black dotted line.

The measurements from figures 4 and 5 give an estimation for the total thickness of the crystals of 20 micrometers. Of course, the operation has to be repeated a large number of times to obtain statistical results. This is only one example taken from one of the samples.

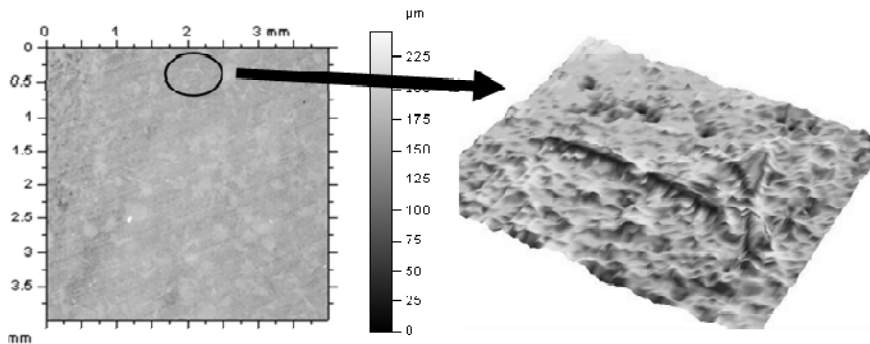
It should be noted that profilometry gives no conclusive information for the samples where the crystals are oriented perpendicular to the surface. Figure 6 shows a mapping of such a sample (A): the spherulitic structures appear slightly lighter than the surface, but are difficult to distinguish. A zoom on the mapping (B) reveals that the crystals are indeed apparent, but that the resolution is far from being sufficient to separate the different flakes composing the structure.

Figure 6: Example of a mapping from a sample with perpendicular crystals. The 3D mapping on the right is a zoom from the 2D mapping on the left.

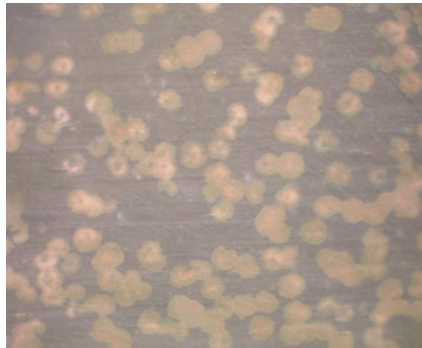
Figure 7 shows an example of an image prior to treatment. The brightness and contrast of the images were optimized using the automatic function on the software. The optimization was not based on the whole image, but on the histogram analysis of a small area of one of the particle on the image. This step created a highly contrasted image where particles appeared red and the background black (figure 8).

Figure 7: Example of an image before treatment by the software imageJ.

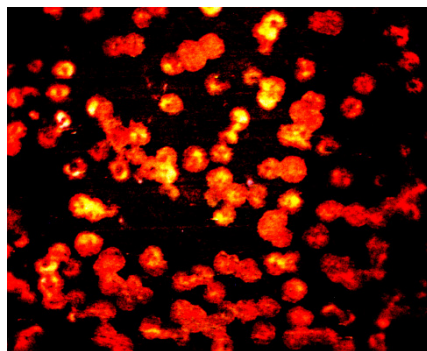
Figure 8: Example of an image after optimization of the contrast and brightness.

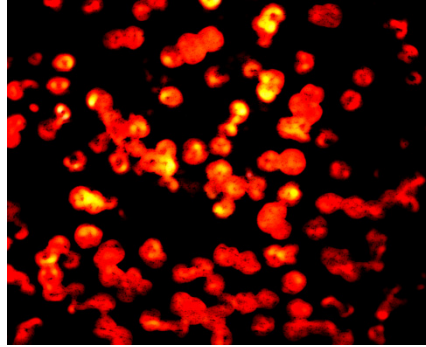
The noise was removed using the 'remove outliers' function of the software, which replaces each pixel by the median value of its neighbours in a given area (figure 9). In this case, a radius of 20 pixels was considered, and the removing was set to occur if the difference between the considered pixel and the median of its neighbour was higher than 10.

Figure 9: Example of an image after noise removal.

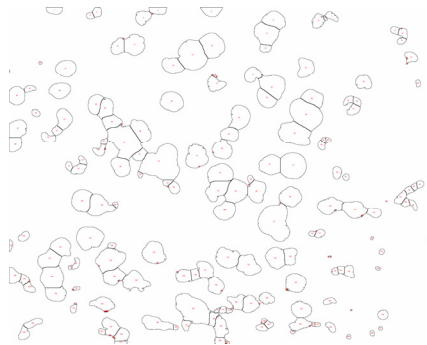
Finally, the 'watershed' function was used to automatically draw the outlines of the particles (figure 12). This step might be the main cause of errors in the measurements, as watershed segmentation works best for convex objects that do not overlap too much. In some cases, the software was not able to correctly separate clusters of particles, which were then counted as one big particle.

Figure 12: Example of an image after the software automatically delimited the particles.

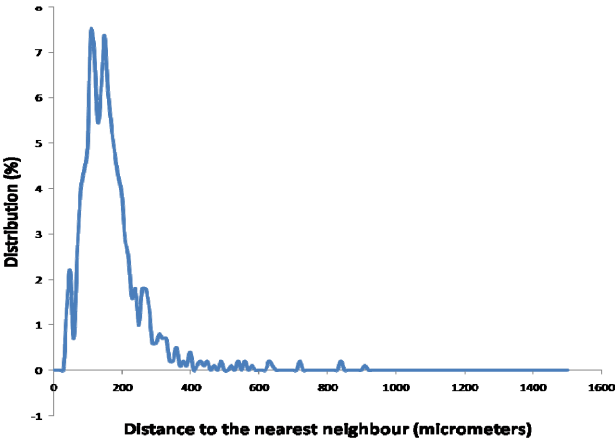
- The coordinates of the centre of the particles. These coordinates were used to calculate the distance between each crystal and its closest neighbour and to verify that the nucleation appeared randomly and homogeneously on the surface (figure 13).
- The Feret's diameter, which is the longest distance between two opposing points of the particle.
- The fraction area of the surface covered by the crystals. As these crystals are artificially grown to act as a mineral coating, this fraction area must be as high as possible. The results showed that even if the crystals seemed very large, they hardly cover 50% of the surface, except in one promising case where almost 100% of the surface was coated.

Figure 13: Example of spatial distribution of the particles on the concrete surface, showing that the nucleation occurs rather homogeneously on the surface.

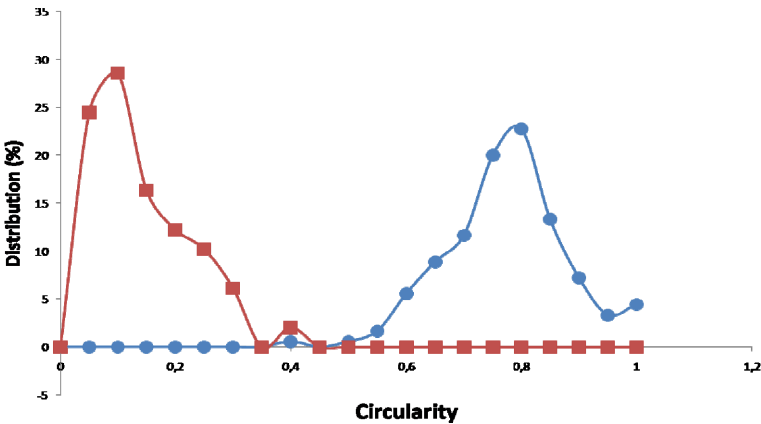
- The circularity of the particle, which is defined by $4\pi \cdot \text{area} / \text{perimeter}^2$. A perfect circle has a circularity of 1, whereas a very elongated particle has a circularity close to 0 (figure 14). This geometrical parameter is very convenient to distinguish the crystals that grow parallel to the surface with regular shapes (high circularity) from the crystals that grow perpendicular to the surface, which have a low circularity.

Figure 14: Two examples of the circularity distribution. The curve marked with squares corresponds to a sample where the crystals have a low circularity because they grow perpendicular to the surface. The curve marked with dots corresponds to a sample where the crystals have a high circularity because they grow parallel to the surface and adopt very regular shapes.
