Material characterisation to understand various modes of corrosion failures in large military vehicles of historical importance

Abstract

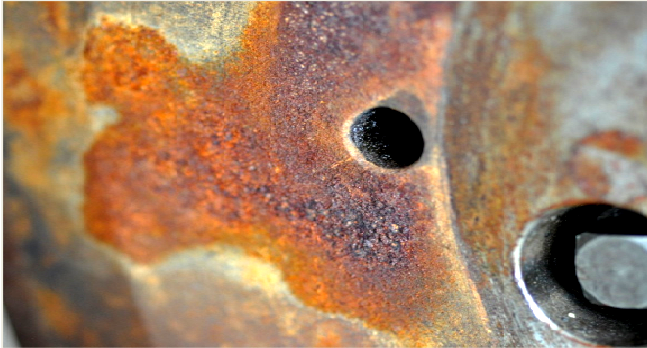
With uniform corrosion a direct chemical attack affects the surface of the metal and then spreads out evenly across the entire surface, results are not usually fatal and it is not classified as one of the severe forms [9]. Figure 1 of the King Tiger's flywheel shows uniform corrosion spreading across the surface. Uniform corrosion was also found in Tog II and FT 17 on considerably larger surface areas. Uniform corrosion, if left to continue, could lead to general thinning of the surface and may transform in to another form of corrosion [10].

Figure 1: King tiger flywheel.

The modes of corrosion identified above can be retarded by using the protective measures such as coatings and paint for uniform corrosion, application of lubrication and exclusion of air in the fretting corrosion, alleviating the stress in stress corrosion cracking, using same metal types in galvanic or applying insulation between two different metals.

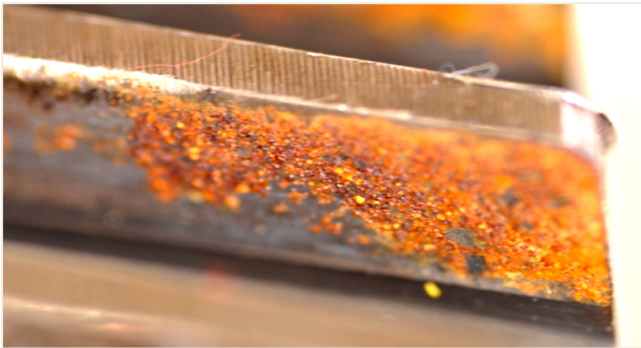
Fretting corrosion occurs at the interface of the interacting surfaces which are subject to relative motions. The King Tiger planetary gears (Figure 2) are a classic example of this form. Interacting mechanical wear lead to the removal of material particles, followed by the oxidation of the material debris and the newly exposed surface [11]. The oxidised debris would act as an abrasive media leading to further wear and fatigue failures could occur [9, 12].

Figure 2: King tiger planetary gears.

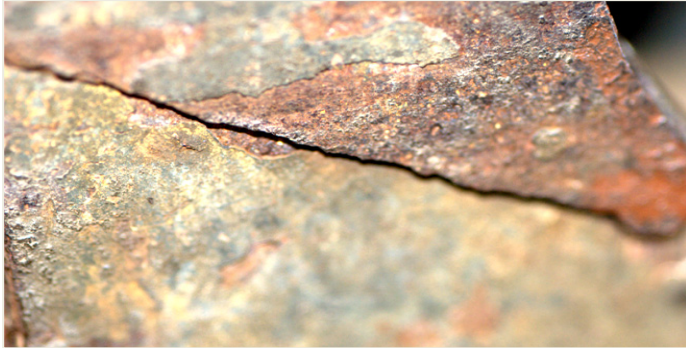
Stress corrosion cracking is considered one of the severe types of corrosion, it could cause a partial or complete failure of a structure especially in the presence of dynamic or static loading and initiation of a stress corrosion crack [13]. The Mark-II Tank glacis plate in Figure 3 shows stress corrosion cracking where a crack is initiated and penetrating through the surface with no significant material loss on the surface. Stress corrosion is difficult to detect, hard to predict and unexpected failure can occur [13, 14].

Figure 3: Mark II glasis plate.

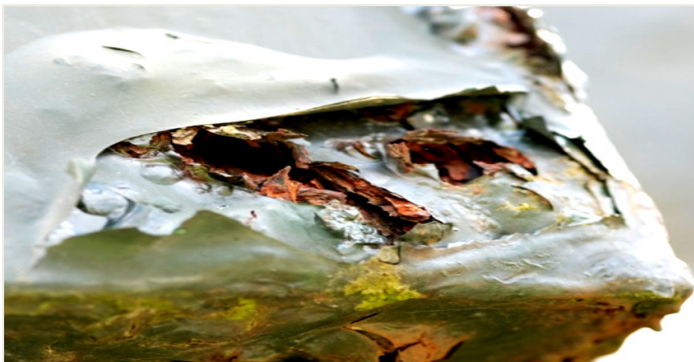
Inter-granular corrosion describes the attack on a metal's or alloy's grains or boundaries [15]. Corrosion products between the grain boundaries exert pressure on the grains and the result is exfoliation corrosion. The Centurion armoured skirt in Figure 4 is an example of exfoliation corrosion leading to lifting or leafing effect. Leafing or lifting effect is a direct result of the expanding corrosive products among the grains of the metals which forces the grains apart [9].

Figure 4: Centurion armoured skirt.

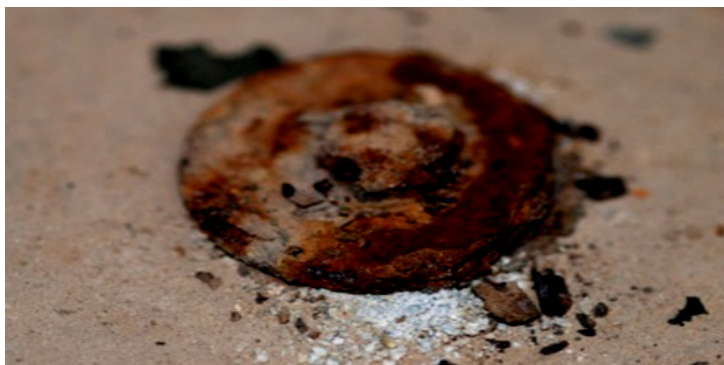
Galvanic corrosion is the electrochemical reaction between two dissimilar metals in the presence of electron conductive path and the preferential corrosion of one metal more than the other [16]. This mode of corrosion was identified in the Scorpion, see Figure 5. The presence of moisture among the bolt, washer and the armoured skirt has caused this type of corrosion.

Figure 5: Galvanic corrosion in scorpion.

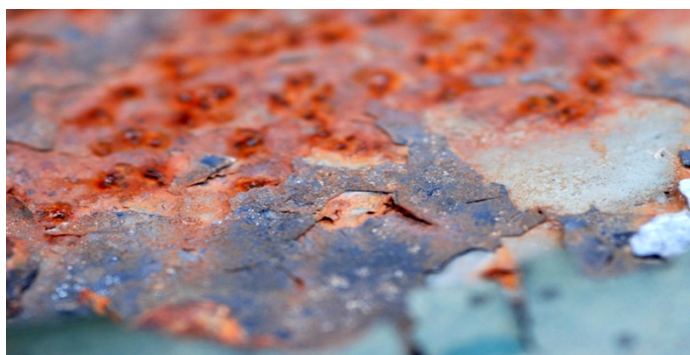
Centurion in Figure 6 shows signs of pitting corrosion. In this case the corrosion is confined to a small point with resulting cavities in the metal. The localised phenomenon of corrosion creates holes in the metal and then penetrates inwards, deteriorating metal from the inside. The corrosion products covers the pit and creating a small hole with no significant material loss on the surface leading to a catastrophic malfunction, it is one of the severe forms of corrosion which is very difficult to detect and hard to predict the result [14, 17, 18].

Figure 6: Pitting in centurion.

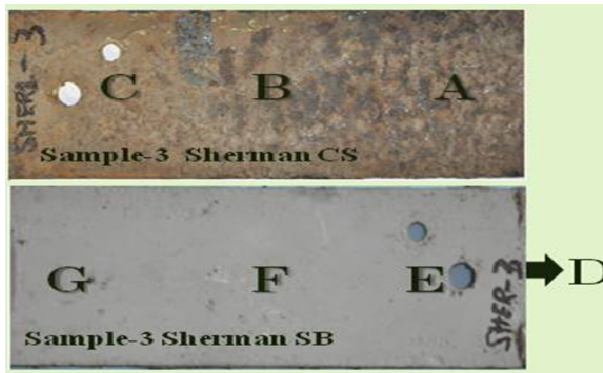
X-Ray fluoresce (XRF) was conducted on three points A, B, C on corroded, E, F, and G on sand blasted surfaces and point D on the cross section of the sample, see Figure 7. Table 2 shows results of the points A, B and C. On averages Fe 92.07% is the highest, second highest is the Si 5.39%, Mn 0.91% was the third highest and the lowest was Cu with a trace of 0.04%.

Figure 7: XRF points on Sherman.

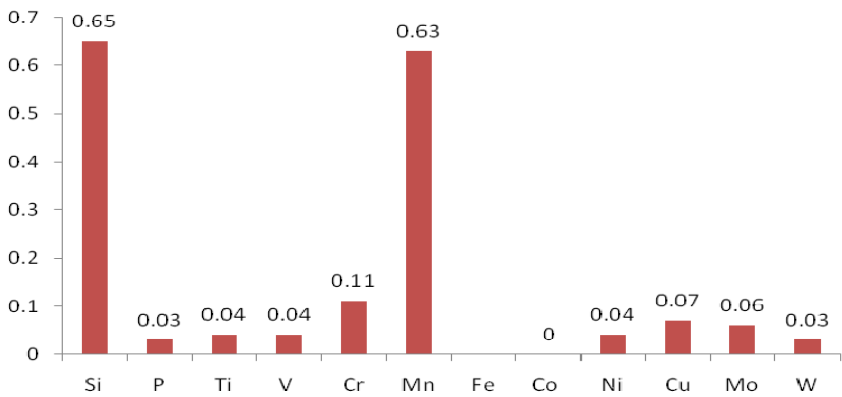
Figure 8 shows the graphical representation of the XRF conducted at point D where Fe 98.30% is the highest, second highest is Si 0.65%, Mn 0.63% the third highest and traces of Ti, V, Co and Mo were identified.

Figure 8: XRF analysis of point D, No Fe (98.30%) included.

The alloying elements such as Mn, Cr, V W and Mo identified though XRF are used as hardening agents to improve hardness, ductility and tensile strength [19]. Also Mo, Mn and P are used for the rust and corrosion prevention. Mo is used in high strength alloys and super alloys for strength and wear resistance [20].

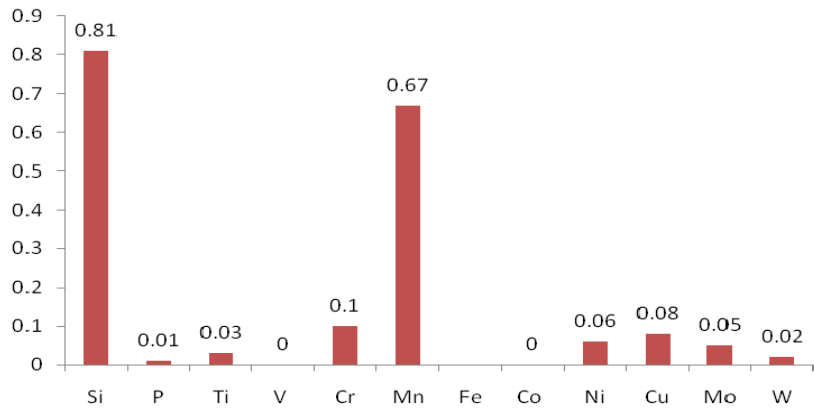
XRF conducted at points E, F and G on the sandblasted surface shown on averages Fe 98.12% the highest, Mn 0.66% second highest, Si 0.59% the third highest while W 0.02% the lowest and no traces of Co or V were identified. Figure 9 shows the graphical representation of the XRF analysis at point G.

Figure 9: XRF analysis of point G, No Fe (98.09%) included.

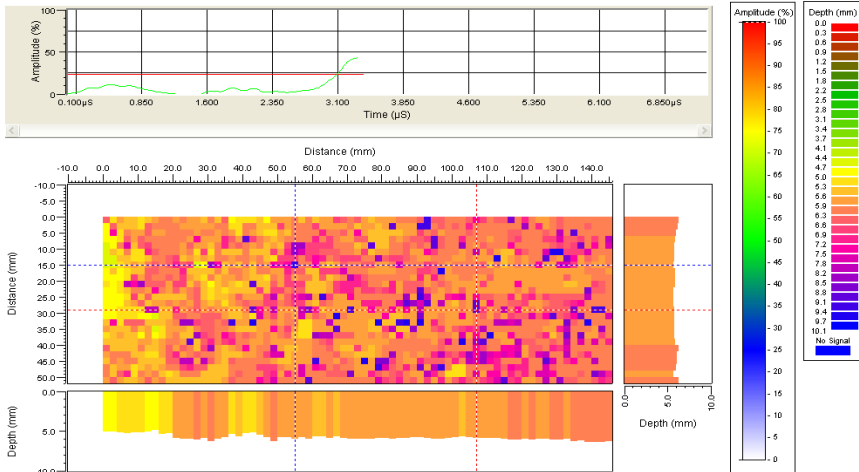
Figure 10 shows the end views and the c-scan of the sample with implementation of colour coding Red for 0.00 mm and Blue for 10.00 mm. Two cursors Red and Blue show the X-axis, Y-axis location and the corresponding depths of the particular points on the sample.

Figure 10: Pulse echo scan of M4A1.

Sherman M4A1 was designed by Lima Locomotive Works in the United States. At the time of manufacture the armoured thickness range was kept between maximum of 62.00 mm and a minimum of 12.00 mm [21, 22]. However it is not practical to follow any possible modification in the armour thickness and because of this reason the highest thickness recorded in the scan is considered the maximum thickness. During the service life, exposure to extreme environments has led to the deterioration and material loss. The ultrasonic scan of has shown a remarkable material loss of 5.20 mm between the maximum remaining thickness of 9.80 mm and the minimum remaining thickness of 4.60 mm. Currently in the museum collection, the Sherman travels between two controlled and uncontrolled environments. Varying environments and the likelihood of failing protective measures, temperature fluctuations, humidity ratio variations, rain water and the extent of chemical reaction etc will influence the rate of corrosion and in the controlled environment corrosion residues from may result in indoor atmospheric corrosion [23, 24].

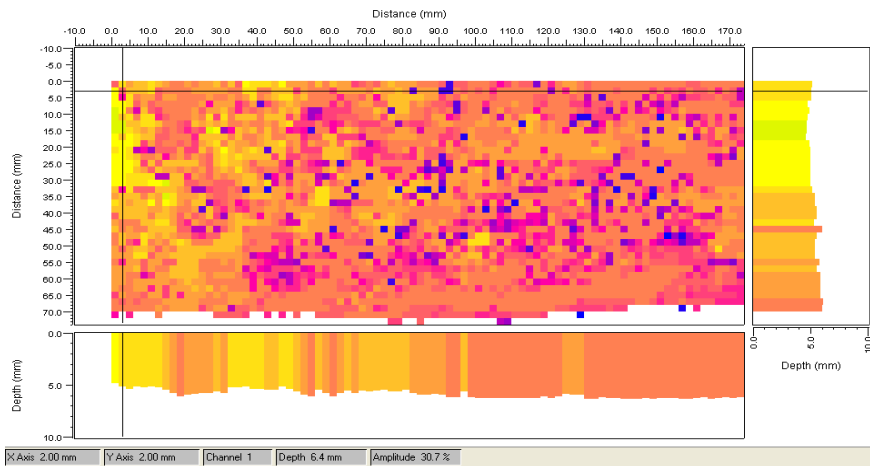
A user defined area is taken for finding the maximum and minimum thicknesses starting at 2.00 mm on the X-axis, 2.00 mm on the Y-axis in Figure 11 and finishing at 172.00 mm on the x-axis and 66.00 mm at the y-axis in Figure 12 respectively to avoid any distortion in signals at the edges. The scan detected maximum remaining thickness of 9.80 mm at horizontal position of 150.00 mm and vertical position of 26.00 mm with a drastic loss in material to a minimum of 4.60 mm at horizontal position of 28.00 mm and vertical position of 8.00 mm. The maximum thickness of 9.80 mm is recorded at two different points. The second lowest depth is 4.70 mm and is detected at seven different

Figure 11: User defined area starting at 2.00 mm on x-axis and 2.00 at y-axis.

positions; third lowest of 4.80 mm at six various points and the remaining thickness of 4.90 mm are recorded at four different points in the samples. The minimum remaining thickness of 4.60 mm is recorded at three different points.

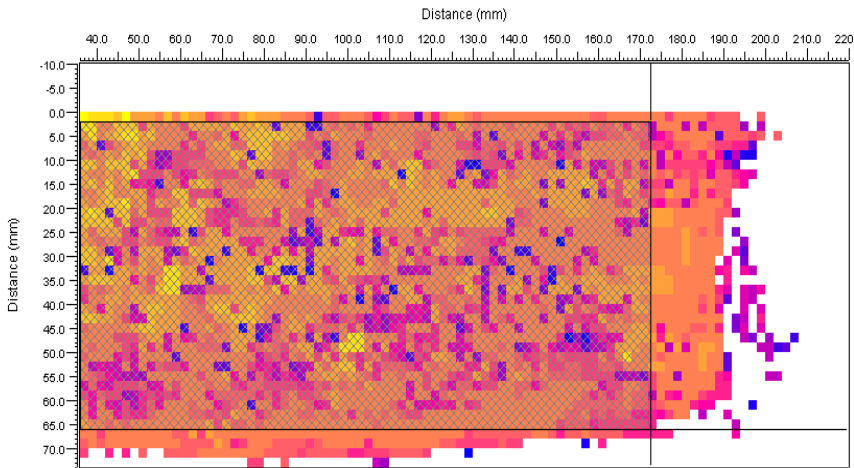
Figure 12: User defined area finishing at 174 mm on x-axis and 66 on y-axis.
