# Structural strategies and measures reducing flood action on architectural heritage

M. Drdáký & Z. Slížková

*Institute of Theoretical and Applied Mechanics of the  
Academy of Sciences of the Czech Republic,  
ARCchip Centre of Excellence Telč, Czech Republic*

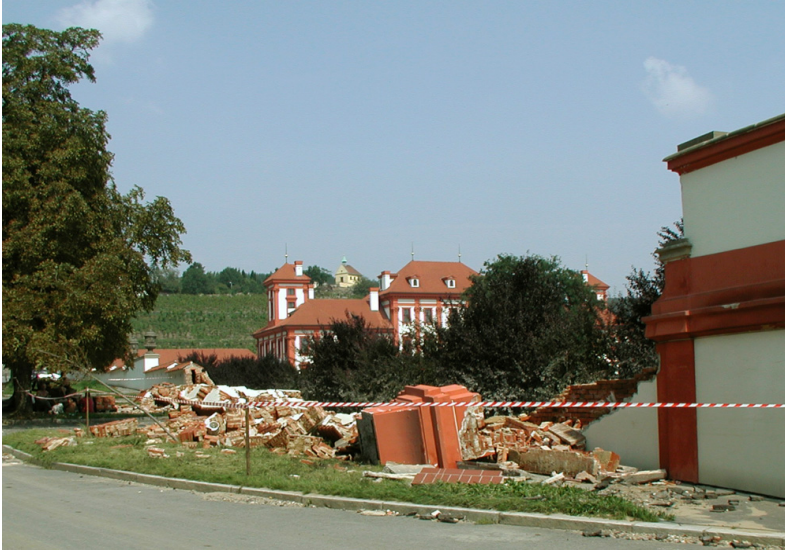
Figure 1: Failed garden wall subjected to water pressure and flow.

In the case of free standing walls balancing water pressure is necessary. This is usually achieved by openings allowing flowing water behind a wall. Short walls, namely the walls in lower floors of buildings might be effectively temporarily strengthened. Walls built with an axis perpendicular to the main water stream direction are to sustain pressure loads which are higher than the pressure from simple immersion not only due to the dynamic action of the mass of water (Fig. 1). The water depth is increased by the backwater effect which might substantially contribute to the water pressure and must be taken into account when designing temporary cellar or ground floor walls strengthening. Parapet walls on bridges may be dismantled and after the flood built up again. In any

case a perfect documentation and even marking of individual stones is useful for an easier assembly after a possible failure.

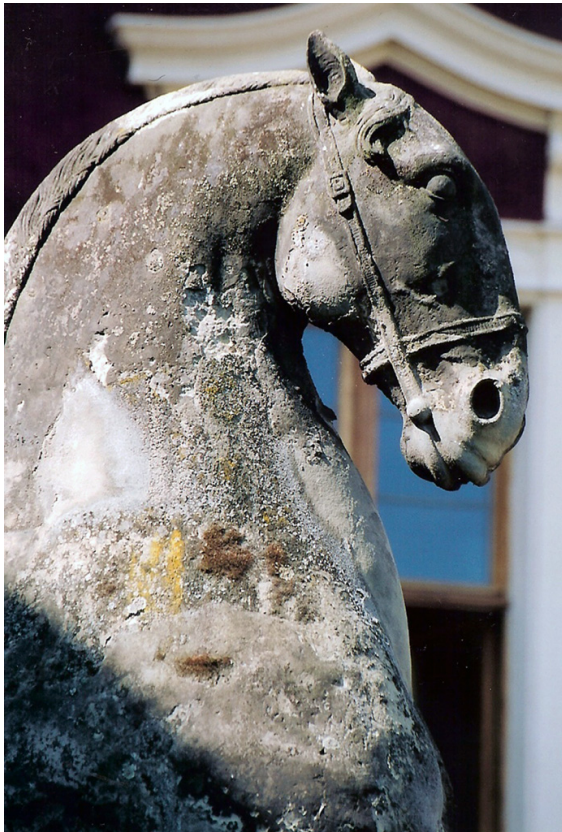
Figure 2: Increased contamination by salts, bio-colonization and surface detachment and disintegration patterns due to inappropriate restoration and treatment before flooding.

Several examples from recent damage on cultural heritage monuments due to natural disaster effects clearly show a very close dependence of the extent of damage on the previous restoration interventions and the health condition of the damaged monument (Drdácký *et al.* [1]). The second author analysed damage on historic objects in the Château Veltrusy park near Prague which were severely damaged by the flood in 2002. There was remarkable difference between objects which had been properly restored before the flood, e.g. a stone bridge with Sphinx, and objects which were neglected or incorrectly restored, e.g. sculptures on the Château monumental stairs, Fig. 2. Even though the bridge was totally immersed in a high water stream, it needed to be only cleaned with water and low pressure steam. In 2004 some hair cracks and slight mortar disintegration were visible in masonry joints. After repeated flooding in 2006 the bridge was only slightly restored (colour retouch, plaster repair). On the other hand, the

sculptures were repaired long before the 2002 flood in a way which applied Portland cement and polyvinylacetate consolidation which substantially decreased water and vapour permeability and kept water inside the material. This increased contamination by salts, bio-colonization and surface detachment and disintegration patterns up to 3 m height. Freezing, moisture dilation and crystallization damage required a very substantial restoration intervention after the flood situation.
