GIS analysis of flood damage using Google Earth

M. Mori & T. Kameyama

*Department of Information and Computer Science,
Kinki University, Japan*

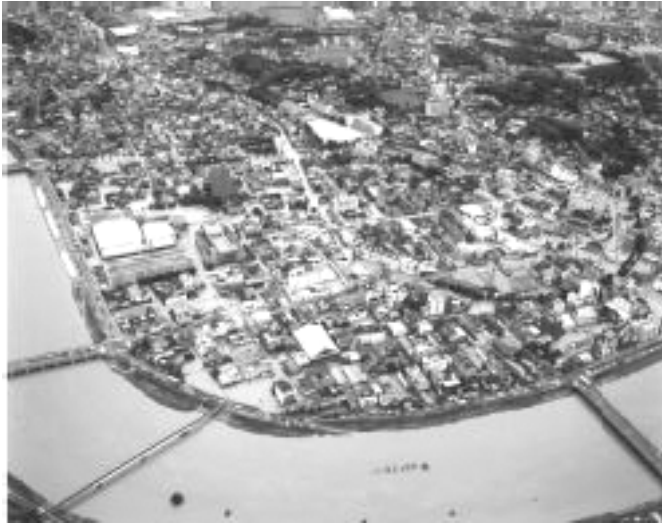
Figure 1: Flooded area of Iizuka City.

Heavy rainfall occurred in Fukuoka Prefecture, Japan, on July 19, 2003 [3]. As a result of the storms, the Onga River overflowed its banks, and the floodwaters reached the central part of Iizuka City. In Iizuka City, several hundred houses were flooded, and many office buildings were inundated with muddy water, causing many kinds of disaster in various areas. Figure 1 shows the flooded area of Iizuka City on the next day of heavy rainfall. A northern part of the Onga River in this figure is flooded. Also, Figure 2 shows the same area before the flood disaster.

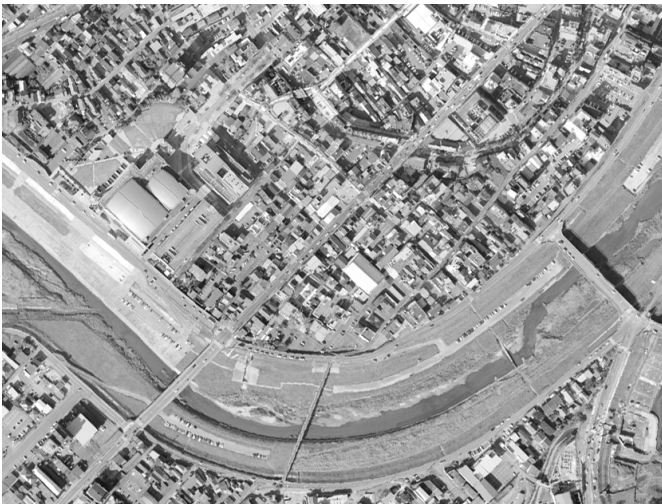
Figure 2: Iizuka City before the flood disaster.

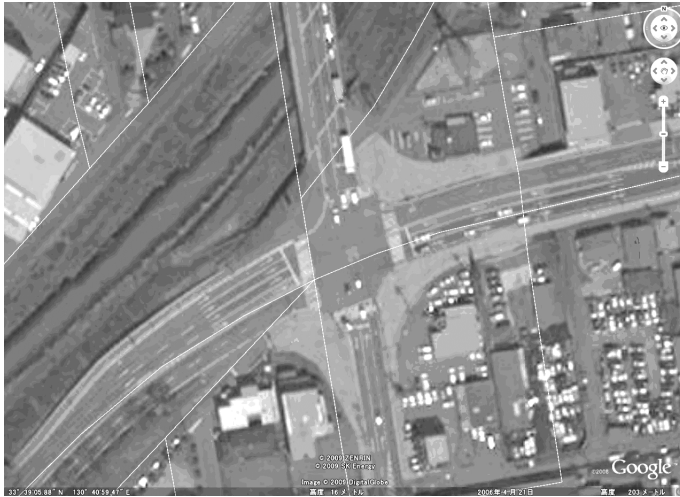
Figure 3: Google Earth image overlaid with a shape file of roads.

Figure 3 shows the Google Earth image overlaid with a shape file of roads in Iizuka City in Japan. The lines of the shape file indicate the center of roads. The shape file of roads is based on a 1:2500 digital topographic map from the Geographical Survey Institute (GSI) of Japan, which contains railroad lines,

water areas, large scaled buildings, and another map attributes. Road lines are generally used for getting ground control points for geometric correction. In this case, the center of roads in the shape file is shifted from those in the Google Earth image.

between Figures 3 and 4 is 14.64 meters at the point of the center of the crossroads.

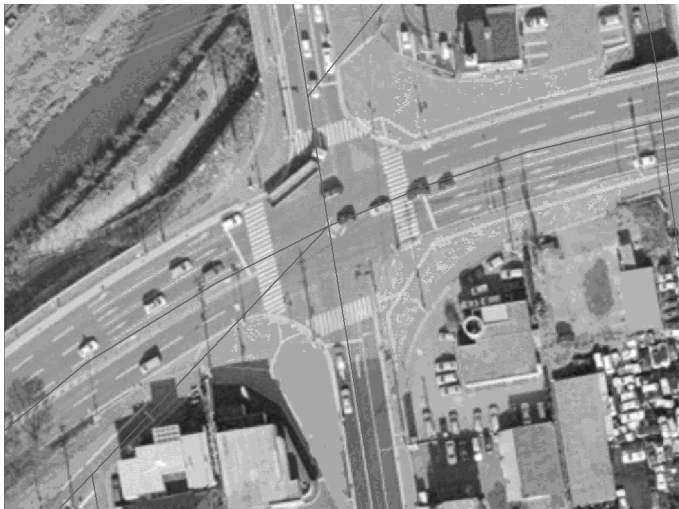
Figure 4: Ortho aerial photo image overlaid with the shape file of roads.

Figure 4 shows the ortho aerial photo image in the same area overlaid with the shape file of roads. The aerial photo image is precisely geocoded. The centers of roads and the shape file coincide perfectly. It is found that the difference

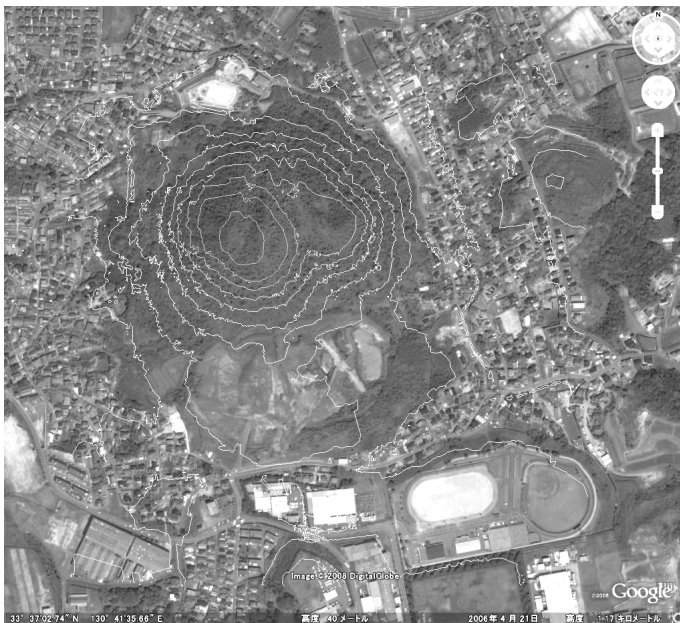
Figure 5: Google Earth image of the Bota hill overlaid with contour lines with 5.0 meter intervals.

Several contour lines with 0.5 to 5.0 meter intervals are generated using ArcGIS. These contour lines are geocorrected to coincide with the coordinates of Google Earth, which are transformed to KML files for the Google Earth application. Figure 5 shows the Google Earth image of the Bota hill in Iizuka City overlaid with contour lines with 5.0 meter intervals for verifying the difference. The contour lines are coincided with the geometry of the Google Earth image.

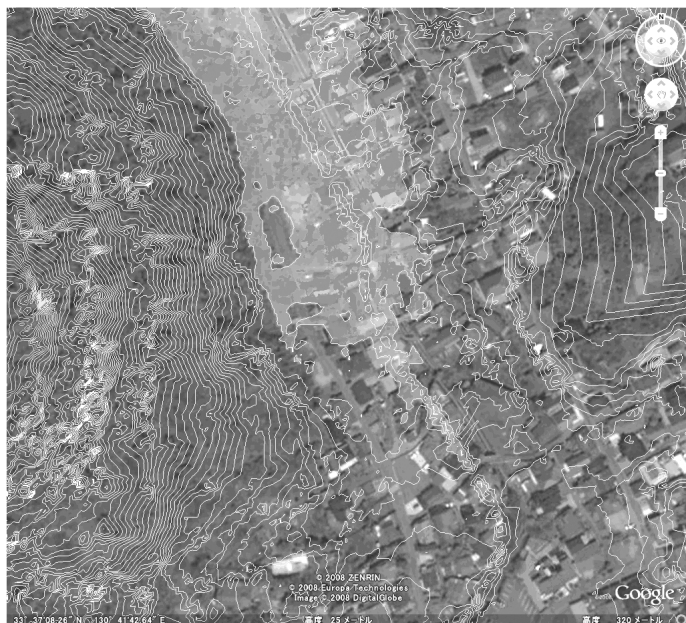
Figure 6: Google Earth image with water levels shown.

Figure 6 shows another Google Earth image with coloured water levels based on contour lines. The coloured areas in this figure show dangerous levels of river flood. Figure 7 shows an enlarged image of Figure 6. Two coloured areas are shown in Figure 7, in which the deeper coloured area indicates the lowest water level in this area. We can estimate each house to be flooded from this image.

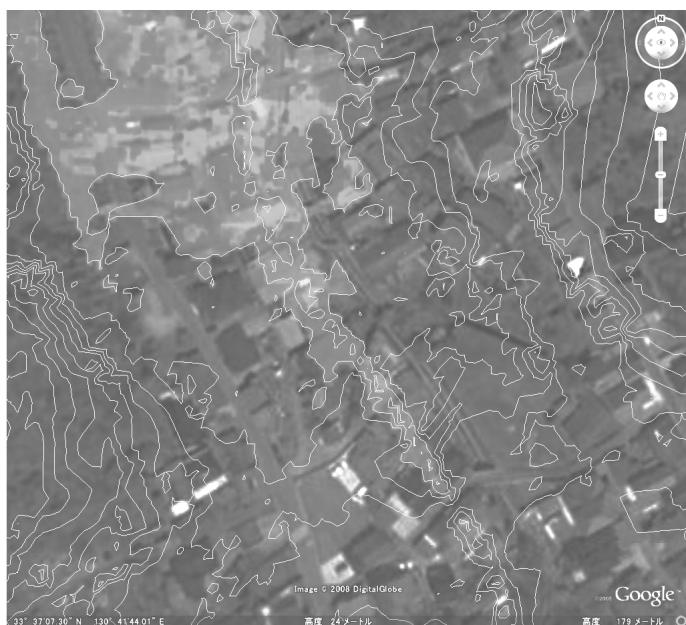
Figure 7: Enlarged image of Figure 6. Two coloured areas are shown.

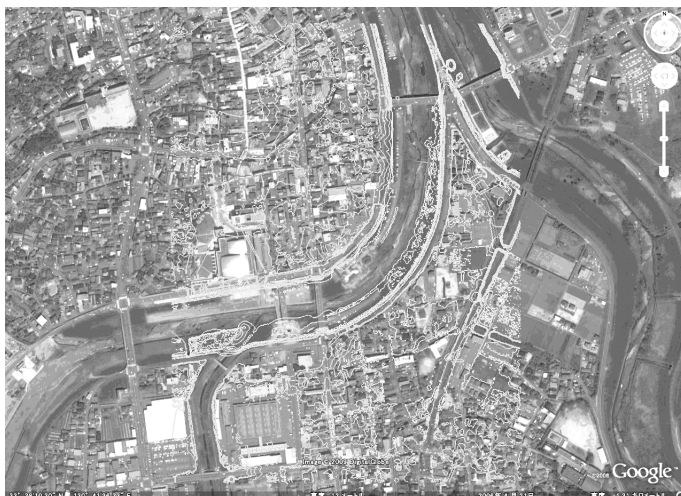
Figure 8: Google Earth image overlaid with contour lines of the same area shown in Figure 1.

Contour lines are shown in Figure 8 overlaid with the Google Earth image of the same flooded area shown in Figure 1. We can estimate the area with the lower water level around the Onga River from this figure. Figure 9 shows an enlarged image of Figure 8. It is found that contour lines of the riverbanks are not correct. The width of the riverbanks is nearly 3 meters.

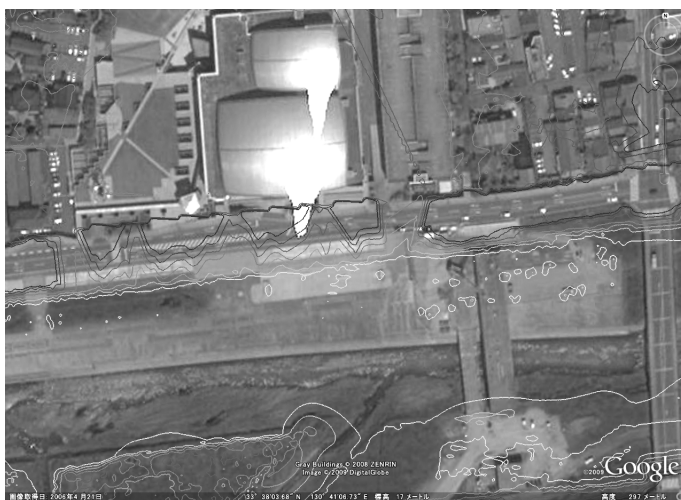
Figure 9: Enlarged image of Figure 8. Contour lines were partially incorrect.
