High density suburbs redevelopment and social housing retrofitting for cities regeneration

A. Boeri & D. Longo

University of Bologna, DAPT, Faculty of Architecture of Cesena, Italy

This paper proposes the analysis of one case study, the Pilastro neighborhood, a significant example of a social housing high density settlement, located in the outskirts of Bologna (IT). This district is an imposing housing estate, chosen for its representation of the social housing heritage in Italy.

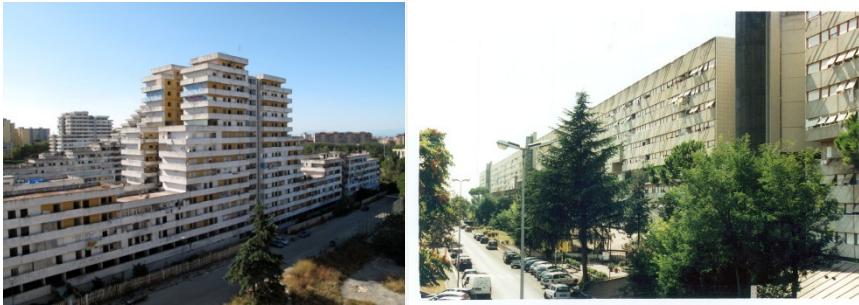
Figure 2: Vele in Naples and Corviale in Rome: symbols of Italian social housing decay.

Special examples are the neighborhoods of Vele in Naples, Zen in Palermo and Corviale in Rome, where besides the problems relating to architectural decay (due to the almost total lack of maintenance on the buildings) there are serious problems relating to social degradation, with a high rate of school drop-outs,

In the instance of Naples, a non-realization of common areas every six floors of a building, a lack of pedestrian paths, playing areas for children, parking areas and bus stops, have deeply affected the quality of social life of those residential districts, forcefully positioned in one of the most problematic neighborhoods of Naples, Scampia.

The original idea was to build a self-sufficient city within the city. Designed as a huge residential unit, it houses, in a single building 1 km long, dwellings for about 8,500 residents. A building of such dimensions, too long for many people, almost a kilometer of solid concrete, with the flaw of having never been completed. Some equipment foreseen by the project was never realized, and an entire floor intended for commercial and business use was abandoned, and later used by squatters who turned it into dwellings. The operating conditions were totally neglected.

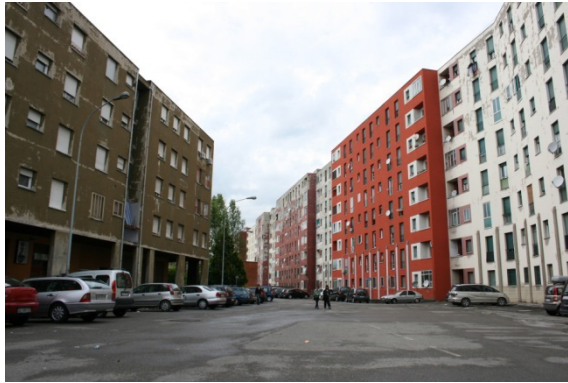
Figure 3: The Pilastro neighborhood in Bologna – Italy.

The Pilastro district was chosen by our research unit for both its dimension and symbolism, as well as for its representative image of social housing heritage in Italy. Pilastro, with its 7,500 residents (about 3,000 less than during the 1970s), is an important settlement of public housing located in the San Donato district in Bologna. It was developed during a period ranging from the end of the 1950s up to the middle 80s and this is the reason why the main development stages of social housing building are represented here, with examples of different typological, technological and constructive experimentations that characterized its evolution.

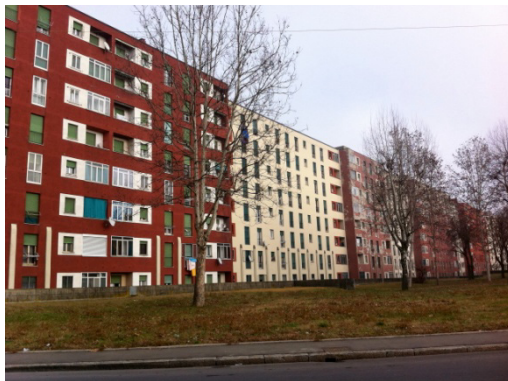
Figure 4: Some already retrofitted buildings in the Pilastro neighborhood.

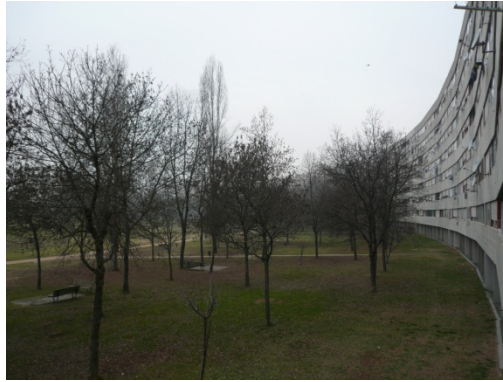
Figure 5: Virgolone building in the Pilastro neighborhood, Bologna.

The strong monotony of their façades, which in the case of "Virgolone" are identical and uninterrupted for 700 m, even if as a result of well intended projects, is today felt by the residents as negative branding and, with no other gelling elements, does not contribute to create an "urban image" that could generate a sense of belonging.

The poor quality of the exterior finishing and the state of disrepair they are in are a clear statement of the current difficulties ACER Bologna, the managing body of the public housing stock in Bologna, is going through in meeting the necessary maintenance works.

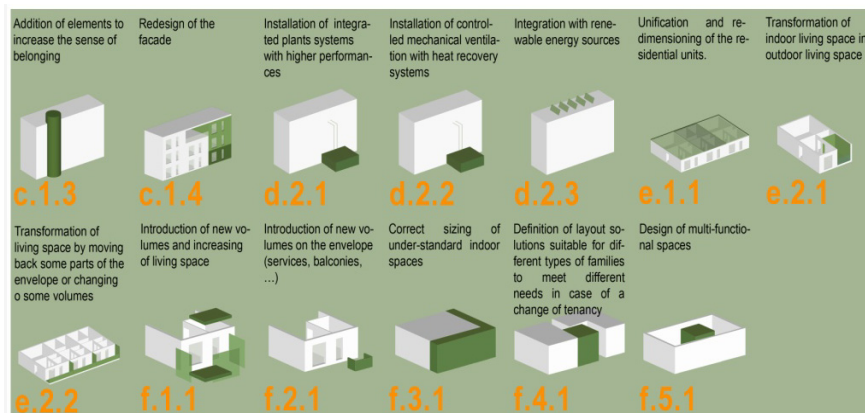
Figure 7: Schemes of “added volumes” in order to increase outdoor and living spaces.

The intervention on the units consists of introducing new volumes, characteristic elements of recognition in order to reduce the sense of disorientation of the residents, redefining the façade in a more modern way.

This strategy, which can be defined as “added volume”, is characterized by moving the façade back or forwards, in order to increase outdoor spaces and recalibrate the size of the living spaces. The addition of volumes on the façade helps to expand and redefine the units, both through the realization of new living spaces, winter-gardens and solar greenhouses, and an increase in the service related spaces and balconies.

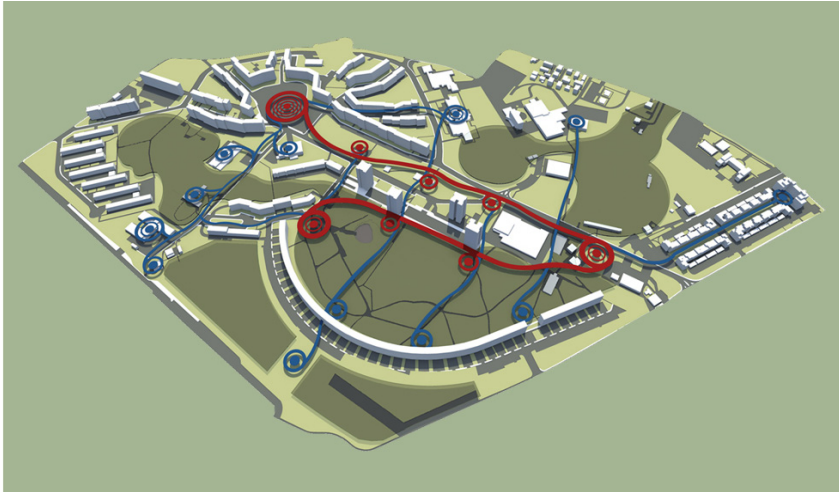
Figure 9: Implementation of functions in the Pilastro neighborhood, introducing strategic activities and services.

- an implementation of the mix of functions in the neighborhood, introducing strategic activities and services;
- an improvement in the relation between the Virgolone building and the surrounding area, by increasing the number of pedestrian and cycle paths connecting the residential area with the park and with the other services of the district;
- a requalification of the community open spaces intended for collective use.
