# Post-occupancy evaluation of pilgrims' accommodation: a case study of Mina in Makkah city

A. M. A. Shehata<sup>1</sup> & A. M. Z. Elzawahry<sup>2</sup>

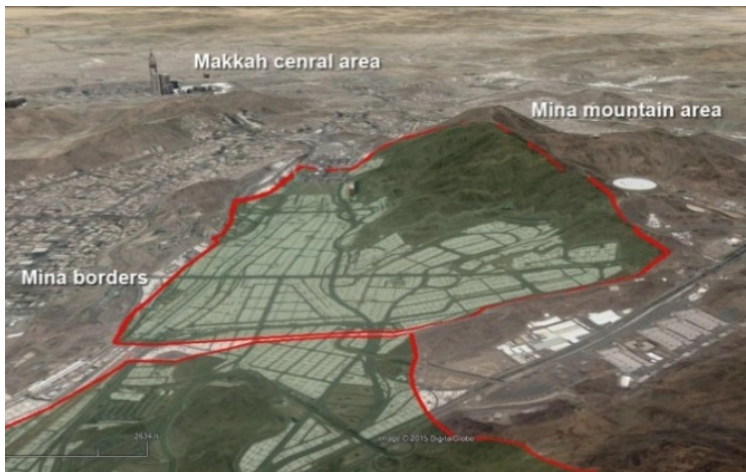
Figure 1: Satellite image of Mina's area [4].

The satellite image of Makkah city (shown in Figure 1), illustrates Mina's location in relation to Makkah city. Mina is located at 6 km to the east of Makkah city; with an area of 8.12 km<sup>2</sup>. As shown in the figure Mina's valley is defined by mountains to the north and south. Mina's valley is 3 km in length by 1.5 km in width, with an elevation varying from 270 m to 320 m above sea level. Steep mountains rise around the valley at elevations up to 1000 m above sea level. Only 52% of Mina's area is developed flat land, while the rest is mountainous. Urban development has extended over almost all over the valley's flat area. Consequently, there is little remaining space for expansion [1, 2].

of the Dhul-Hijja month of the Islamic lunar calendar. Pilgrims have to spend 4 of these 6 days in Mina, a valley that extends 6 km to the east of central Makkah (as shown in Figure 1). The increasing numbers of pilgrims place further strain on Mina's accommodation capacity, which is limited to accommodate 1.3 million pilgrims. The net area allocated for pilgrims has been reduced and all hilly areas have been used to increase the accommodative capacity. To overcome space limitations and temporal constraints, urban designers and decision makers have examined the feasibility of expanding construction on the steep mountains to the north and south of Mina's valley. A Build, Operate and Transfer pilot project was initiated on the northern mountain in Mina to accommodate about 13,000 pilgrims, and a new housing development project in the area of the mountain is about to be tendered.

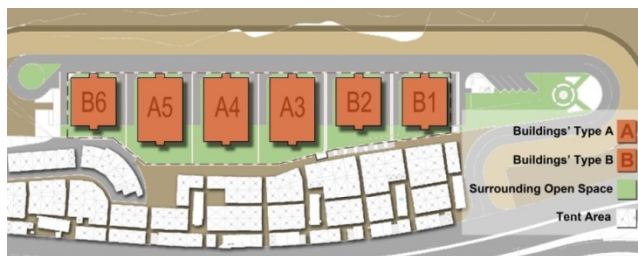
Figure 5: Site plan of pilot housing project in Mina (the author).

Located on a mountain north of the valley, Mina's pilot housing project was initiated in 2004. Six buildings were constructed on 1.3 ha, with a total built-up area of 87,000 m<sup>2</sup>. Figure 5 shows the project's location and spatial layout.

The pilot project site is situated at an elevation of 20 m above the valley, which is where all of the pilgrimage activities take place. The site is served by a cul de sac that is solely dedicated to the conveyance of the project's residents. Another pedestrian access point connects the site to Al-Jamarat Bridge. Additionally, a stairway connects the site to the valley. Figure 5 depicts the project site layout in relation to the valley while figure 6 shows general view of the project and its relation to surroundings.

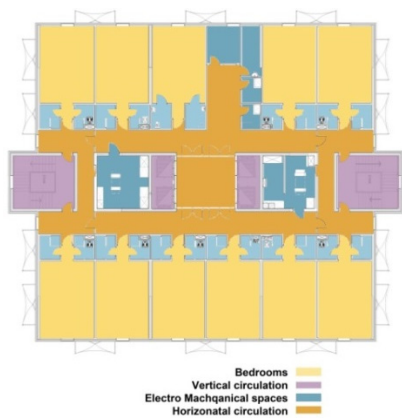
Figure 7: Typical floor plan.

A typical floor plan includes core central services (elevators, staircases, and electromechanical rooms) and identical bedrooms, each covering 32 m<sup>2</sup>, including bathrooms, located along the perimeter of the building shown in figure 7. As shown in Figure 8, the ground floor includes a large outdoor area designed for luggage loading and unloading. It was observed that some of the pilgrims' activities were also performed in these areas. It is noteworthy that the main staircase only serves the first two floors, typically leading out of the building.

The building plans (shown in Figures 7, 8, 9, and 10) reveal a lack of storage area and the absence of a garbage chute and service elevators. The photographs presented in Figures 19 and 20 specifically show the lack of service elevators and storage areas. An evaluation of users’ satisfaction, presented in Figure 19, revealed that 15% were not satisfied with the air conditioning system control. Moreover, 40% of residents reported that their mobile phones did not function within the building spaces, and 15% of residents were dissatisfied with the building communication systems.

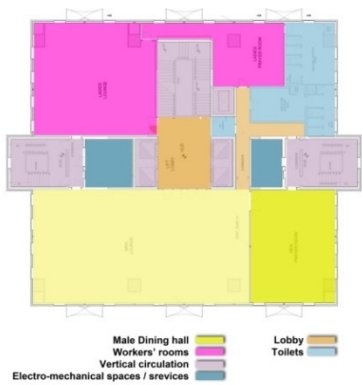
Figure 9: First floor plan.

Fig. 9 shows that the original design of the first floor of Type B buildings had sex-segregated lounges and prayer halls. In addition to providing necessary toilets, the project implementers made some modifications relating to the use of spaces on this floor. They converted the female lounge and prayer hall into workers' rooms. Moreover, they converted the male lounge into a restaurant for men. As Figure 10 shows, the original design of the second floor had separate male and female dining halls, a kitchen, and offices. The project implementers expanded the kitchen to take the place of the female dining hall, and changed the male dining hall into a female dining hall. The final outcome of the modifications was to dispense with the female prayer hall and the gender differentiated lounges, while simultaneously enlarging the two sex-segregated restaurants, as well as the kitchen.

During the project's implementation, as per the plans shown in Figures 9 and 10, one of the two dining halls was moved from its original location on the second floor to the first floor. This extended the dining area and kitchen area to 456 m<sup>2</sup> and 268 m<sup>2</sup>, respectively, with a total area ratio of 0.40 m<sup>2</sup>/resident. It may be worth mentioning here that the restaurant ran a self-service open buffet. However, the dining hall had no service entrance. Moreover, this area was not adequate for catering to the large number of pilgrims.

According to the original design layout, separate male and female prayer halls (respectively, 99 m<sup>2</sup> and 67 m<sup>2</sup>) were located on the first floor of the building. However, the female prayer hall was closed down after operations began. Consequently, female residents had to perform their prayers in their bedrooms. Because of the limited space for prayer, additional male prayer spaces (see Figure 9) were allocated within the surrounding area.

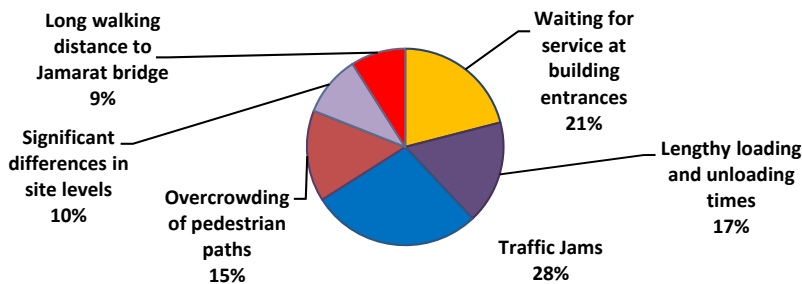
Figure 11: Reasons for users' dissatisfaction with the layout facilities.

The chart in figure 11 reveals that 28% of the pilgrims indicated that their most dissatisfactory experience was related to traffic jams and reaching the building. A total of 21% of the pilgrims found overcrowding at the building entrance upon their arrival to be the most dissatisfying experience. The second chart in figure 12 indicates that the first day (arrival day) in Mina was the most dissatisfactory day in relation to all of the indicators associated with the site layout, building entrances, and arrival-related services.

POE based on users' satisfaction proves to be an effective and appropriate tool in reaching recommendations on Mina's accommodation buildings performance. The most important conclusion emerging from this study is that utilization of the mountainous area will augment Mina's built environment and its accommodative capacity. However, comprehensive interdisciplinary approach entailing multisystem development should be adopted for Mina's built environment. Any future expansion should be independent from the existing services, traffic networks, and utilities within the Mina valley. Accessibility and connectivity for the mountainous area should be maintained, ensuring linkages to target destinations in Mina in the proposed development project. Since the project is being developed in a mountainous area with limited accessibility, all of the required services (e.g., commercial and health services) should be provided onsite as per site planning standards [15].

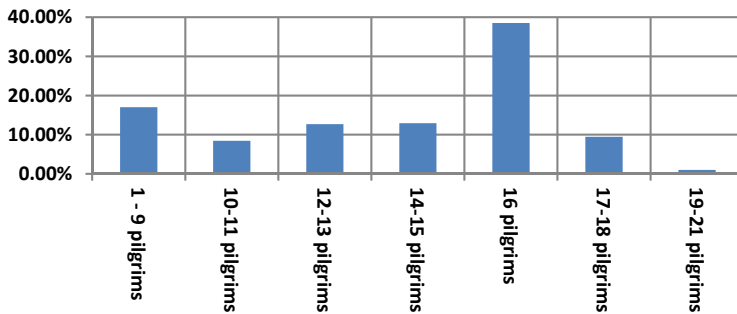
Figure 13: Housing occupancy rates.

The first chart in Figure 13 indicates that 50% of pilgrims were housed in rooms accommodating more than 16 persons. The results shown in the charts reveal that between 66% and 72% of the residents were satisfied with the area of their room, its furniture and finishing, and the bathroom.

Based on the fees pilgrims have paid, a net area of 2.75 m<sup>2</sup> per pilgrim should be satisfying. Rooms with different occupancy capacities should be provided with maximum number of 12 persons per room.

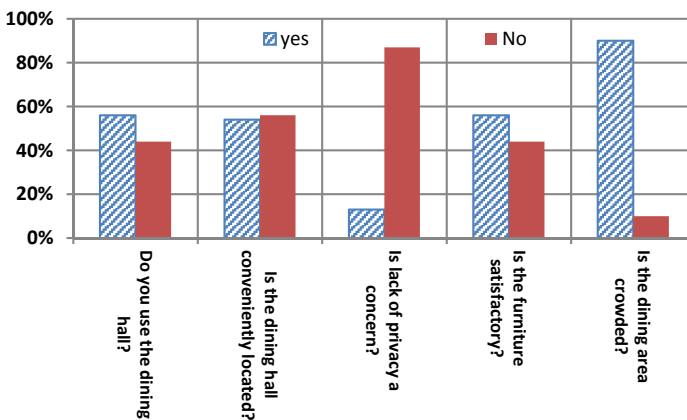
Figure 15: Pilgrims' satisfaction relating to catering facilities.

The charts in Figure 15 depict pilgrims' satisfaction relating to catering facilities. The following conclusions can be derived:

- A total of 44% of the residents did not use the restaurant because it was overcrowded.
- A total of 90% of restaurant users reported overcrowding.
- A total of 55% of users noted that the queuing time to find an empty spot took about 18 minutes, while obtaining service usually took approximately 12 minutes.
- Both the food hall and the kitchen were perceived as being inadequate by 56% of the restaurant users.

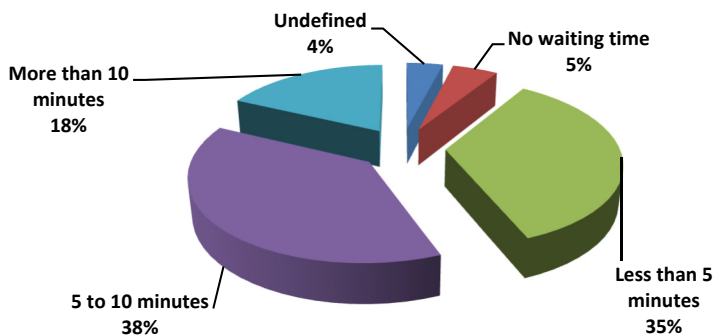
Figure 16: Users' satisfaction relating to elevator waiting times.

Figure 17 graphically depicts findings on users' satisfaction regarding elevator services that are based on direct observations and their timing during pilgrimage days. These reveal that:

- 35% of the users waited for 5 minutes to use the elevator service.
- 37% of users waited for between 5 and 10 minutes to use the elevator service.
- 18% of users waited for more than 10 minutes to use the elevator service.

Regarding circulation components of the buildings, the study proved that adequate numbers of elevators should be provided of sufficient capacity and in appropriate locations. All of the floors in a building should be accessible by service elevators. Elevator lobbies should be of a suitable area. The main staircases of buildings should connect all floors. Horizontal corridors should be clearly identifiable and connect all building elements.

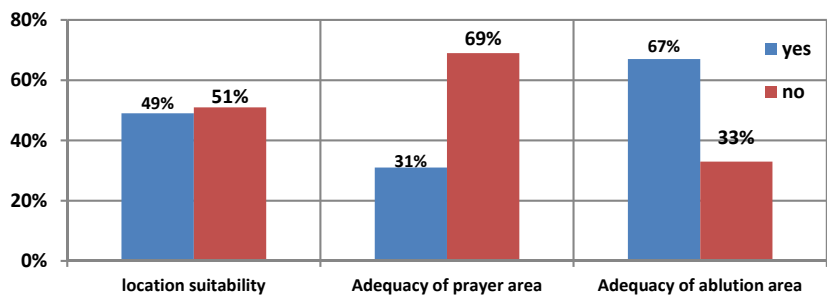
Figure 17: Users’ satisfaction relating to prayer spaces.

Indicators for the prayer area included the location of the prayer, hall, the prayer area, the suitability of the ablution area, and crowding. Figure 18 presents the findings for the most significant indicators. It reveals that 56% of male users were dissatisfied with prayer halls in terms of locations and spatial relationships to other functional building components. The level of dissatisfaction relating to associated sanitary services was not the same as for the prayer halls, because pilgrims used toilets located within their bedroom areas.

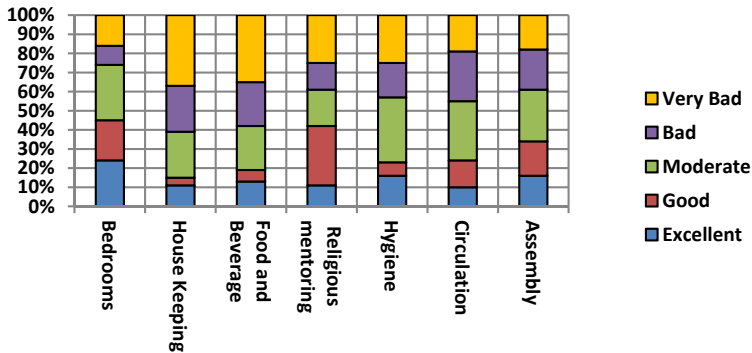
Figure 19: Users' satisfaction relating to management, operation.

An evaluation of indicators relating to the management of facilities, presented in Figure 20, showed that approximately 60% of the pilgrims were dissatisfied with the housekeeping, room service, kitchen service, and the maintenance of public spaces.

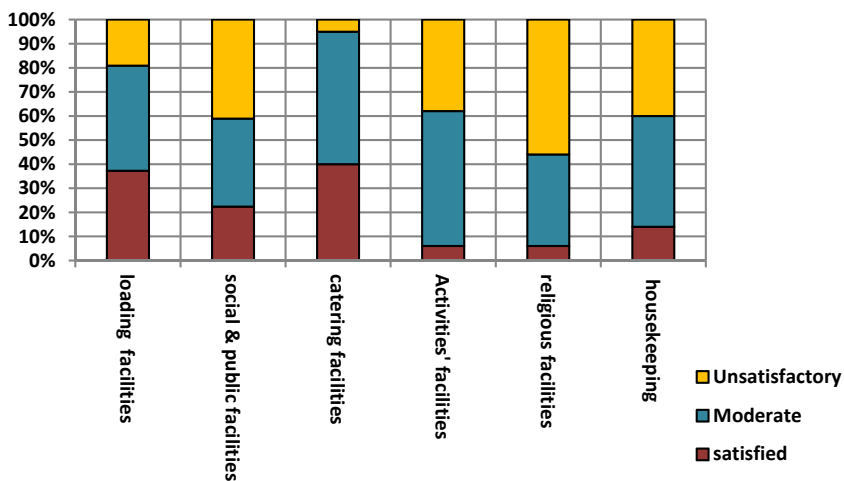
Figure 20: Overall users' satisfaction

Users were asked about their overall pilgrimage experience. Figure 21 provides a summary of the results for key indicators relating to overall users' satisfaction. These indicators included loading facilities, social and public facilities, catering facilities, religious facilities, and housekeeping. The chart shown in Figure 20 indicates that a total of 63% of the pilgrims were not satisfied with the building's religious facilities. A percentage of 40% of the users' sample indicated their dissatisfaction with housekeeping services and social and public facilities, while 37% of the users were satisfied with loading services.
