# Rehabilitation of an important cultural and architectural heritage: the traditional adobe constructions in Aveiro district

D. Silveira, H. Varum & A. Costa

*Civil Engineering Department, University of Aveiro, Portugal*

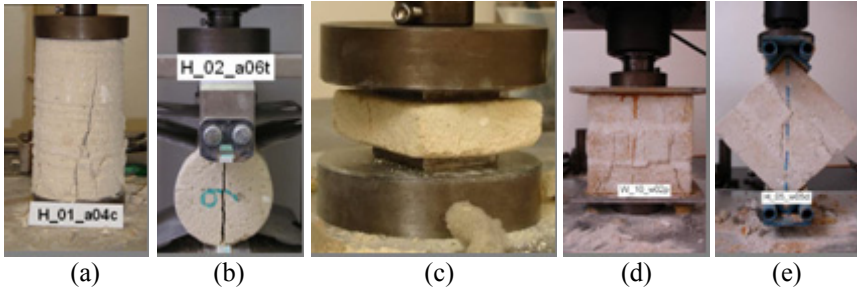
Figure 2: (a) simple compression test on adobe specimen; (b) splitting test on adobe specimen; (c) simple compression test on mortar specimen; (d) compression test on wallet perpendicular to the bed joints; and (e) compression test on wallet diagonal to the bed joints.

A total of 101 cylindrical specimens, 51 proceeding from houses and 50 from land dividing walls, were submitted to mechanical tests: 83 specimens were submitted to compression; and 18 to splitting tests, fig. 2.

10 mortar samples (2 from plaster and 8 from joints) taken from 3 different houses were submitted to compression tests, fig. 2.

To estimate the compression and shear strength of adobe traditional masonry walls, 13 small wallets with 17×17×10cm were constructed and submitted to compression tests, perpendicular to the bed joints and diagonally, fig. 2.

The wallets were constructed at a reduced scale (1:3). For the construction of the wallets, prismatic blocks were extracted from adobe units taken from existing constructions, and a mortar with a composition similar to the one traditionally used was adopted.

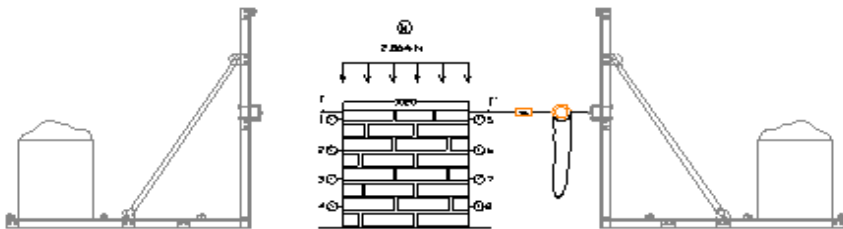
Figure 3: Laboratory testing layout: wall specimen; reaction frames; horizontal displacement transducers; dynamometer; and horizontal loading system.

The wall tested in laboratory was subjected, initially, to a non-destructive dynamic test, to estimate the natural frequencies in each direction. These measured frequencies help on the dynamic characterization of the adobe masonry wall, and also on the calibration of numerical models. In a second phase, it was conducted a destructive test imposing constant vertical load combined with in-plane horizontal cyclic forces. During the test, displacements were measured at four points on each side of the wall. In fig. 3 is presented a general scheme of the testing layout, including the wall specimen and the loading and displacements measuring systems.

The wall tested in the laboratory was constructed with units taken from an existing construction and with a mortar having a composition similar to the one traditionally used. The wall constructed and tested has the following dimensions: 1.08m height, 1.02m width and thickness of 0.185m. The boundary conditions at the base of the wall avoid lateral displacements and rotations.

The natural frequencies in the two horizontal directions (transversal and longitudinal) were measured with a seismograph. A frequency of 10.94Hz in the transversal direction was measured and, from it, an average modulus of elasticity of 316MPa was estimated. Subsequently, it was applied a vertical load of 2.86kN on the top of the wall, and in-plane horizontal forces were imposed, in cycles of increasing amplitude, till the collapse was reached. A maximum horizontal force of 3.2kN was applied. The failure mode was traduced by the opening of a horizontal crack at the base of the wall.
