# SAFETY ASPECTS RELATED TO IMPLANTED BREAST PROSTHESES

Silicone implants are largely used both in aesthetic and reconstructive medicine, thanks to their recognized biocompatibility. The damage of breast prostheses as a consequence of accidental impacts, is however one of the possible critical situations in their use. The behaviour of silicone breast prostheses in case of accidental impacts, for example in a car accident, is studied by experimental crash tests, accounting for the action exerted by seat belts during impact. Possible effects of aging over the mechanical response of the implants are also considered and approached. Static compression tests performed after long term aging indicate a possible degradation of prosthesis mechanical performance, which should be considered when analysing the possible consequences of an accidental damage.

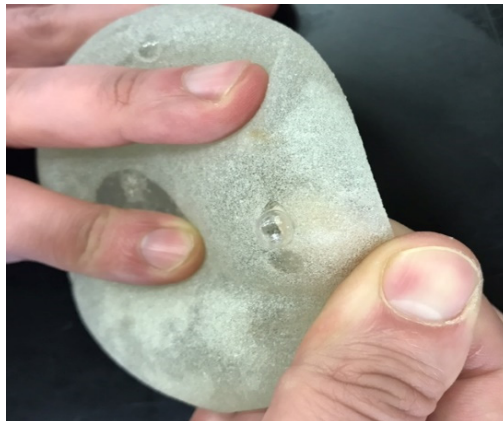
Two crash conditions, simulating impacts at 50 km/h and 90 km/h were selected. In the first situation, no evident rupture was visually observed. In the second crash conditions a clear rupture, with loss of gel, was observed (Fig. 5). The measured maximum deceleration was of about 25 g for both impacts, but in the second crash the time span was of course longer. Fig. 6 shows two instant frames of the impact events recording.

Figure 5: Damage of the prosthesis and gel leakage after impact.

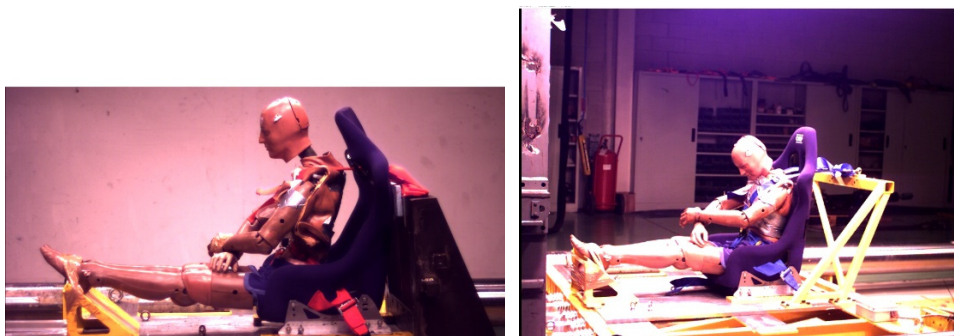
Figure 6: Instant pictures of the dummy during impact.
