# **Criteria for integration of new structures in the conservation and restoration of adobe ruins: the temple of the ex-mission of Cocóspera in Sonora, México**

L. F. Guerrero Baca & F. J. Soria López

*División de Ciencias y Artes para el Diseño,*

*Universidad Autónoma Metropolitana - Unidad Xochimilco, México*

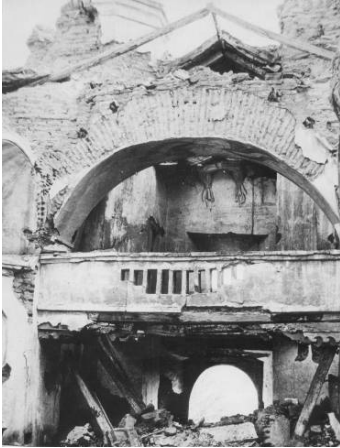
Figure 1: Interior view of the choir in the 1920's.

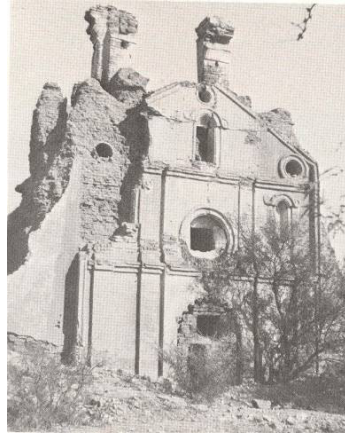
Figure 2: The main facade of the temple in 1920.

- Facades: The critical point as far as stability is concerned, is the main facade. This part of the building has many problems: loss of its verticality- it is leaning outwards; there is not an adequate binding between the brick facade built by Franciscans and the adobe wall built by the Jesuits; it has many horizontal cracks dividing the facade in various blocks that are unstable.

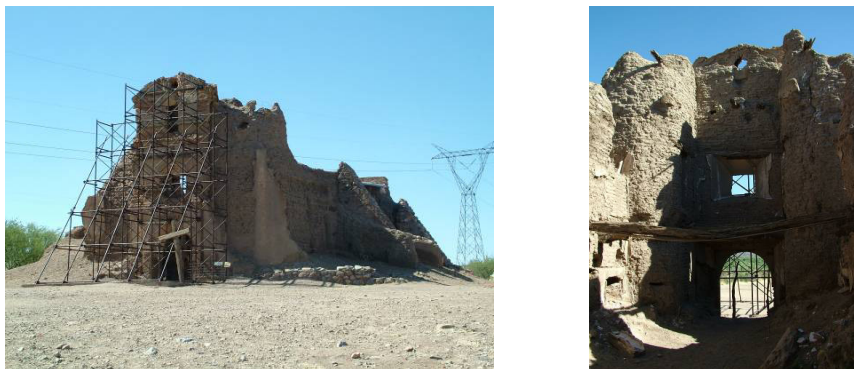
Figure 3: View of the 18<sup>th</sup> century ruins of the temple built by Jesuits and Franciscans in Cocóspera, Sonora.

- Walls: They are highly deteriorated and must be consolidated as soon as possible. There is no danger of collapse because of the width (2.7 mts.) of the walls and also due to the fact that their original height has been drastically diminished. However their exposure to environmental conditions is totally inadequate, where the combined action of water, wind, sun and temperature changes will continue to erode and degrade the adobe walls. Immediate actions of consolidation and protection are required. The tests made to the adobe bricks revealed a good load bearing capacity of 10 kg/cm<sup>2</sup>, which is above the usual standard of 9 kg/cm<sup>2</sup>. Similarly its capacity to breaking effect was 5 kg/cm<sup>2</sup>. The composition of the adobe was calculated by sedimentation process, which indicated that the original building material has 19 % clay, 37 % silt and 47 % of sand and gravel, which gives the adobe a very adequate consistence and internal cohesion [10].

- Roof: Almost all traces of the original roof systems have disappeared. The lack of this element has had a tremendous effect on the deterioration process of the building as a whole. Obviously the main problem is the exposure of the adobe structure to environmental factors, but it is not the only one. Without the roof the "head" of the walls are not connected and have an isolated structural behavior.

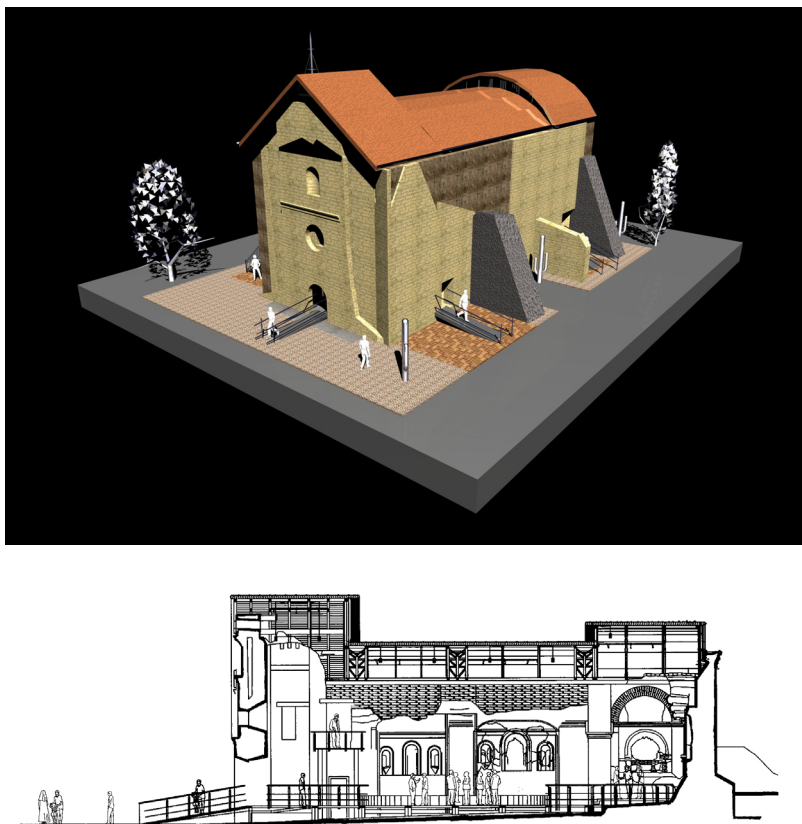
Figure 4: Top, a model of the new roof seen from the outside. Bottom, an interior view of the temple with the new roof.

- The new roof intends to recuperate the general volume the temple once had, without being the same. It also recreates the three different levels that the original roof had. The main idea is to insinuate the lines and forms of the primitive church, without reproducing them in a literal way, just in a similar manner. In this same way the trusses to support the roof structure retake the rhythm of the adobe ribs of the temple, which also obeys the structural logic of the building, exactly where the Franciscan reinforced the structure in order to sustain the roof.

- The trusses will support a wooden roof that will be covered on its exterior side with copper, which is a resistant material, lightweight, and gives a distinct finishing to the roof. The whole structure will be much lighter than the original roof and will not stress walls or foundations. The calculations show that the load at the base of the walls will be of  $2.7 \text{ kg/cm}^2$ , being much lower than the resistance detected in the test of the adobe.
