Preserving reinforced concrete

A. Foster, C. Atkins & L. Buckley

Mott MacDonald, Materials and Corrosion Engineering, UK

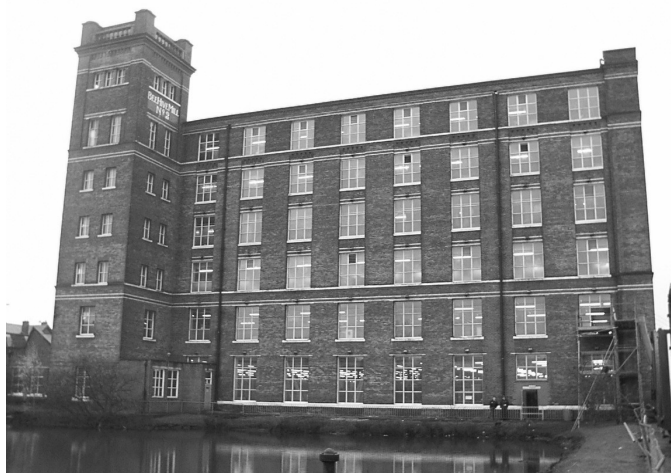
Figure 1: Beehive Mill.

An initial inspection identified that the corrosion was being caused by carbonation of the fill material, combined with the presence of aggressive chemicals within the fill. It was decided to employ a cathodic protection system to prevent corrosion of the filler joists and embedded beams. Carbon fibre plates were used to enhance the structural capacity of the floor. Carbon fibre plates were selected as the strengthening measure for ease of handling as all access to

The cathodic protection system was developed using mixed metal oxide coated titanium ribbon installed in 5mm thick chases cut directly into the existing concrete between the joists. The titanium ribbon was embedded into the chases and then backfilled.

Overall the system was split into two independently controlled areas and monitored using embedded silver/silver chloride reference electrodes. The system was successfully energised at a low current density and achieved protection in accordance with the international standards.

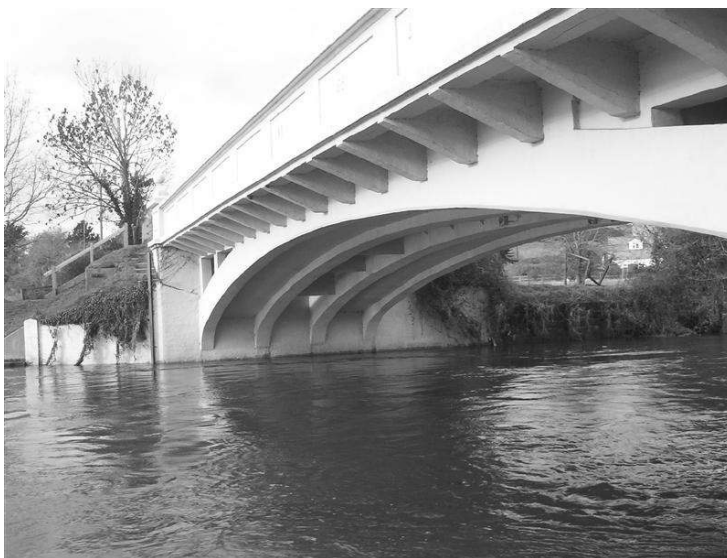
Figure 2: Thorverton Bridge.

This bridge is the main access to a small village in Devon in the south west of England. It dates from 1908 and is the oldest reinforced concrete bridge in Devon. Significant corrosion was identified due to carbonation of the concrete. Little chloride contamination was found in spite of the fact the structure had been regularly deiced using chloride based deicing salts. In addition to this the structure had been identified as understrength under the 40 tonne assessment programme and therefore required strengthening.

The solution developed was based on casting additional concrete arches between the existing arches. A cathodic protection system was installed to ensure durability. The cathodic protection was based on discrete anodes comprising a coated titanium rod inserted into a carbonaceous gel. These anodes were up to

0.5m long and were interlinked using titanium wire back to a central power and control unit. The monitoring system was routed back to a remote system that could be monitored and adjusted via a telephone system.

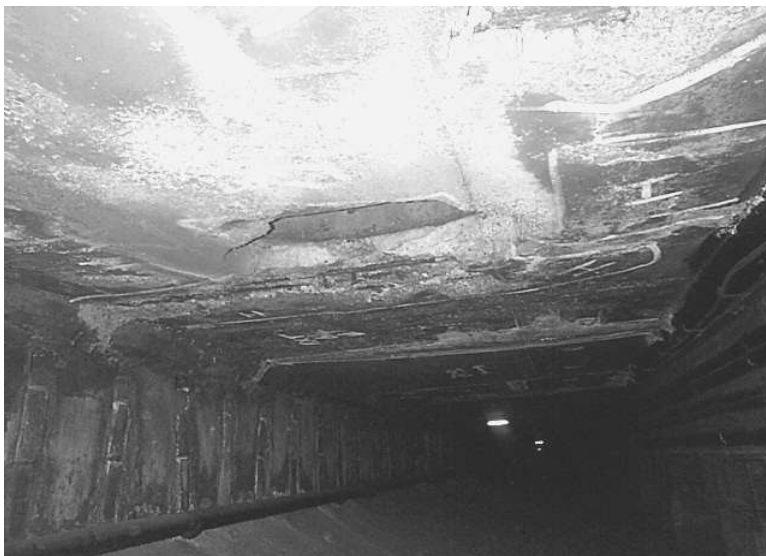
Figure 3: Soffit degradation prior to repair at Queensway Tunnel.

After a routine inspection significant corrosion of the deck soffit was identified. This was due to carbonation, accelerated by the dry air being constantly blown over the surface of the concrete. Chloride testing was undertaken on the top of the deck and significant chloride was identified throughout the tunnel, despite the fact that the tunnel had never been deiced. This was attributed to vehicular traffic tracking chlorides in from the surrounding area.

The repair procedure was complicated by the access. Whilst there was plenty of room under the main bore, in order to get to this area entry and exit was via small passages. Based on the difficulties in accessing the job the repair process was developed using ultra high water pressure jetting to remove all loose and delaminated concrete, and dry sprayed concrete to reinstate the removed concrete. All spoil had to be removed and all materials had to be brought to the area of work via the same limited access points.

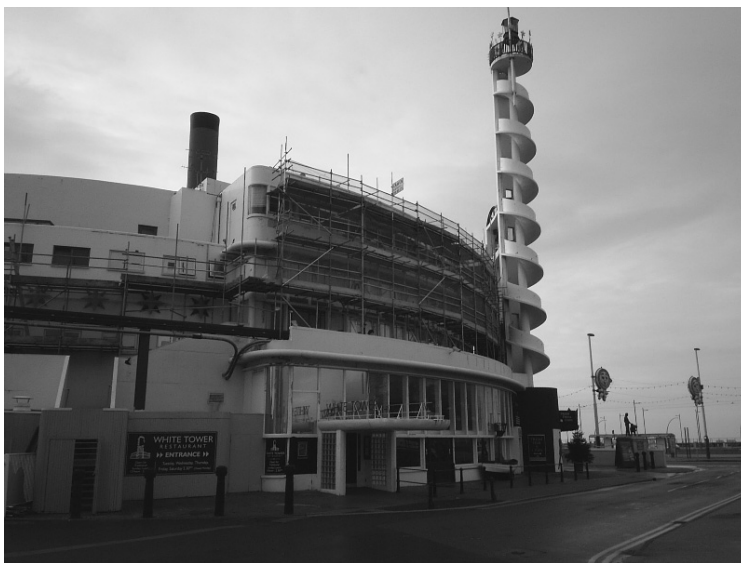
Figure 4: White Tower prior to completion of repairs.

The White Tower building in Blackpool is a fine example of Art Deco style. The building was constructed in 1939. The external envelope was originally made up of white Portland cement with a quartz aggregate. Over the years it had succumbed to extensive chloride contamination. In addition it had been coated and patch repaired many times. In 2005 a £500,000 repair project was undertaken. Due to the extent of degradation and previous repairs it was not possible to restore the original finish to the structure as little of it remained.

Wright. This gives the initial impression of a high quality finish, however the concrete behind the façade is of poor quality, heavily voided and rapidly degrades.

The repair procedure involved the removal of all loose and delaminated concrete and reinstatement with appropriate repair materials. In spite of the benefits that cathodic protection normally provides in minimising the extent of breakout, it was not appropriate for this structure as the façade was made up of many individual precast elements. This would have required a very complex CP system which would have precluded the repair contract. Once the repairs were completed the whole structure was recoated [5]. The structure owner has introduced a rolling programme of inspections to enable the maintenance of the building to be better planned.
