Seismic behavior of a thatched house at Minehama village in Akita, Japan

K. Ueta, C. Cuadra, K. Tokeshi & M. B. Karkee
*Graduate School of System Science and Technology,
Department of Architecture and Environment Systems,
Akita Prefectural University, Tsuchiya, Honjo, Akita, Japan*

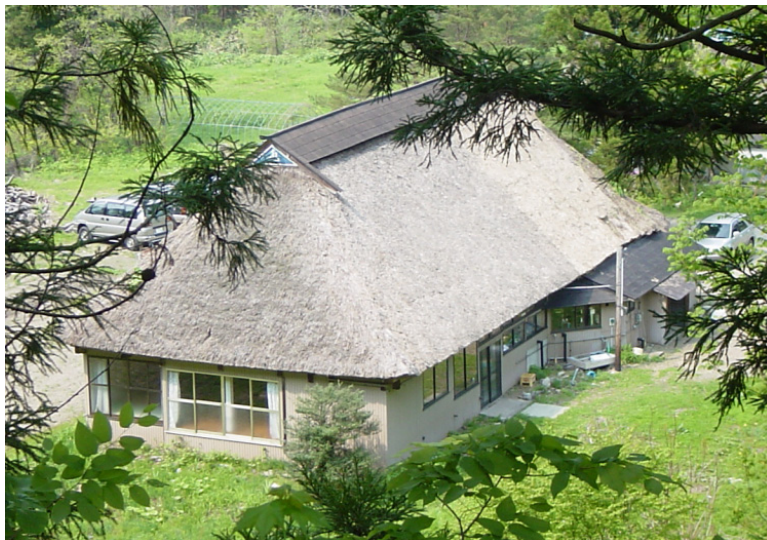
One of the buildings, called building C, was chosen to perform the micro vibration measurements and the correspondent analysis. Details of this selected structure are shown in figure 2. The dimensions of this building are 9.40m wide and 20.30m long. The interior of the building consists of the earthen floor where the kitchen and tools store are located, and also there is a part of Japanese tatami

Figure 2: Detail of C building.

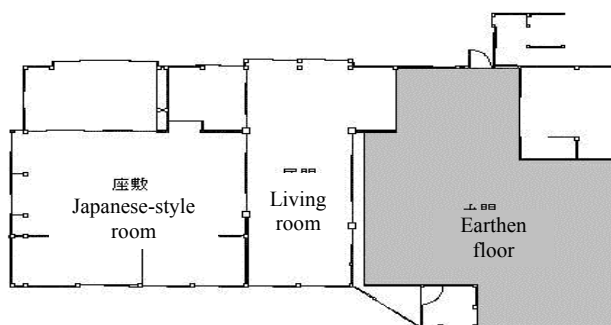
Figure 3: Plan view of C building.

mat floor for a living space and bedroom. The structural system is a frame that permits the creation of a large inner space, as can be observed in figure 3.

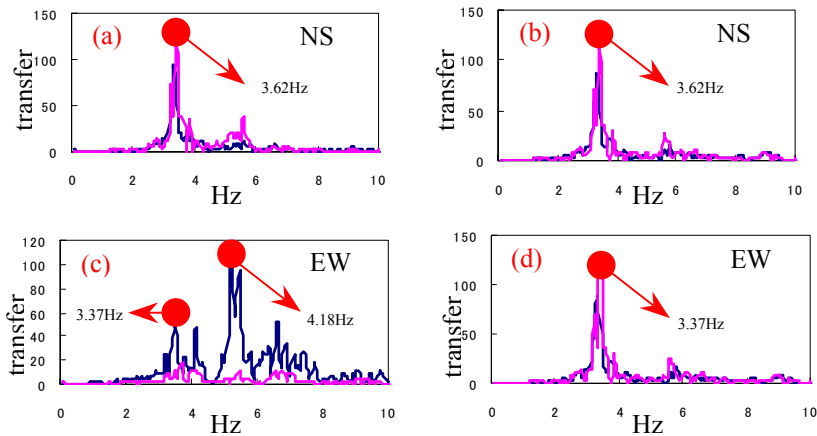
Figure 5: Horizontal transfer functions from microtremor measurements.

The results of the Fourier analysis are shown in figure 5. It can be observed from figure 5(a) and (b) that the value of the predominant frequency in the NS direction is 3.62 Hz. In case of the EW direction, a clear peak at 3.37 Hz is shown in figures 5(c) and (d). Also a peak at 4.18 Hz was detected that corresponds to torsional mode.

Mode of vibration	Microvibration measurement (Hz)	FEM analysis (Hz)
Horizontal EW	3.37	3.44
Horizontal NS	3.62	3.60
Torsional	4.18	4.39
