Effectiveness of seismic retrofit for stone masonry structures

V. Kilar¹ & D. Marušič²

2.1 Description of church in Solčava

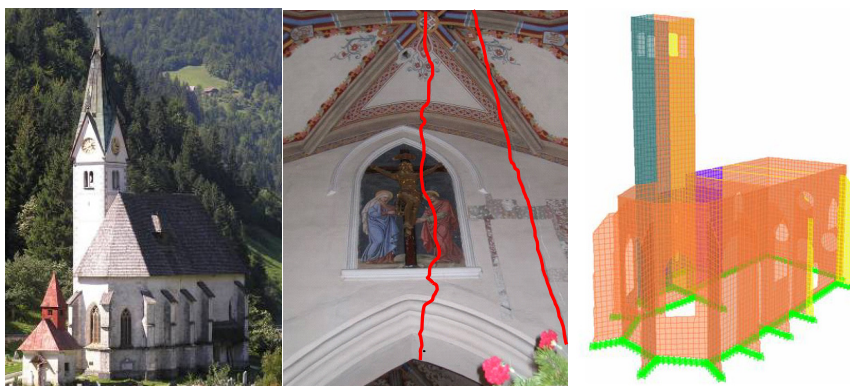
Figure 1: Church in Solčava (Slovenia): photos and mathematical model.

The church of “Marija Snežna” was built in the second half of the 15th century (Fig. 1(left)). In past centuries it was repaired several times, and according to our

information the last time it was repaired thoroughly was in 1824. The arch thickness is constant and it amounts to 37 cm. The thickness of walls varies from 72, 87, 110 and 120 cm. Today the church is heavily cracked; we can see wide cracks of walls on the outer and inner sides as well as cracks in arches and stone groins (Fig. 1(middle)). The main reason is the subsiding of the NE wall of the main nave and presbytery (side opposite to bell tower), which has weaker foundations than other parts of the church. As a primary rescue measure we first demanded the strengthening of the foundations in order to prevent the threatening vault collapse (partly completed at the end of 2006). Other recommended retrofit measures are described and discussed in the last part of the paper.

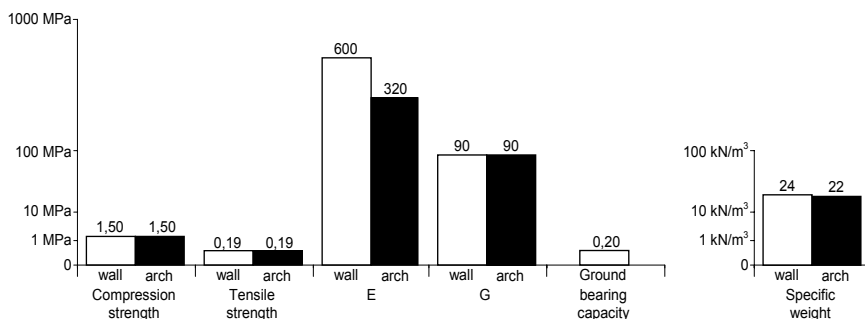
Figure 2: Stone masonry and ground characteristics (cube root scale).

The church is built of stone aggregate connected with lime mortar. The size of stone pieces in walls varies from small pieces with maximal diameter up to 25 mm to larger stone units reinforcing the corners and vertical strengthening columns. The arches are built of stone grains with maximal diameter 20 mm. According to the results of material testing performed by IRMA in 2004, the

compression strength of lime mortar varies from 1,0 – 1,5 MPa for the walls and from 1,5 – 2,0 MPa for the vaults and tower (Leskovar, 2004).

Based on these data and obtained moisture gravimetric measurements (ranging from 6.2 to 10.6%), the compression and tension strengths and elastic and shear modulus of walls and arches have been estimated. These values were further compared with the recommendations given by Tomažević (1987). In our analysis we have used the average values obtained from both sources. The used material characteristics are summarized in Fig. 2. The allowable ground stress obtained from the geotechnical report amounts to 200 kPa.

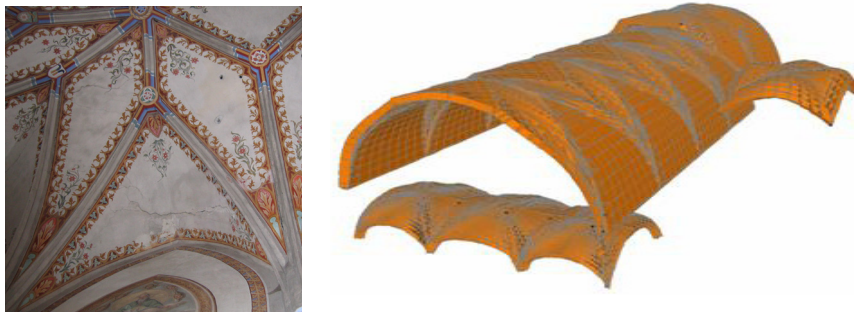
Figure 3: Arches: photo and mathematical model.

The church was modeled with the computer program SAP2000 (Computer & Structures, 2006). The maximum side length of 2D planar 4-node and 3-node elements was limited to 40 x 40 cm. Particularly complicated was the modeling of groins and arches connections which required adequate refinement of the numerical model mesh. The number of all used finite elements was around 21000. For practical reasons the arches were modeled separately from the walls. The arch reactions were transferred to the joints at the tops of walls. The whole wall model with the bell tower was then loaded also by the reactions given by the wooden roof construction. Separately were considered also the existing steel ties. It is assumed that the arches are pinned to the walls and that the walls are fixed into the foundations. The arch photo and their mathematical model are presented in Fig. 3.

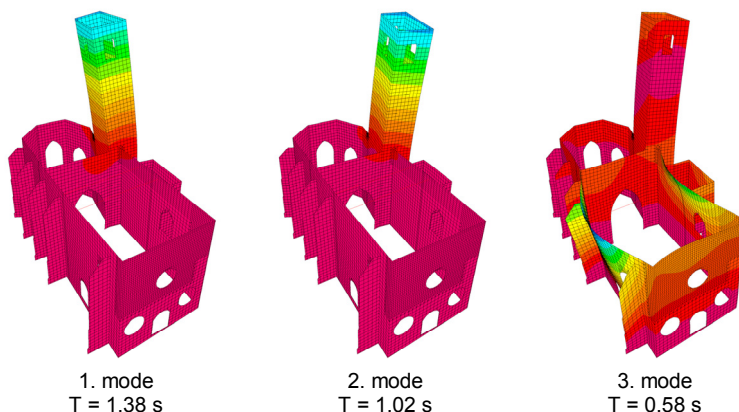
Figure 4: First three fundamental modes.

The numerical model should include all vibration modes that significantly influence the response. According to Eurocode 8 this requirement is fulfilled if we take into account all modes that give the effective mass at least of 90% of the whole mass, or all modes with effective mass greater than 5% of the whole mass. In our case the influence of higher modes is extremely important. We had to consider 24 vibration modes. The first three modes are presented in Fig. 4. The first two fundamental modes of the bell tower amounts to 1,38 s (direction N-S)

and 1,02 s (direction E-W). The movement of the top of walls becomes significant only at the third fundamental mode (0,58 s) or at higher modes.

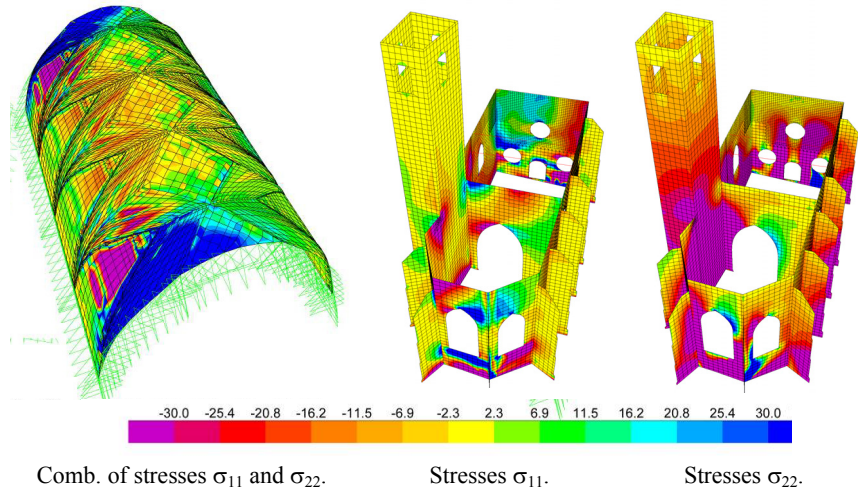
Figure 5: Stresses in the arch of main nave and in church walls due to vertical displacement of NE wall for 2 cm (10-2 Mpa).

The existing church is heavily cracked due to the subsiding of the wall foundations on the NE side of the main nave (opposite to the bell tower). The selected analysis results of the existing church subjected to the vertical displacement of the foundations of the NE wall foundation for 2 cm (actual displacement obtained at the spot) are presented in Fig. 5. For the arches the maximal main stress combination at the top side of the arches is shown. For the walls the stress σ_{11} acting in local direction 1 (for all elements it lies in horizontal plane) and the stress σ_{22} acting in local direction 2 (for all elements it lies in vertical plane) are shown. Thus, the stresses σ_{11} might cause the cracks propagating in the vertical direction and σ_{22} the cracks in the horizontal direction. Considered allowable stresses are $\sigma_{dop1}=0,19$ MPa in tension and $\sigma_{dop2}=1.50$ MPa in compression. The results show that the tensional allowable stresses were exceeded in several parts of the main nave and presbytery, mainly at the spots where the cracks actually appeared. The subsiding of the NE wall would be critical also for the stability of the vaults. The church in its existing

state is practically statically instable. Every subsequent subsiding of foundations might cause the collapse of the church vaults. For this reason we have required an immediate strengthening of the foundations which took place at the end of 2006. The analysis of the church with retrofitted foundations is presented in section 4.

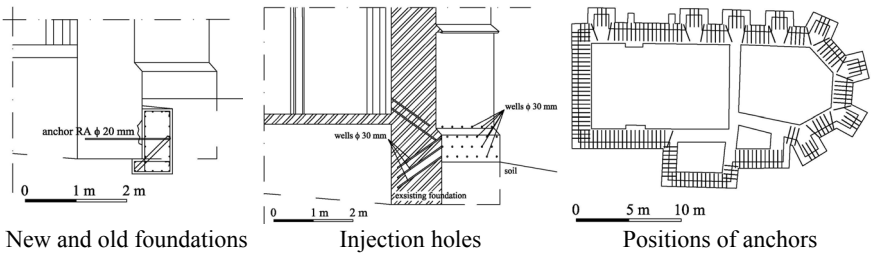
Figure 6: Design project of the new foundations (LEGRO, 2006).

The actual vertical stress under the NE wall of the main nave of the church amounted to 270 kPa and exceeded the allowable stress (200 kPa) for approximately 30%. The eccentricity of the vertical resultant (25.5 cm) fell slightly out of the existing foundation core area (23.3 cm). The analysis results showed that the foundation should be at least 2.4 m width. The retrofitting of the

foundations took place at the end of 2006 (Fig. 6 and 7). After the injection and widening of the existing foundations the injection of the ground bellow them was also performed. The injection works were performed by Uretek® using their floor lifting method (<www.uretek@uretek.si>).

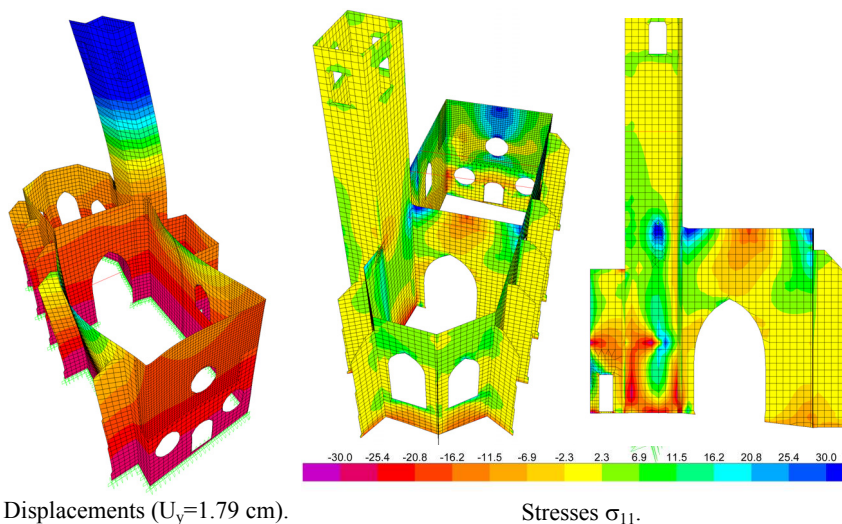
Figure 8: Maximal displacement of bell tower and stresses in church walls due to vertical and earthquake loading (10^{-2} Mpa).

The analysis results for the vertical dead and live load show that the allowable stresses are not exceeded in the case of vertical loading. However, the combination with earthquake loading according to EC8 shows that the church is absolutely unsafe for eventual earthquake treat. The deformation shape for Y direction displacement and stresses σ_{11} in the walls are presented in Fig. 8. The

maximum X and Y displacements of the tower top amount to $U_x=1.17$ cm and $U_y=1.79$ cm. The maximum displacement at the wall top perpendicular to the wall plane amounts to 0.63 cm (in front entrance wall with the rosette). The tensional stresses σ_{11} are exceeded in number of places, especially in the wall tops and connections of bell tower and church.

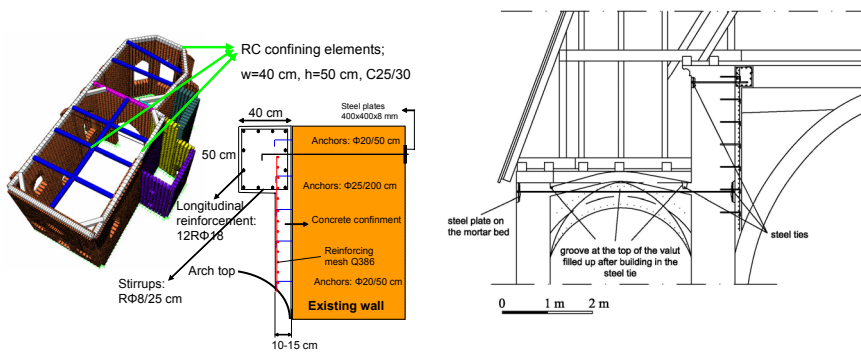
Figure 9: Required retrofitting construction measures (RC confining elements at the top of walls above the arches, steel anchors, walls concreting).

According to the results obtained in section 4 we have concluded that the most effective retrofit measure must be the connecting of tops of walls by a confinement system that simulates a “rigid diaphragm”. In the main nave we have suggested the system of confining RC beams at the tops of walls with additional transversal cross beams above the arches (Fig. 9). The confining RC beams must be added around all wall tops in the space between the vault base and vault top. They must be anchored to the church walls with steel bars with diameter 20 mm and every 2 m with the screw anchors with bolts fixed to the steel plate on the other side as shown in Fig. 9.

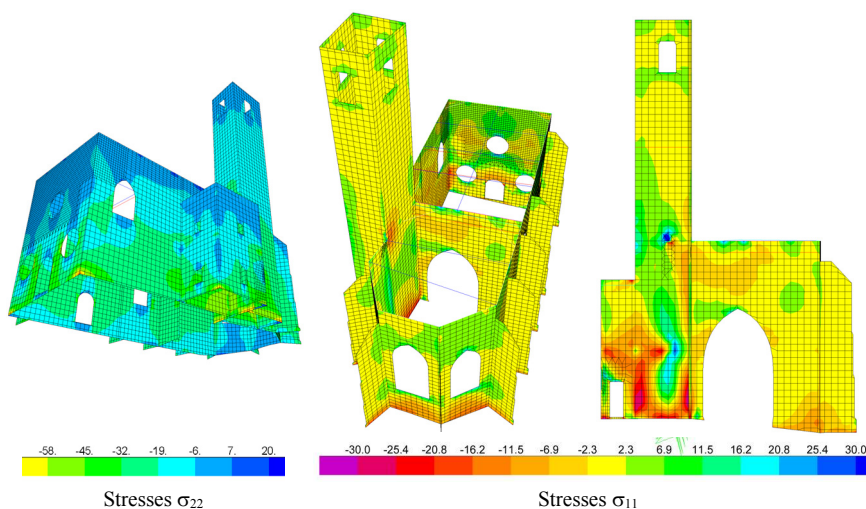
Figure 10: Stresses in retrofitted church due to vertical and earthquake loading (10^{-2} Mpa).

The analyzed model of the retrofitted church includes only the proposed RC confining elements, which might simulate a rigid horizontal diaphragm as described in 5.1.1. Other proposed measures were not taken into account. The selected analysis results are presented in Fig. 10. It can be seen that the behavior

of the church (except for few spots at the junction of the tower and the wall) remains elastic during the design earthquake.

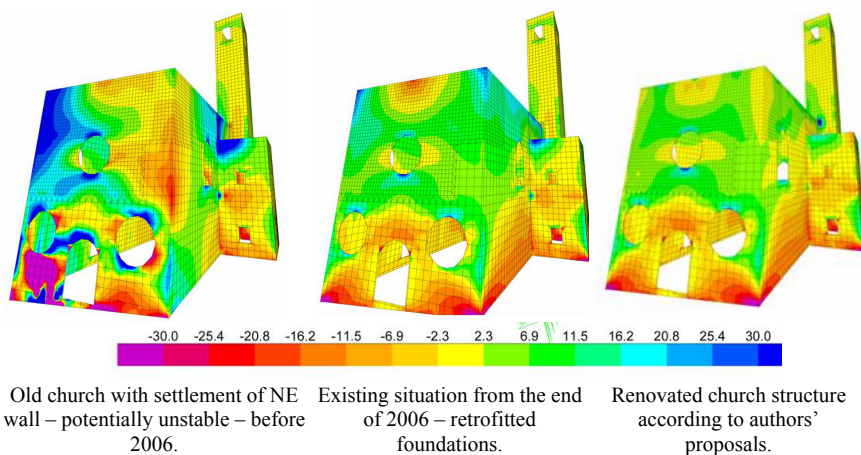
Figure 11: Comparison of stresses σ_{11} for different renovation stages (frontage: view from west side) due to self-weight and earthquake (10^{-2} Mpa).

The numerical analyses covered three renewal stages of the church in Solčava, e.g. a) original church with subsiding of the NE wall foundation, b) church with new retrofitted foundations and c) church with the proposed RC confining elements simulating a rigid diaphragm at the top of the walls (Fig. 11). It was shown that the church in stage a) is practically unstable and that the church in stage b) is stable for vertical loading, but it is not capable of withstanding the earthquake loading according to EC8 (note that this is also the present state of the church at the beginning of 2007). Stage c), which includes the RC horizontal confining elements by authors proposal, proves to be adequately safe fulfilling the EC8 requirements. We can conclude that the proposed measures should be carried out as soon as possible.
