Earthquake resistance of a historical brick building in Akita Prefecture, Japan

C. Cuadra, K. Tokeshi, M. B. Karkee & Y. Sakaida
*Graduate School of System Science and Technology,
Department of Architecture and Environment Systems,
Akita Prefectural University, Tsuchiya, Honjo, Akita, Japan*

Abstract

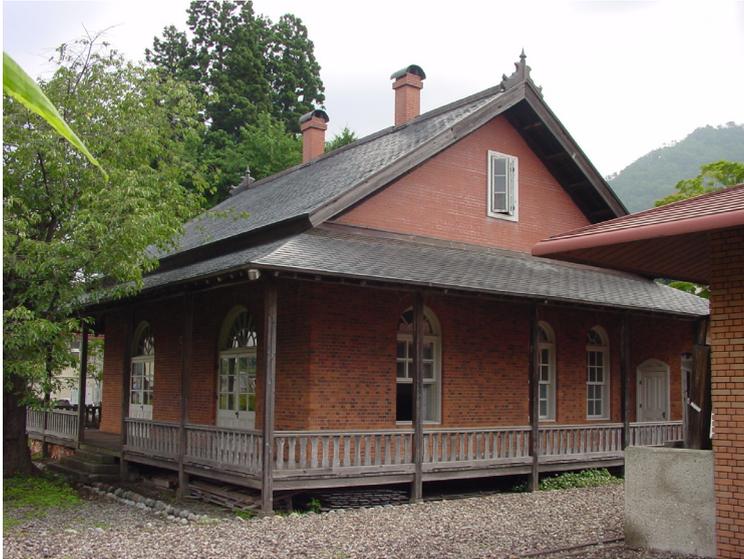
The building, object of this study, is located in Ani village in Akita Prefecture and it was constructed during the 12th year of the Meiji period (year 1879). It was constructed to be the house of Adolf Mecker, a German engineer that came to Japan to work in the mines of the Akita region. As can be observed in figure 1, the main structure is formed by the masonry walls and complemented by a wooden structure that forms a kind of fence around the building. The architectural style corresponds to the Gothic Renaissance with some arches to form the windows and doors openings. The masonry units were fabricated with clay of the zone and burned in a factory constructed for that specific purpose. The design and the direction of the construction of the house were done by Mr Mecker himself.

Figure 1: Building object of the study.

The building under study, has suffered the action of some earthquakes, and the most recent was the Moriyoshiyama earthquake in the year 1982. This earthquake was a near source earthquake and partially destroyed the building. The Prefecture government reconstructed the building replacing the triangular gable wall of the second story by light material instead of clay brick masonry. Then only the first floor walls remain with the original dimensions and with clay brick lied with cement mortar.

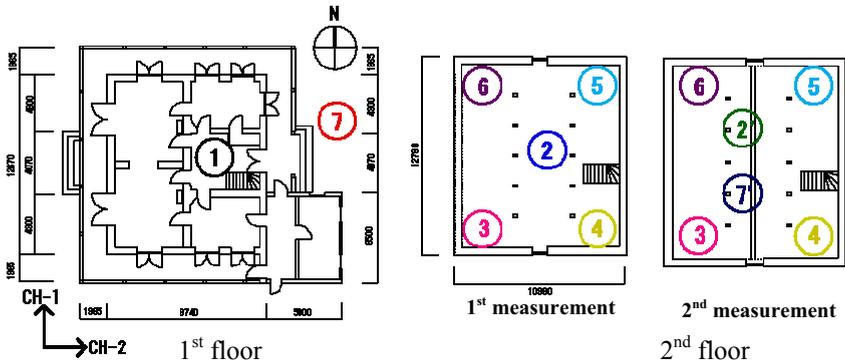
Figure 2 shows the plan distribution of the building, where the sensors were located in the following arrangement for the first set of measurements: one sensor at the first floor (1), five sensors at the second floor level (2, 3, 4, 5, 6) and one on the ground (7). For a second set of measurements, the sensors 2 and 7 were located at the top of the central beam of the roof. These points of measurement were called 2' and 7'. The measurement of microtremors were measured in the three principal directions (east-west (EW), north-south (NS) and

Figure 2: Points of microtremor measurements.

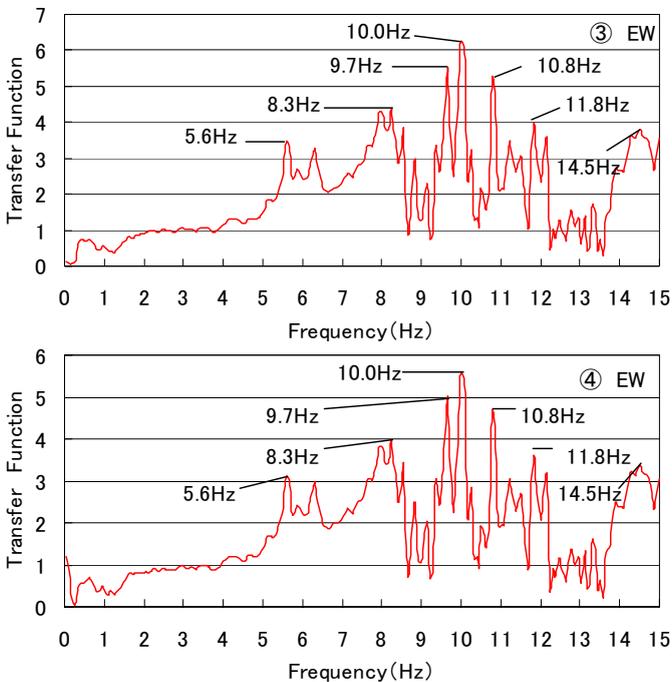
Figure 3: Transfer function results for EW direction.

up-down (UD)) at each point. The micro vibrations were measured simultaneously during 500 seconds with a sampling frequency of 100Hz. Then, stationary portions of the records were selected to calculate the transfer function that permits to estimate the predominant periods of vibration of the structure. The results of the transfer function for the horizontal vibrations are shown in figure 3 and 4. The transfer function at each measured point of the structure was divided by

the one at the first floor level, to only obtain the vibration characteristics of the upper structure. According to these transfer function results, multiple peaks can be observed in such a way that is not possible to obtain only one characteristic frequency. Therefore, the mode of vibration is not a simple horizontal normal mode. Instead of it, the modes of vibration are intricate. These complex modes of vibration can be explained by the concentration of the mass of the structure in the walls instead of in the slab.

Microtremor measurements (Hz)	FEM analysis (Hz)	Point of measurement
8.3	8.3 (mode 1)	2', 3, 4, 5, 6, 7'
8.8	8.8 (mode 2)	2', 5, 6, 7'
9.2	9.3 (mode 4)	2', 5, 6, 7'
10.8	10.7 (mode 6)	3, 4, 5, 6, 7'
11.8	11.9 (mode 8)	3, 4, 7'

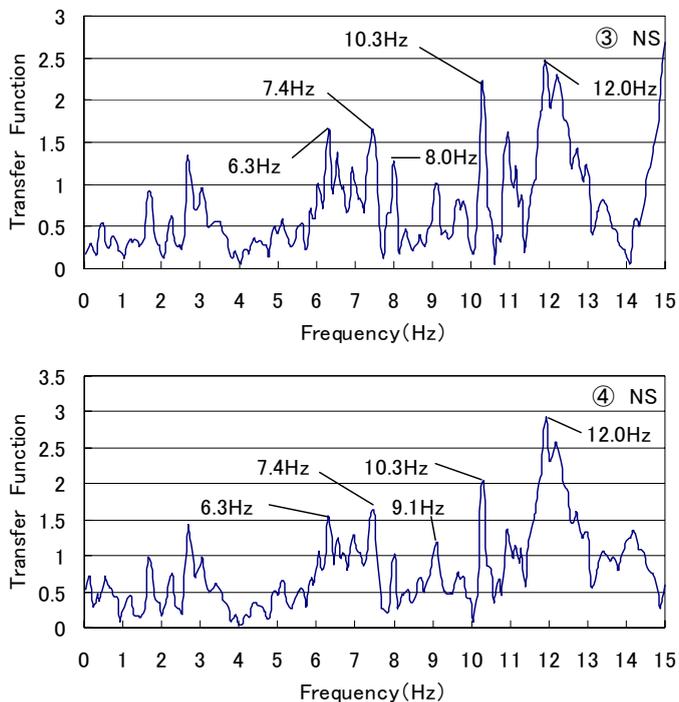
Figure 4: Transfer function results for NS direction.

Microtremor measurements (Hz)	FEM analysis (Hz)	Point of measurement
9.1	9.1 (mode 3)	3, 4, 5
10.3	10.3 (mode 5)	3, 4, 5,
10.9	11.1 (mode 7)	3, 4, 5, 7'
12.0	12.0 (mode 9)	3, 4, 5, 6
12.5	12.6 (mode 10)	2', 3, 4, 5, 6, 7'

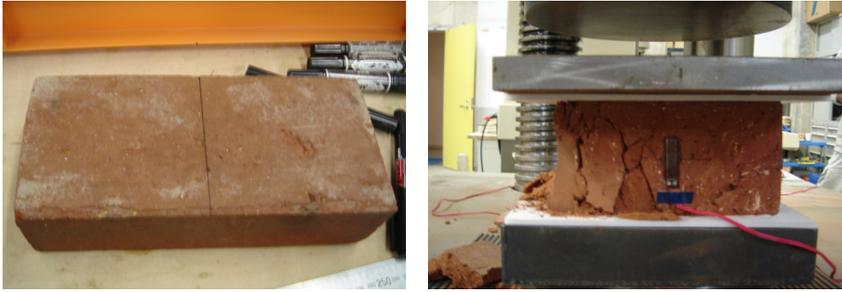
Brick units selected from those that were stocked near the building were used to determine the physical and mechanical properties of the bricks. From the stock it was difficult to distinguish between those units used in the old construction and those used for the repair works. Independently of this condition, units showing good aspect were selected for the laboratory tests. These units can be observed in figure 5.

Figure 5: Brick units employed to obtain the physical and mechanical properties.

Suction ratio (%)	Density (gr/cm ³)	Compression strength (N/mm ²)	Young Modulus (N/mm ²)
24	1.64	12	1.06×10^4

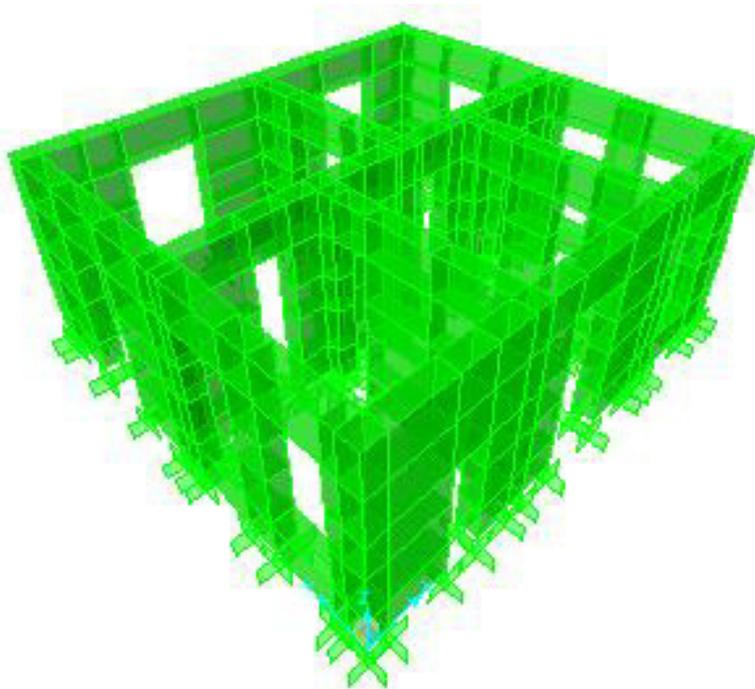
In order to compare the measurement results with analytical procedure, a Finite Element Model (FEM) was constructed considering only the brick masonry walls. This assumption is done with the intention of obtain the influence of the mass of the walls on the modes of vibration. Here it is assumed that the wall, including the mortar has homogenous properties and they are equal or similar to that obtained for the brick units. The model was constructed referring to the available plans and direct measurements of the building. In total, 280 parallelepiped solid elements were used. The complete model is displayed in figure 6.

Figure 6: FEM model.

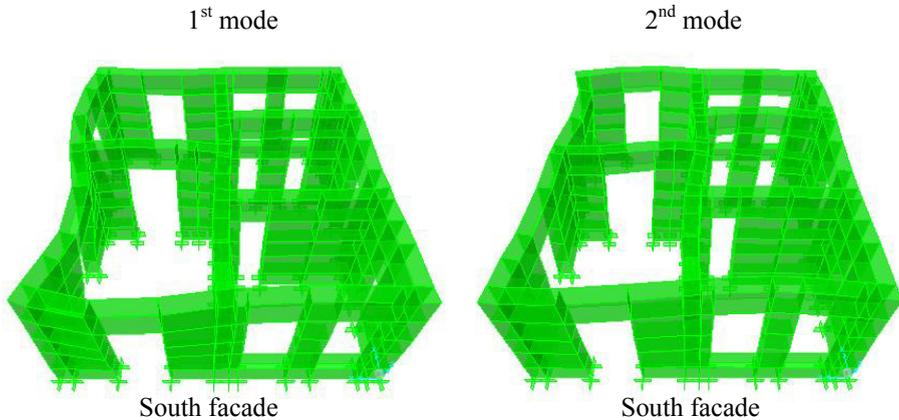
The 10 first modes of vibration were obtained from the tri-dimensional analysis in which frequencies varied from 8.3 Hz to 12.6 Hz. By comparing these with the results of the microtremor measurements, a good agreement is observed in the modes of vibration detected as a peak in the transfer functions. In tables 2 and 3 the comparison of the predominant frequencies obtained from measurements with analytical results are presented for EW and NS directions, respectively. The right column indicates the measurement point in which the predominant frequency was observed. The finite element method result shows in parenthesis the order of the mode of vibration obtained from the 3D analysis. As an illustrative example, the first 2 modes of vibrations are shown in figure 7.

Figure 7: Analysis results for the first 2 modes of vibration.
