Reconstructing Hilandar Monastery 2004-09: the first phase

P. M. Milojevic

*School of Architecture and Planning, University of Auckland,
New Zealand*

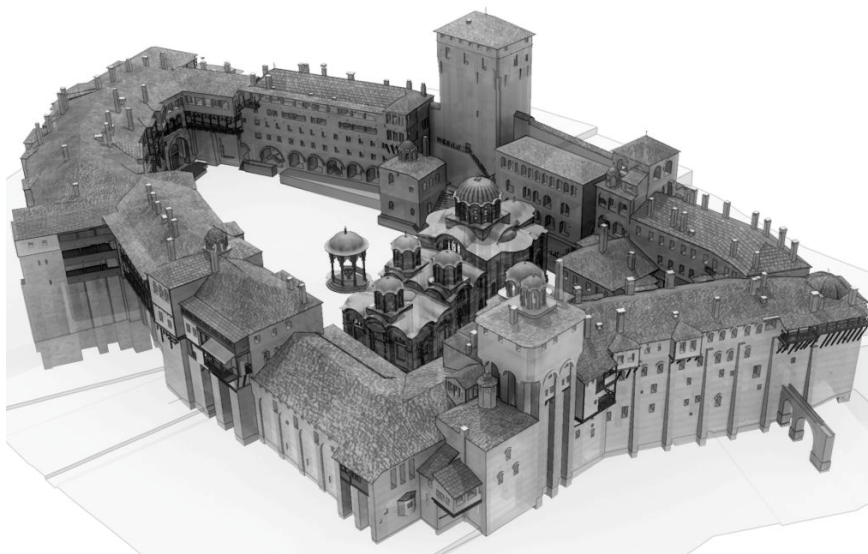
Figure 1: Hilandar Monastery, Mount Athos: digital model, render view from the southwest (Yat Wai Lo 2009).

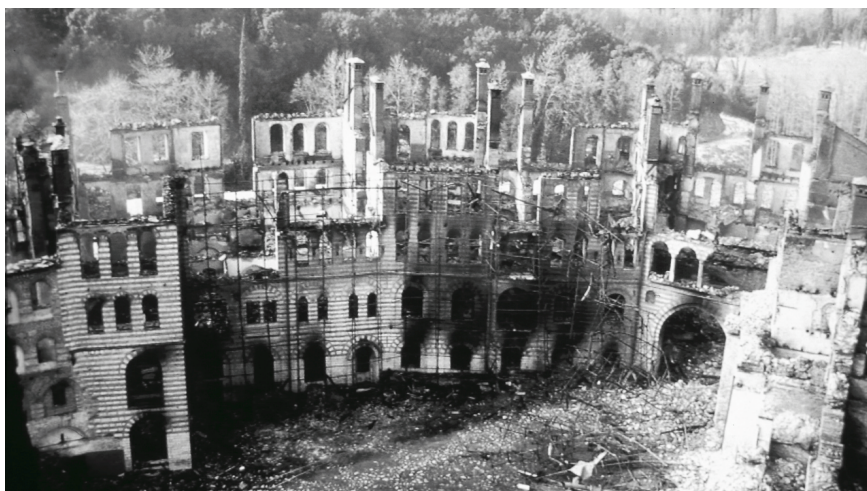
Figure 2: Hilandar Monastery, Mount Athos: north courtyard from the southeast top of Saint Sava tower (anon. 6 March 2004).

Six years after the celebrations around the 800th anniversary of its founding (Subotic [17]) the Imperial Serbian Lavra of the Most Holy Mother of God, Hilandar Monastery (Mount Athos, Macedonia, Greece), is now and has been for quite some time, the focus of considerable attention by philologists, historians, art and architectural historians (Fig.1). In Hilandar Monastery, the last-remaining Serbian monastic foundation of three on Athos, a fire on the night of the 3–4th of March 2004 destroyed approximately one half of the main building ensemble of this UNESCO World Heritage Site. This catastrophe struck towards the end of an eighteen year long phase of conservation and structural upgrading work of this architecturally-renowned continuously-inhabited walled enclosure comprising some 20,000 square metres of accommodation within the walls, gates and towers. The Saint Sava and Saint Demetrius towers to the northeast and northwest of the monastery church, from the earliest Serbian phase (Nenadovic [14]) of this building ensemble acted as fire-breaks against the huge conflagration from ‘taking’ the treasury, library, refectory, residential ranges and other communal facilities of the south courtyard. Emergency crews held the fire back from taking the 14th Century church, which is considered ‘the finest on Athos’ and certainly ‘one of the finest Byzantine churches anywhere’ (Mylonas [13]), the northwest corner of which was only eight meters from the four storey 13-14th Century Saint Demetrius towers which had caught fire first early that night and burned out completely. Aerial photographs taken in the first light of the morning shows the extent of damage (Fig 2). The timber fabric of the internal

wall, floor and roof structure burned out such that the massive weight of the stone slab-tiled roofs collapsed such that the buildings collapsed into themselves; finally the lighter stone curtain walls fell. In all 15,000sqm of the 14–19th century fabric comprising residential ranges and four chapels was lost. Closely following on from the departure of the emergency crews, and the appearance of national and international VIPs, Athonite representatives, architectural conservators, arrived to direct emergency clean-up crews and assess the damage, along with building documentation specialists and so initiating the first wholesale rebuilding of an Athonite complex in Modern times. While the usual variety of reconstruction parameters has come up for consideration, including a definition of an exact description of the loss of unexpected opportunities and problems in the reconstruction have arisen. The particular (i.e. theological, cultural, architectural and financial) concerns and interests of, and complex interrelationship between, the small brotherhood of the monastery itself, and the four Serbian Belgrade-based bodies to whom the conservation architects Professor Mirko Kovacevic and Nenad Sekularac report (The Hilandar Foundation/*Zaduzbina Svetog Manastira Hilandar*, The Institute for the Protection of Cultural Monuments of the Republic of Serbia/*Zavod za Zastitu Spomenika Kulture Republika Srbija* [ZZSKRS], The Patriarchate of the Serbian Orthodox Church/*Srpska Pravoslavne Patrijarsija*, and the Serbian Ministry of Culture/*Ministarstvo Kulture Republika Srbija*) is negotiated with the Centre for the Protection of the Heritage of the Holy Mountain/Κέντρο Διαφύλαξης Αγιορείτικης Κληρονομιάς in Thessaloniki, Greece (ΚΕΔΑΚ) which oversees, among other things, all building work on Athos regardless of whether the monastery is Greek, Russian, Bulgarian or Serbian.

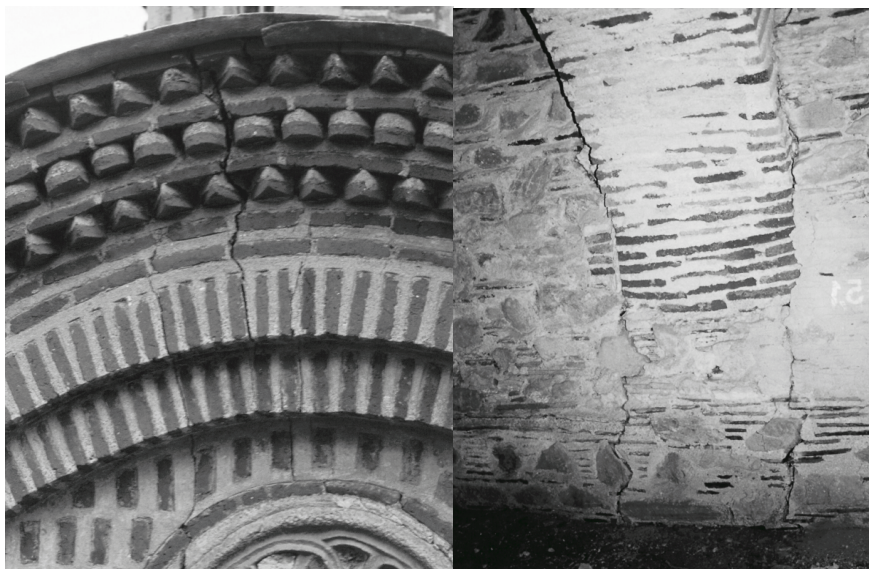
Figure 5: Hilandar Monastery, Mount Athos: cracking in cornice masonry of *katholikon* esonarthex, and cracking at base of diaphragm arch at ground level of Saint Sava tower (Kovacevic 1992).

The ZZSKRS's conservation of the structural cracking and splitting of the massive stone and brick George, Sava and Milutin towers and the smaller, more structurally complex, *katholikon* and Saint Basil chapel/*parekkleseion* Svetog Vasilije in the Hrusija fortress, the most critical intervention involved stabilising the gradual and incremental vertical cracking and movement due to a

combination of the disintegration of the internal lateral timber floor and roof reinforcing and accumulated effects of water infiltration and seismic forces exacerbated by the considerable weight of the massive stone roofs in the case of the towers. Having, with Nenadovic, first employed a technique of consolidating and stabilising the building fabric of the Nova Pavlica Monastery *katholikon* near Brvenik in Serbia in the late 1980s using tie-rods and an injected binding agent, Kovacevic stabilised the five Hilandar structures using the same process of reinforcement and consolidation; the Demetrius tower in 1992–1993, the Milutin in 1995–1997, the Sava in 1999–2001 and the smaller ecclesiastical structures simultaneously. In all cases the cracking was ‘stitched-up’ by drilling diagonally through the mixed stone, brick and mortar wall fabric in both the horizontal and vertical axes and inserting a 20mm diameter stainless steel tie-rod with tensioning sleeves (Fig 6, left) between and below the internal floor joists in both axes and inserting the anchor plates into the thickness of the wall (Fig 6, right) and masking these from view by burying them in the heavy external wall fabric and thus binding or reinforcing the external bearing wall structures of each of the towers levels by a horizontal and vertical matrix of tie-rods and plates steelwork. Subsequently, elasticised Pozzolana mortar was pressure injected into all of the internal wall voids through the major cracks and through new holes drilled (on a 50–60 cm grid) into the walls’ vertical surface to access the internal voids. In the case of the Saint Basil chapel in the Hrusija fortress, the drilling for the tie-rods

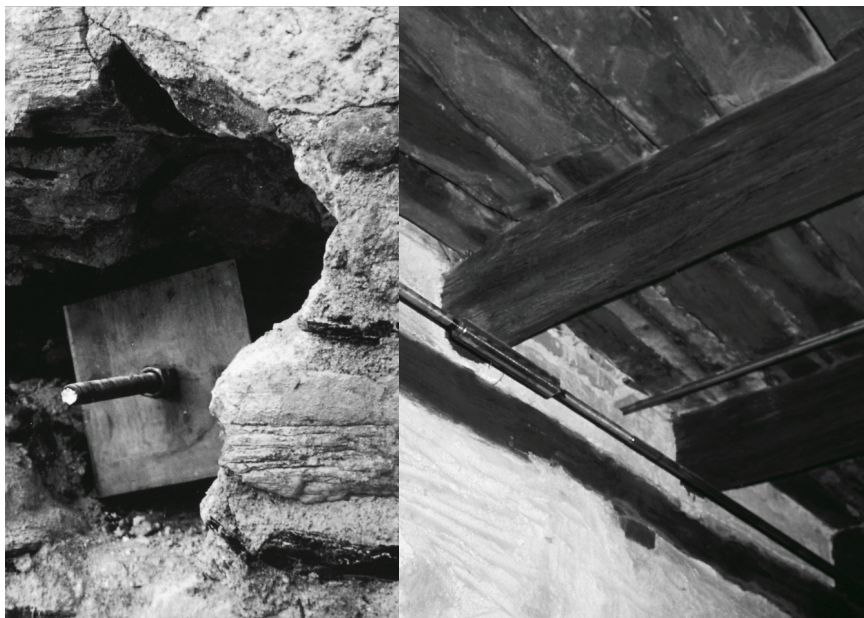
Figure 6: Hilandar Monastery, Mount Athos: Saint Sava tower, tie-rods wall anchoring and non-invasive positioning under floor (Kovacevic 1998 and 2000).

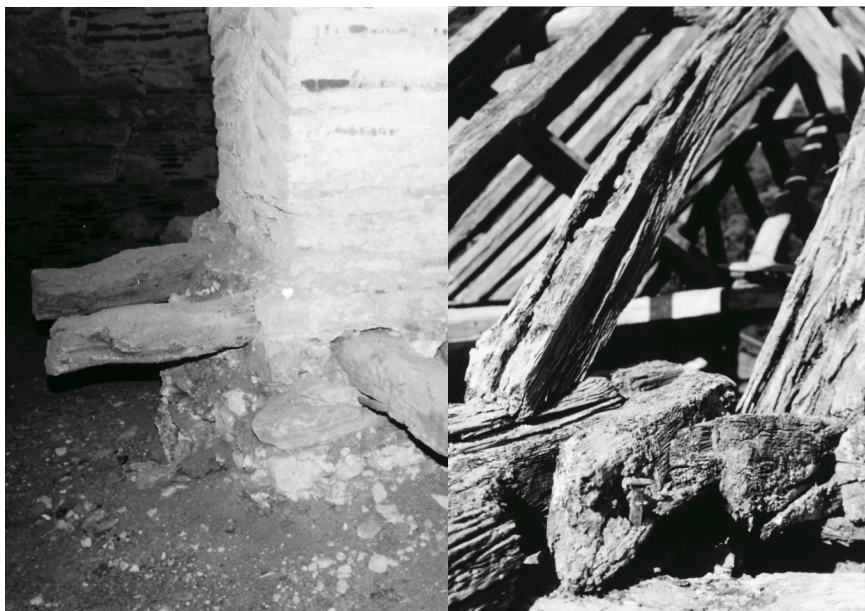
Figure 7: Hilandar Monastery, Mount Athos: Saint Sava tower, chestnut subfloor pier anchors and roof structure as found (Kovacevic 1997 and 1999).

were made in order to be able to anchor the chapel walls to the adjacent curtain wall of the fortress. In the case of the two towers, essential sub-structural and super-structural work involved renewing the chestnut timber rafters where rotting of individual members (Fig. 7, right) in the Sava tower had put strain on adjacent members to the point of an imminent failure of the entire roof structure (Nenadovic [15]), and the renewal of the chestnut anchor timbers in the pier foundations (Fig. 7, left). In the case of the penultimate level of both the George and Sava towers, reinforcing was anchored into a new concrete mass that replaces the pre-existing dry rubble fill found between the top of the vaulted ceiling structure of the floor below and the floor surface above in order to add structural cohesion in the event of powerful seismic activity.

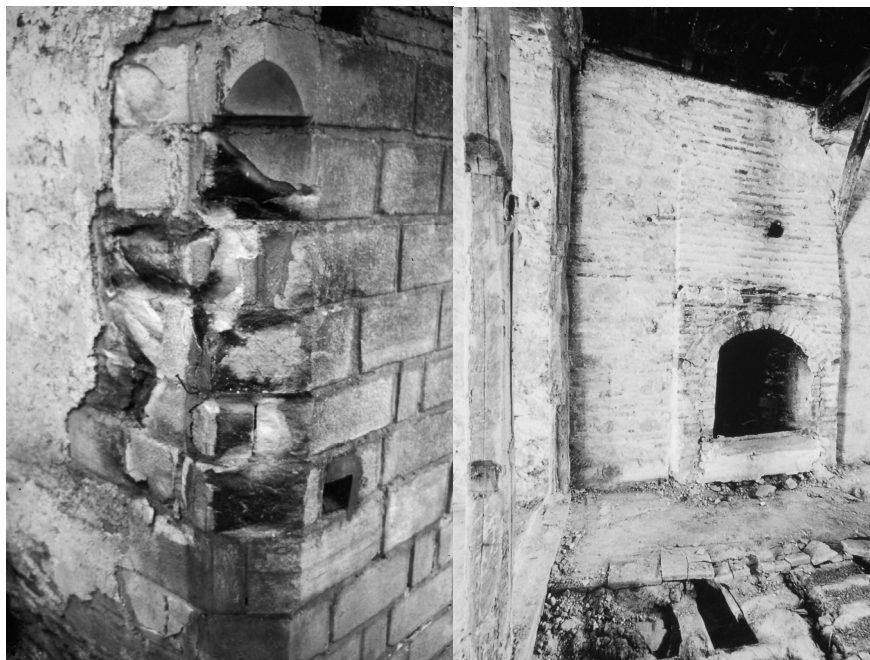
Figure 8: Hilandar Monastery, Mount Athos: 1816-1821 Range/*Konak*, ornamental corner detail and a hearth revealed by the fire destruction (Kovacevic 1997 and 1999).

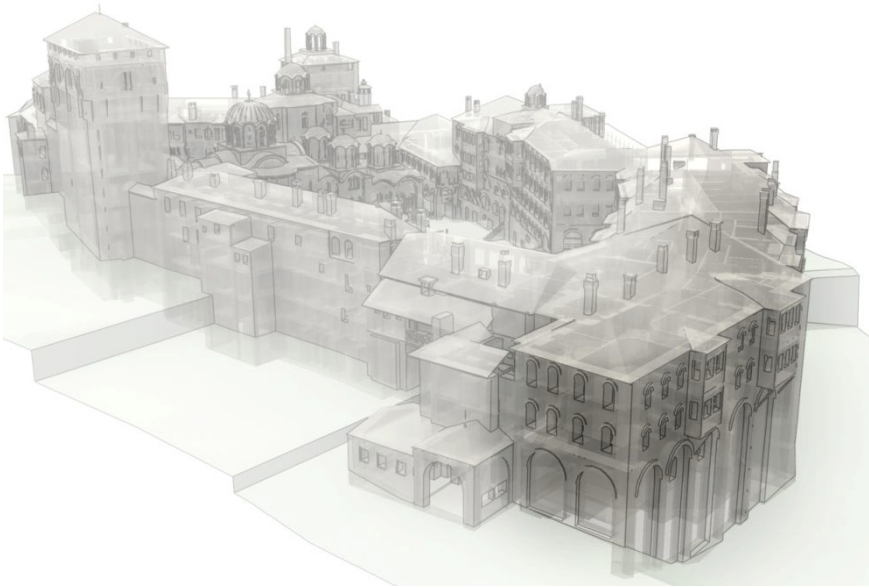
Figure 9: Hilandar Monastery, Mount Athos: digital model, view from north-east approach with the 1814 Range/*Konak* highlighted (Wai Yat Lo, 2009).

mid-2006 when the seven month long reinstatement project was begun on the three level 538sqm 1814 Range/*Konak*. While the synodal meeting room/*sinodik* on the top level and Bishop Melentija's cell/*Kelija Vladika Melentije* on the middle level are to retain their original usage, the exceptionally high ground level storeroom is to be the bookshop on the ground levels and gallery on the basement level. The reconstruction of this range involved the stabilisation of the large and unusual 13m high central pier in the manner that the towers were reinforced in the 1990s. Currently the work at Hilandar is focussed on the reinstatement of the 1816–1821 Range/*Konak*, the monastery's largest (2724sqm) structure, which housed the reception/*gostionica*, administrative offices/*kanzlarije* and conservation labs/*konservatorske radionice* and the majority of the guests' cells/*kelije*, started in October 2007 and currently is at about the mid-stage of its completion, which is due in early 2011. The exceptional weight of the collapsed stone slab roofs pulverised much of the stored marble refectory furniture, grain milling and printing equipment and wooden carts, resulting in the loss of a possible reinstatement of this area, which had been purpose-built as a donkey stall. In this range a fundamental conceptual question regarding reinstatement has emerged: whether some late 19th Century retrofitted iron reinforcing beams are now to be reinstated. That is, if one is to be regulated by the immediate pre-fire condition or rather to restore the structure to an original or other condition prior to pre-Modern and Modern upgrading work.

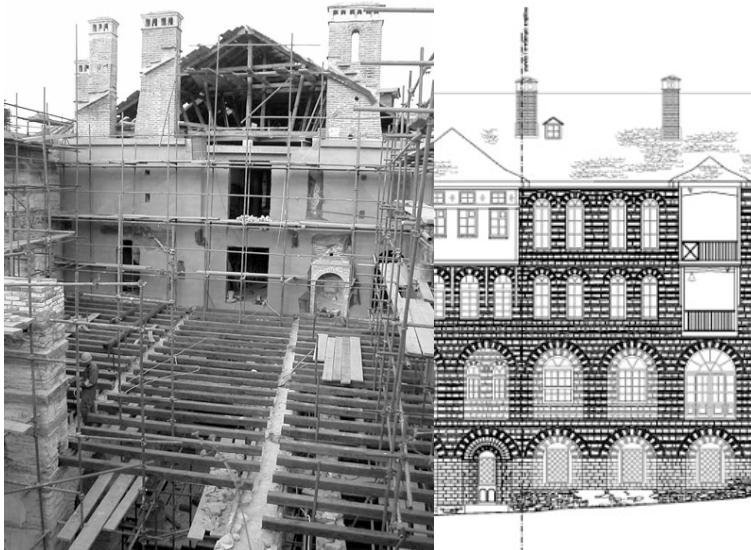
Figure 11: Hilandar Monastery, Mount Athos: 1816–1821 Range/*Konak*, section (Paraskevopoulos 2005) and the main pier (Kovacevic 2006).
