## Reconstruction of Rector's Palace atrium in Dubrovnik: a key role of column connections

D. Lazarević, J. Atalić & K. Fresl

*Faculty of Civil Engineering, University of Zagreb, Croatia*

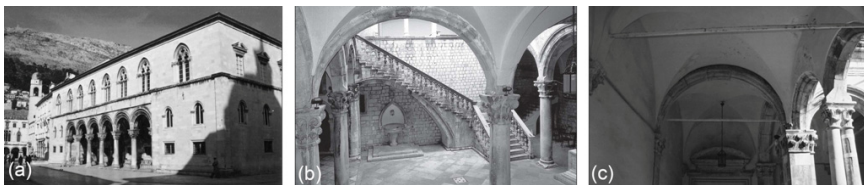
Rector's palace (fig. 1(a)) is a traditional structure placed inside the historical part of Dubrovnik, called the Old town. The massive stone walls of the Palace surround the inner opened structure, known as the atrium (fig. 1(b)), where the origins of the problem are located. It consists of two storeys, each defined by the quadripartite masonry vaults (fig. 1(c)), and filled with a weak material up to the floor level. The back side of the vaults is supported by masonry walls, while the front side lies on the stone columns, which mostly constitute the inner façade (fig. 2(a)). The first floor columns are coupled and have a smaller diameter,  $d = 23 - 25\text{cm}$ , than those on the ground floor,  $d = 50\text{cm}$ . Between columns, which carry the floor vaults, there are also columns that carry only decorative front arches. On the northern front, instead of on the row of columns, ground floor vaults lie on a long masonry wall, along which the stone stairway leads to the floor level (fig. 2(b)). At the corners, the floor vaults are supported by massive brick columns (marked on fig. 2(c)).

Figure 1: Rector's Palace: (a) front view, (b) atrium (ground floor), (c) atrium (first floor).

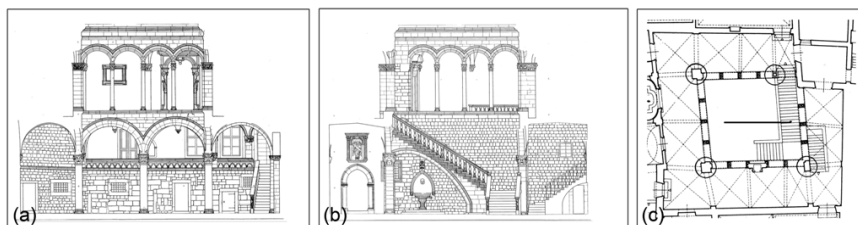
Figure 2: Atrium: (a) south front, (b) north front, (c) plan of the floor.

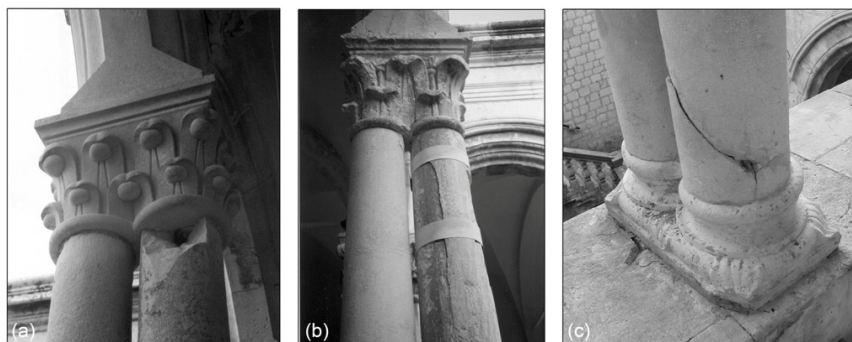
Figure 3: Fractures on column connections: (a) and (b) with capital, (c) with base.

Detailed analysis of specific fractures around the column connections revealed some bad features of contact between the column and the base as well as the column and the capital. Carefully smoothed stone contact areas are joined with iron dowel which is centrally placed in a slightly larger hole and finally filled with lead (fig. 5(a)). Old masters must have thought that columns were uniformly compressed, so such precise finishing of contact areas was very well suited for transmission of such uniform vertical stresses.

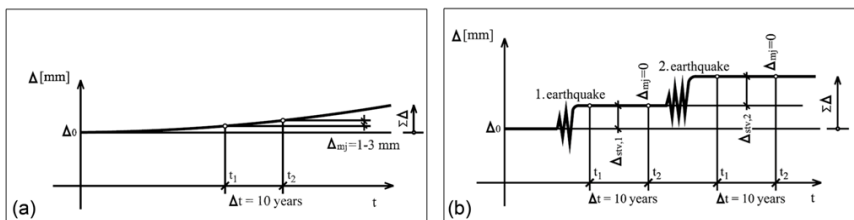
The logical hypothesis about large relative vertical displacements between the columns, as the main reason of damages, was not confirmed by observations, geotechnical and surveying measurements. However, this statement is only conditionally discarded because of the short measurement time scale and the possibly slow (fig. 4(a)) or discontinuous (fig. 4(b)) ground displacements, where the latter appeared immediately after seismic event. These scenarios offer an explanation why precise instruments did not detect any movement over the period of a year or two.

Figure 4: Possible long time displacement of support: (a) slow and continuous, (b) immediate and discontinuous.

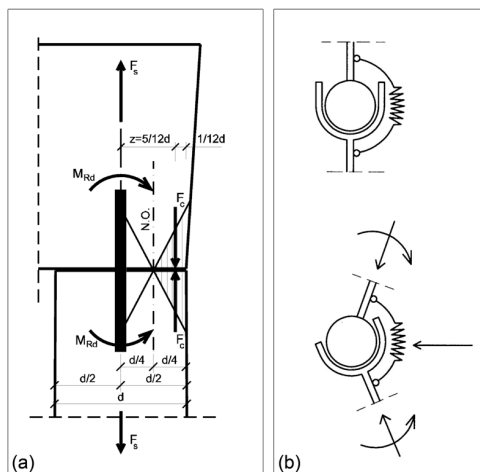
Figure 5: Connection Contact Model: (a) rotational capacity; (b) undeformed and deformed state.

Unfortunately, it will be shown in the next section that they were completely wrong. Furthermore, as the dowel can transmit only very small tensile force due to insufficient dowel anchoring (about 10 cm) and the lack of adhesiveness amplified by the influence of weak mechanical properties of lead, especially its tendency to creep. Therefore, the dowel can safely maintain only compression and transverse force (with a help of friction between stones at contact). It is obvious that such a connection has a very small rotational stiffness and therefore the contact behaves almost like a hinge (more precisely, like a hinge with an added rotational spring with small stiffness). So, contact behaviour can be primarily described like a ball-in-a-cup (fig. 5(b)). Note, even intuitively, that such a contact is very sensitive to any horizontal disturbance.

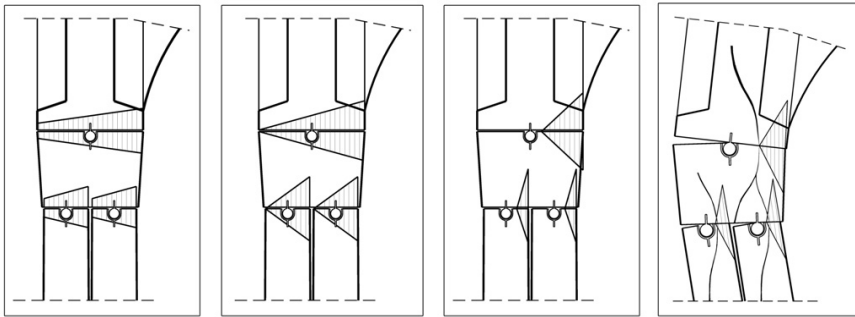
Unfortunately, connections are mostly loaded eccentrically (note the position of the thrust line in fig. 8(b)). Even small horizontal displacement of connection causes relative rotation between column elements and results in high local stresses at the edge of a column, because the joint has only very limited ability to compensate rotations (fig. 6). When stress concentration exceeds the compression strength of stone, the deviation of compression trajectories generates unwanted tensile force which easily exceeds small tensile strength limit of stone and causes a column to split (fig. 7(a)). This force is effectively covered with stirrups (in reinforced concrete) or with steel rings (as it appears here), tightened around almost crumbled columns. Eventually, this leads to fractures near contact surfaces, splitting of columns and capitals and thereby a complete loss or a very significantly reduced bending stiffness.

Figure 6: Progress of contact stresses with an increase of lateral load.

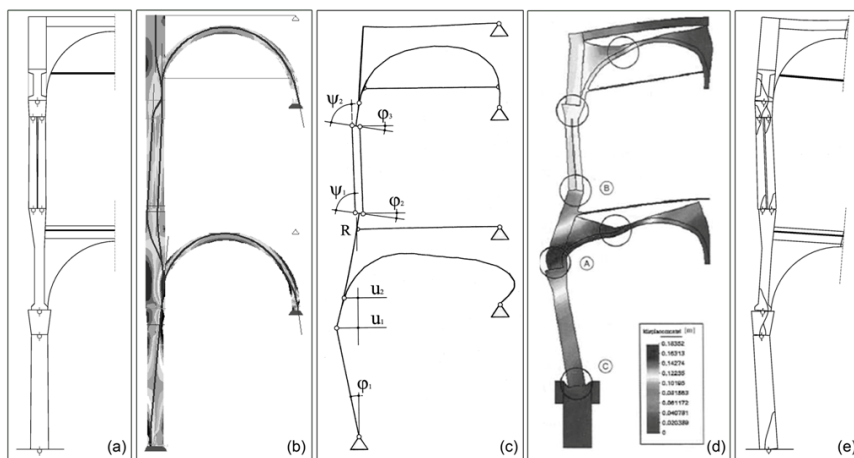
However, if the connections are idealised as hinges (fig. 8(a)), the eccentrically loaded bearing system (fig. 8(b)) can easily turn into a mechanism. Note that only three hinges on the characteristic vertical line are sufficient to render the system unstable (fig. 8(c)). Eventually, most of connections are seriously cracked (on the descending part of  $M - \psi$  curve; see fig. 7(c)) and the global bearing capacity of the atrium is almost exhausted (fig. 8(d)). Structure does not have bearing capacity reserves and the overstressed joints cannot effectively unload. High contact stresses cannot be redistributed to neighbouring bearing elements

Figure 8: Behaviour of characteristic section: (a) position of hinges, (b) thrust line, (c) frame model, (d) stresses in section, (e) calculated cracks.

due to the small degree of indeterminacy. It is interesting to note that the computed crack positions (fig. 8(e)) is in agreement with those found on the real structure.

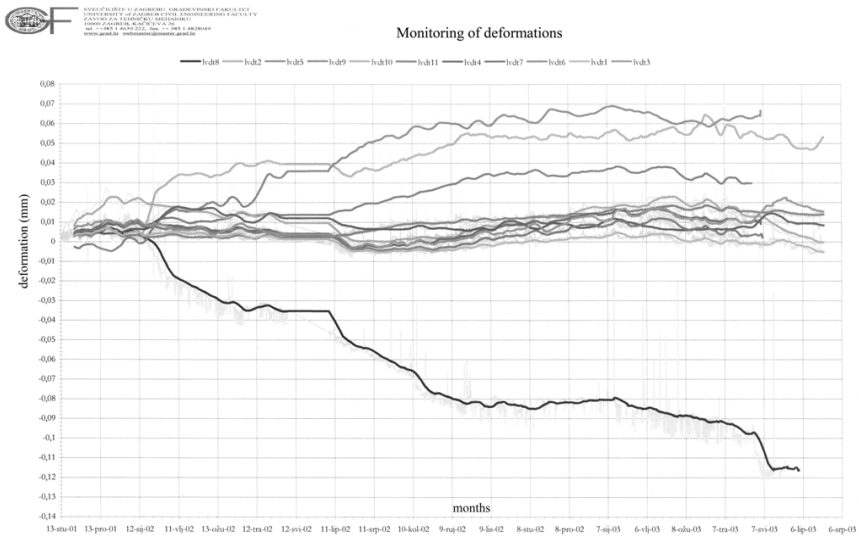
Figure 9: Monitoring of active cracks as measured during a period of 22 months.

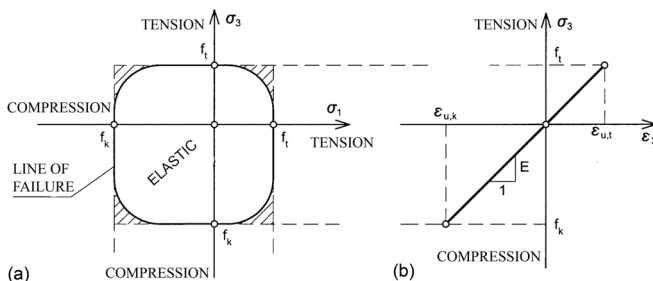
Figure 11: Fracture criterion: (a) failure surface, (b) one dimensional  $\sigma - \epsilon$  curve.

Failure criterion of material was defined by the modified theory of normal stresses, which was originally developed by Galileo and Rankine. This simple theory predicts the failure of an initially elastic material, with no ductility and no post critical reserves. Fracture criterion is defined by the expression:

where  $\sigma_1$  and  $\sigma_3$  are the highest and the smallest principal stress at the Gauss point of an element. Here, positive values imply tensile, and the negative value implies compressive stress (fig. 11). The values  $\sigma_a$  and  $\sigma_s$  are defined by:

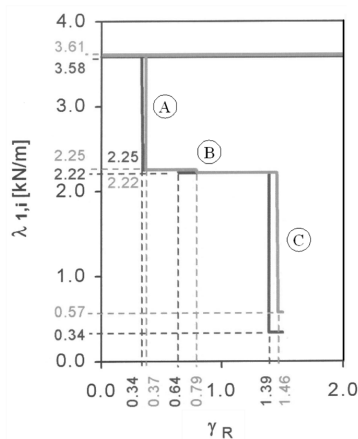
Based on this criterion, materially nonlinear analysis with load increments of 1% of the total load was conducted. Within each step, the full Newton – Raphson method was applied. Stability of the analysis was monitored by the line search method, using the bisection for computing a zero point and an underrelaxation factor equal to 0.8 was adopted for additional stability purposes. Convergence criterion was based on an energy norm. Convergence was deemed to have been achieved and the next step was started if the current energy was lower than  $10^{-5}$  of the energy at the start of the step. Using this algorithm, stress concentrations and the exclusion of overstressed elements were easily detected. Degradation of stiffness was monitored by plotting the relation between the first eigenvalue of tangent global stiffness matrix and the safety factor for estimated dead load (fig. 12). After three substantial step changes in the eigenvalues, here labelled as A, B and C (three hinges were developed), the global stiffness was so small that the model became practically unstable.

Figure 12: Decrease of the first eigenvalue of the global tangent stiffness matrix.

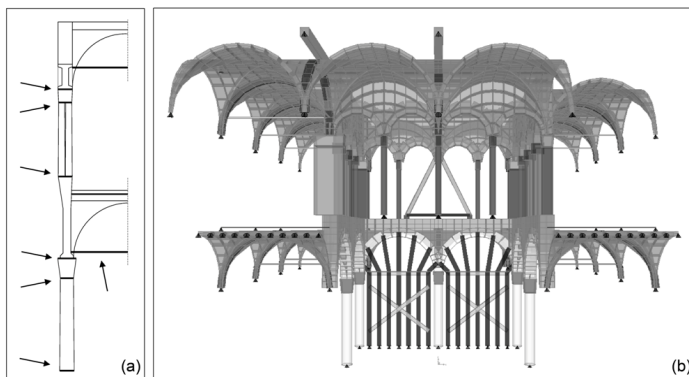
Figure 13: Reconstruction: (a) locations of intervention, (b) numerical model.

Some form of repair (or even replacement) of critically damaged columns and capitals is clearly inevitable. Proposed intervention will include thin layer of lead (4mm) placed between the two connected areas (fig. 13(a)). The material such as lead will enable small rotations and will shield connected areas from large stress concentrations. Lead is already used to fill dowel holes and the additional horizontal thin layer appears as an appropriate and almost invisible intervention.

In order to reduce load eccentricity in columns, which primarily exists due to thrust of first floor vaults, new braces are envisaged. These will be slightly prestressed (30 kN) and properly anchored. This visible (and frequently unpopular) intervention is needed if the thrust line is to be centred, which will in turn minimize consequences of serious earthquakes. Furthermore, existing braces and anchors from earlier interventions at the second floor are overstressed and must be replaced in any case. This issue is absolutely vital, as without them, the thrust line lies outside the column section and the structure is unable to sustain even a dead load.

All potential reconstruction phases were also checked using a nonlinear staged construction model, with element inclusion/exclusion when required as the analysis progresses in time. These elements were carefully placed in such a way that loads on structural elements in all intervention phases were on the conservative side (fig. 13(b)). With these interventions, the safety factor of the structure is increased by approximately 20% and it is hoped that any future interventions on columns will be significantly delayed.
