Application of a combined computational-experimental approach for the service life estimate of exterior plasters of historical buildings

V. Kočí¹, J. Maděra¹, R. Černý¹ & P. Rovnaníková²

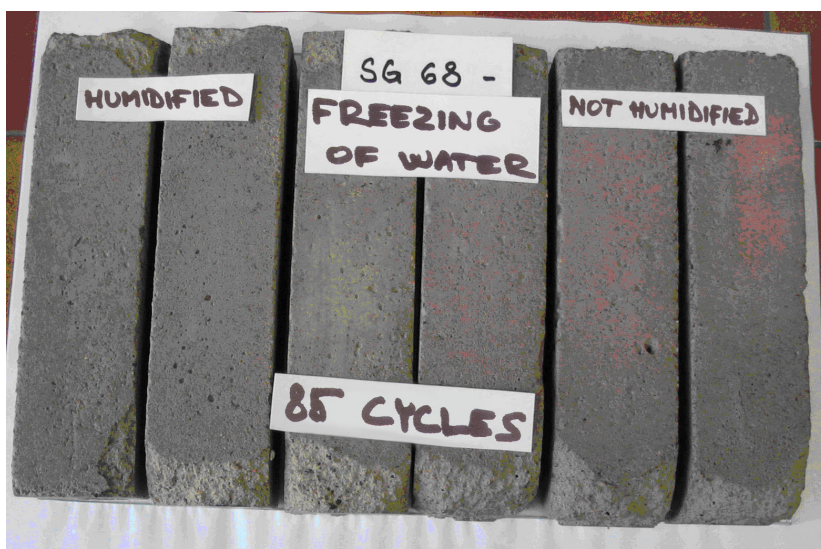
Figure 1: Damage of LPD (SG 68) after 85 cycles.

water, wiped by paper towel and put into plastic bag. Packed specimens were put into freezing box for 6 hours. After removal, the specimens were kept in lab with temperature of $20 \pm 1^\circ\text{C}$ for 2 hours, then were put into water bath for 16 hours. This cycle was repeated until the visible damage of specimens. Number of freezing cycles causing damage of plasters is summarized in Table 1. The two sub columns in LPD plaster column correspond to its two layers; SG 68 is the base layer and SP 64 G the external layer. Damage of LPD plaster (SG 68) is shown in Figure 1.

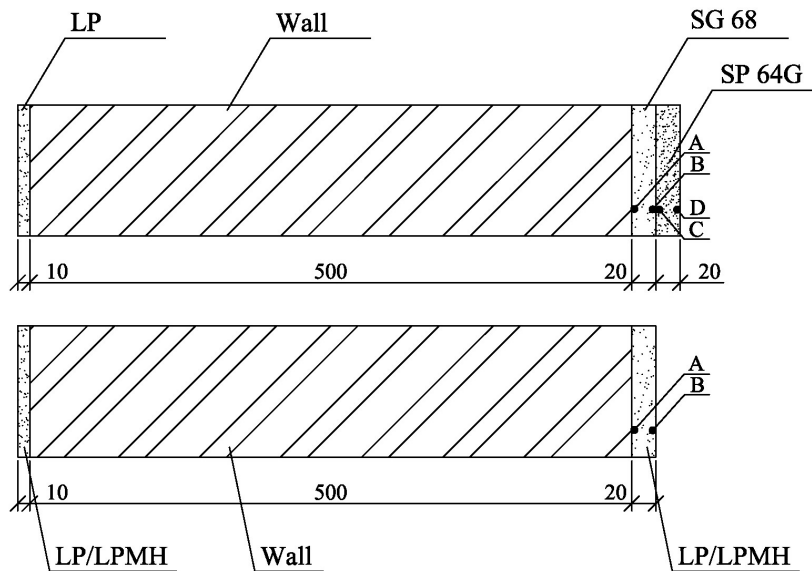
Figure 2: Material combinations.

The load-bearing wall was assumed to have a thickness of 500 mm. It was provided with 10 mm thick interior plaster and 20 mm thick exterior plaster. Materials of interior and exterior plasters were the same for LP and LPMH. In the case of LPD, we used lime plaster on interior side. Overall thickness of two-layer LPD plaster was 40 mm (2×20 mm). Material combination with investigated points in plasters is shown in Figure 2.

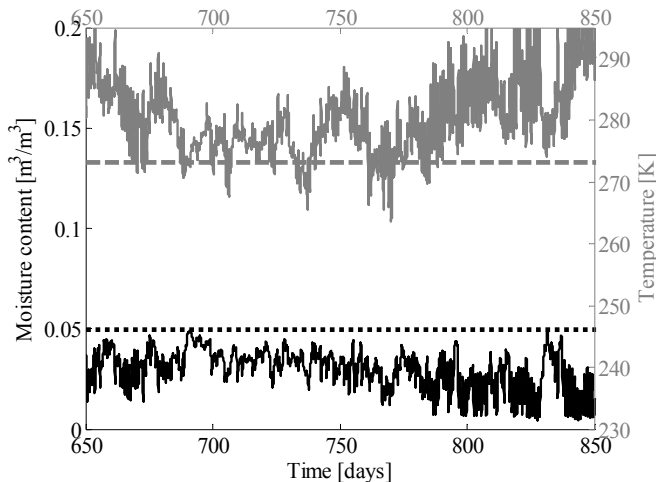
Figure 3: Hygrothermal performance in point B of LP applied on brick masonry.

There are not any freezing cycles in LP applied on brick masonry because of low moisture content. This is obvious in Figure 3, which captures hygrothermal performance in point B.

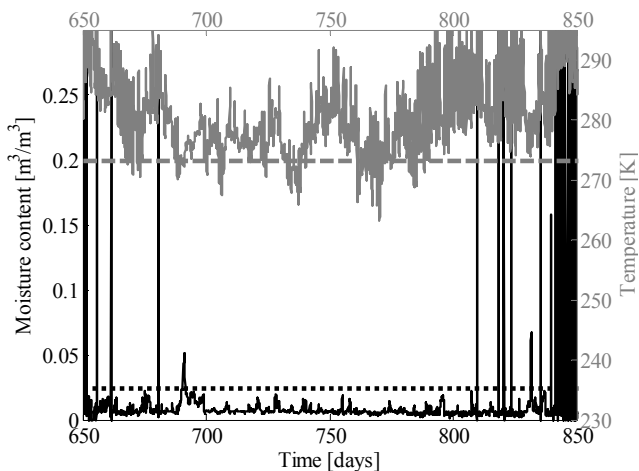
Figure 4: Hygrothermal performance in point B of LPMH applied on brick masonry.

A specific behaviour can be observed for VOMH applied on brick masonry. On the interface between the plaster and load bearing structure, there are not any freezing cycles because of low moisture content, but on the surface of plaster, there are many variations in moisture content in summer months as we can see in Figure 4. We counted one freezing cycle during a reference year in 691st day which took 13 hours.

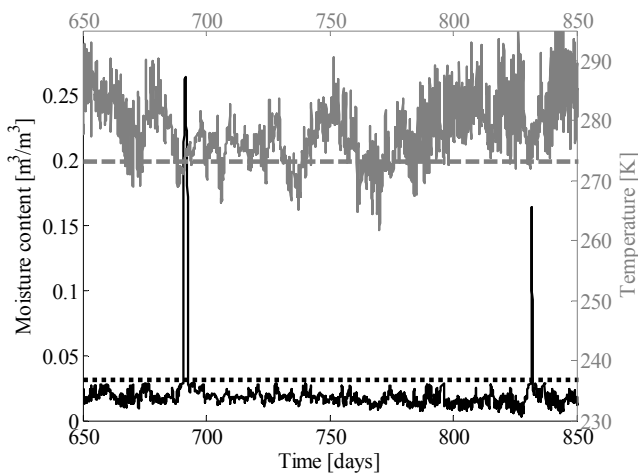
Figure 5: Hygrothermal performance in point D of LPD applied on brick masonry.

Moisture content in the internal layer of LPD is too low to creation of freezing cycle. However the same we cannot say about the external layer. There was one freezing cycle arisen in the 691st day and took 14 hours. This can be seen in Figure 5.

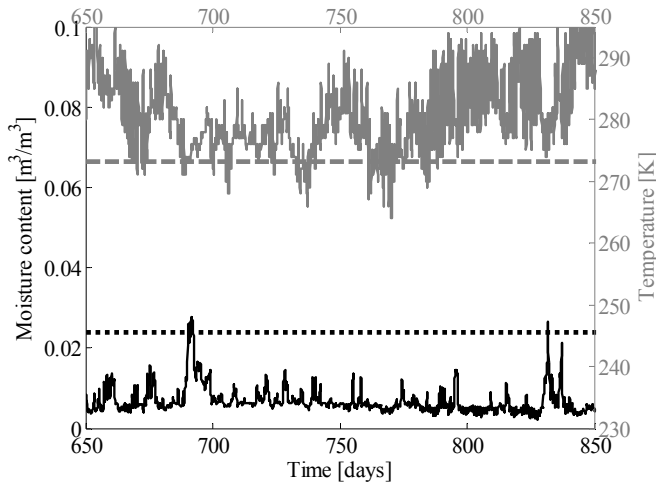
Figure 6: Hygrothermal performance in point A of LPMH applied on arenaceous marl masonry.

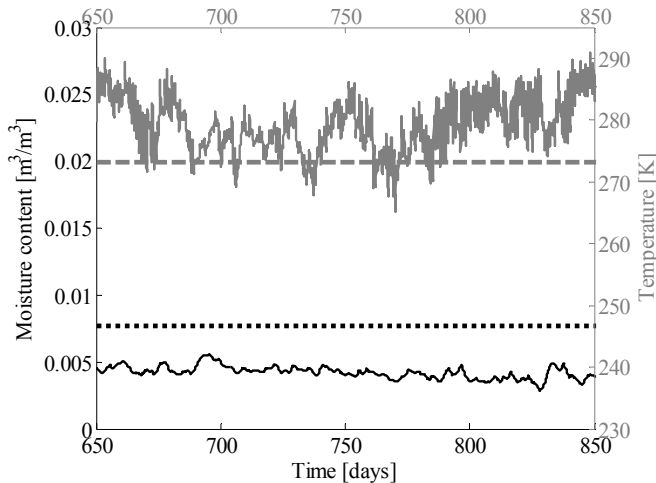
Figure 7: Hygrothermal performance in point B of LPD applied on arenaceous marl masonry.

Water contained in the internal layer of LPD did not get frozen anytime, which is presented in Figure 7. Hygrothermal performance of external layer of LPD was similar to Figure 5, and there was one freezing cycle in 690th day which took 24 hours.

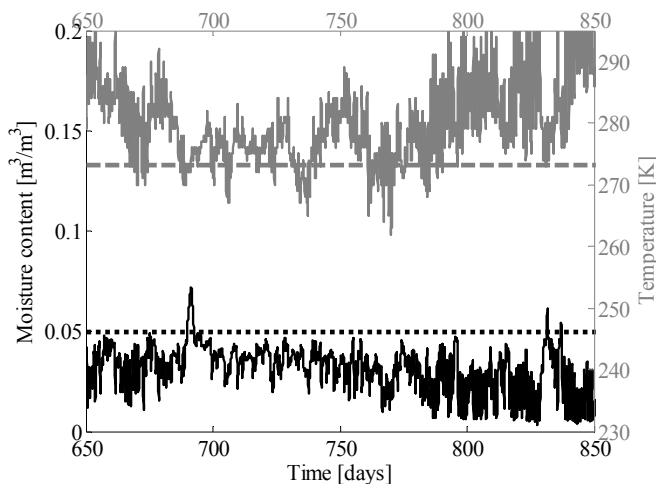
Figure 8: Hygrothermal performance in point B of LP applied on sandstone masonry.

Only sandstone masonry provided with LP gave suitable conditions to creation of freezing cycle. There were two cycles on the surface in 690th and 691st day which took 12 and 22 hours. This is shown in Figure 8.

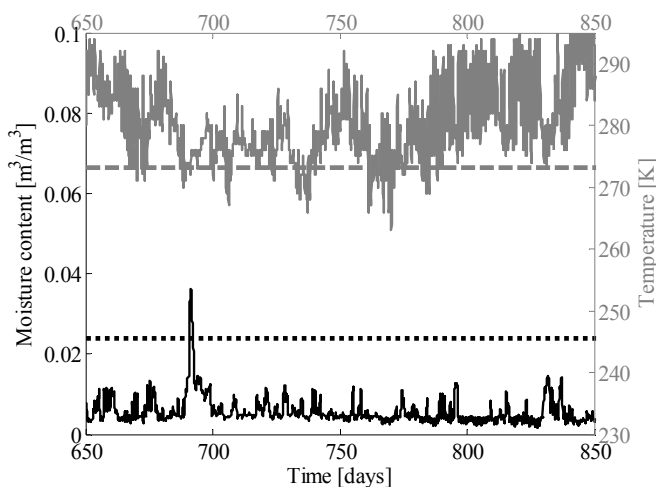
Figure 9: Hygrothermal performance in point A of LPMH applied on sandstone masonry.

LPMH applied on sandstone masonry showed high moisture content differences on the surface again. This led to creation of three freezing cycles in 690th and 691st day of simulation which took 16, 22 and 4 hours. One cycle was counted in 691st day on the interface between the plaster and load bearing structure, too and took 10 hours (Figure 9).

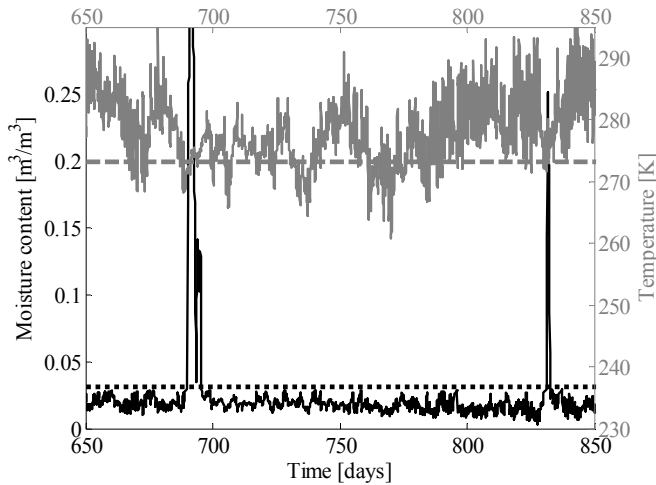
Figure 10: Hygrothermal performance in point D of LPD applied on sandstone masonry.

Due to the low moisture content the internal layer of LPD applied on sandstone masonry cannot be damaged by freezing water. However, water contained in external layer of LPD reached overhygroscopic state simultaneously with temperature below zero twice a year. So, we could count two freezing cycles in 690th and 691st day which took 33 and 7 hours (Figure 10).

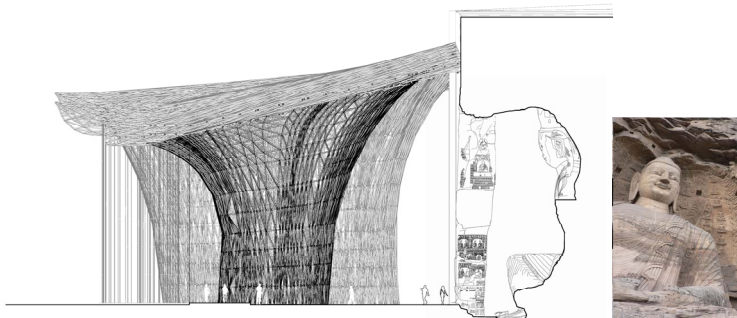
Figure 1: Proposed mushroom canopy to protect Buda statue.

of the requirements is that the shelter it is not supported by this ridge. This requirement is an important consideration because the proposed structure should not read as part of the historic site, as they have no common culture. Moreover, the ridge could not be used to provide reliable support without the need for major intervention. The proposition shown in fig. 1 was selected for further investigation.

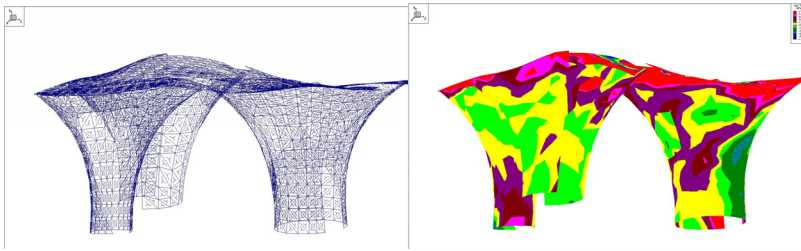
Figure 2: Model mesh and stress distribution after completion of the adjustment process.

In addition to the areas of high stress concentration the figure also reveals areas of low stresses. At the areas of low stress in the structure, the material is not used efficiently and may be removed or replaced by transparent, non-structural panels. The process of removal of the material subjected to low stresses was carried out manually in an iterative fashion. At each step, those plates subjected to the lowest stresses were removed and the remaining structure was reanalyzed. In subsequent steps, a new set of plates appeared with low stresses, and these were removed in turn. Fig. 2 also shows the approximate shape of the structure after the plates had been removed. It is interesting to observe the locations of voids in the canopy and “mushroom” columns. The voids in the canopy allow for articulation with lighting panels, and openings in the columns might be used as entrances into architectural spaces programmed for services and shops.

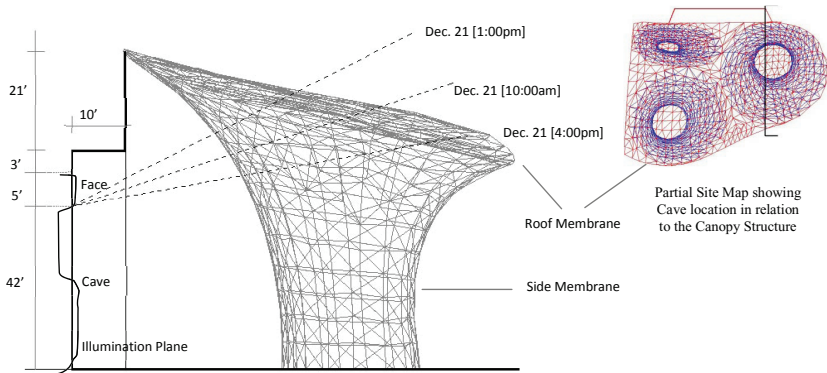
Figure 3: Daylighting study set-up.

A daylighting study is conducted to investigate the effect of a proposed canopy structure on illumination level inside the cave using three roofing materials; PVC polyester fabric, ethyl tetra fluoroethylene (ETFE) and polytetrafluoroethylene (PTFE). The largest cave of 50'x70'x50' size is selected for this investigation. We focus on the illumination level on the face of the statue. Actual illumination plane is considered in line with the face as shown in fig. 3. Three mushroom columns which support a roof structure stand in front of this cave. The roof and side walls of this structure are central surfaces for this study. The opening of the cave is 50' tall and 70' wide which is the only source of daylight. This study mainly focuses the illumination levels on a plane of 8'x 8' representing the face. This study is conducted for overcast sky conditions for December 21.

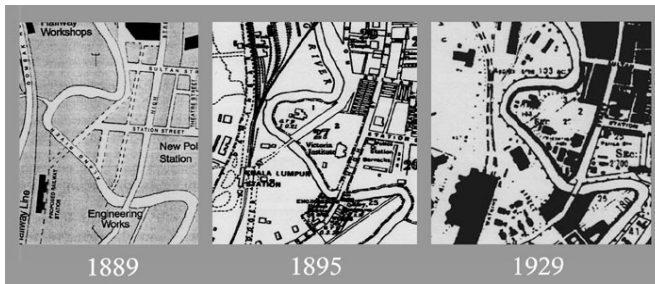
Figure 3: VI Building construction phase [5, 6].

The present VI building dates from 1929. Before that the VI was located in High Street (now Tun H.S. Lee Road) in the heart of old Kuala Lumpur town where the school was first established in 1893. As the school grew over the decades, its environment also grew and changed, mirroring the parallel growth of Kuala Lumpur [5]. The building construction phase is shown in Figure 3.

When Malaya government approved the establishment of the VI, eight acres of land on the left bank of the Klang River were set aside. The map of 1889 in Figure 3 shows a vastly different Kuala Lumpur from that of today. Construction began in 1893 of two buildings, one a school block known as Block 1 and the other a large bungalow for the Headmaster. Block 1 had two floors, the ground floor being mainly of brick while the upper part of the building was largely timber floor. The map of 1895 shows the school a year after it opened. Block 1 fronts High Street while the Headmaster's Bungalow is further away at the bend of the river. While the map of 1929 shows a vastly changed VI All the buildings that make up the school complex are in place [5, 6]. The map of 1939 in Figure 4 shows a significant change in the former VI complex.

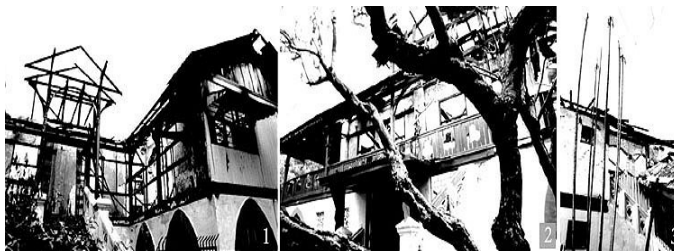
Figure 6: Effect of fire to Block 1 VI in 1999 [6].

inscribed on it and which had stood for 106 years was consumed by the flames. Such photograph as in Figure 6 below shows the incident where no.1 shows the skeletal remains of the porch facing High Street; no. 2 shows the southern façade with its small wooden porch and no. 3 shows the northern façade with part of the long curving porch most of which has been spared [6].

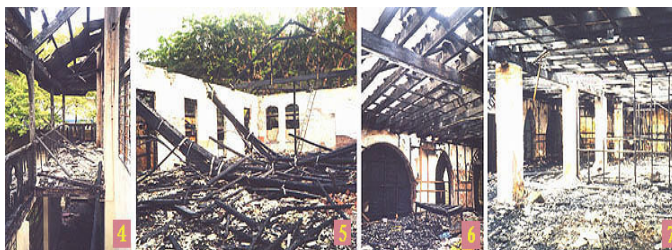
Figure 7: VI heritage building after fire in 1999 [6].

In the photograph in Figure 7, no. 4 shows the southern façade from the top of the stairs, no. 5 shows collapsed rafters on the first floor beams, no. 6 shows the ground floor with ubiquitous gothic arches in the background and no. 7 shows the ground floor with remains of partitioning that were probably of post-1960 vintage [7, 8].
