## Non-destructive methods as a tool in the assessment of monumental buildings condition

G. Concu & B. De Nicolò

*Department of Structural Engineering, Cagliari University, Italy*

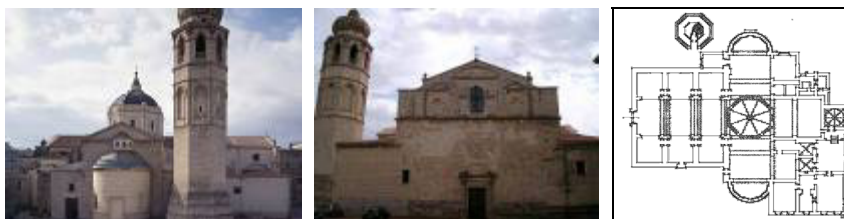
Santa Maria Church (1130) was rebuilt during the reign of Mariano II after being destroyed in a siege. Of the original structure of Mariano only parts of the apse and base of the bell tower are left, as well as the Gothic Chapel of the *Rimedio*, which houses some medieval sculptures. Parts of a more ancient Byzantine edifice can be seen in the court. The church was restored in the 17<sup>th</sup> century, but 3 chapels were left in the ancient Romanesque style. The current Baroque style comes from a 19<sup>th</sup> century restoration. The northern side of the building is joined by the beautiful medieval bell tower, having octagonal cross-section and finished in the 17<sup>th</sup> century with a dome majolica-covered. The façade is made of regular trachite blocks. The interior has a Latin cross plant, and is made by a single wide nave with three chapels on each side, a square apse and a quadrangular transept. The intersection between the nave and the transept is covered by the octagonal dome (fig. 1).

Figure 1: From left to right: northern view, façade, cross section.

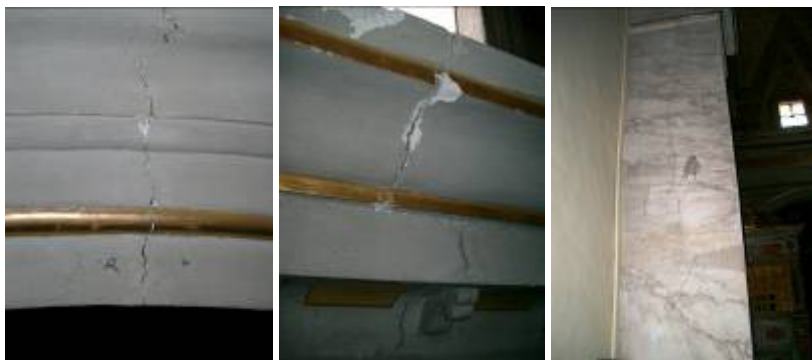
Figure 2: Crack patterns. From left to right: middle of arches, above arches, along the joint façade-walls.

The accessing arches of the lateral chapels contiguous to the façade showed visible crack patterns (fig. 2):

- in the middle of the arches
- on the masonry above the arches, at an angle of about 45° towards the façade and developing towards the ledge
- along the vertical joints between the façade and the chapels lateral walls.

Some of the cracks seemed to have been compensated in the past.

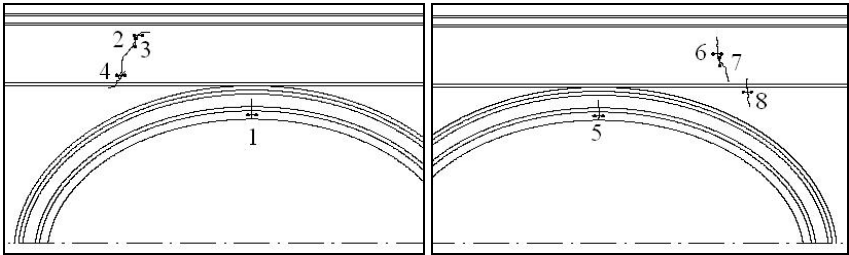
Monitoring of cracks has been set up in order to assess possible risks and to understand the mechanical behaviour of the structures before planning any kind of intervention. Aiming at evaluating the differential movement of the arches and the façade, the most serious cracks have been monitored for 14 months. The displacements have been measured by a digital extensometer having  $\pm 1$  micron accuracy. In the detail, the monitoring interested 8 cracks, located on the middle of the two arches and on the above masonry (fig. 3). The trend of cracks displacements is reported in fig. 4. Right and left positions are referred to an observer with backs to the apse.

Figure 3: Monitored cracks. Left: right arch, points 1-4. Right: left arch, points 5-8.

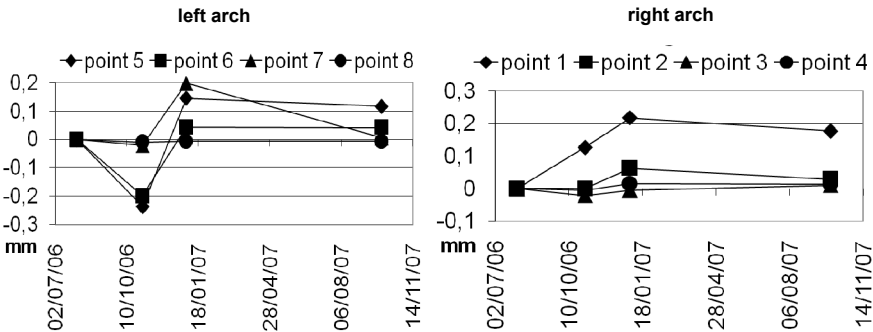
Figure 4: Trend of cracks displacements.

Collected data pointed out the following results:

- the two arches showed quite similar behaviour, with a maximum displacement of about 10,21mm
- displacements trend seemed to depend on temperature's changes: cracks experienced the top closing at the end of the summer, when materials reach their maximum dilatation, and the top opening during the winter

- displacements trend was quite sinusoidal, with very low time-increasing amplitude for points 1 and 5.

- cracks detected through visual inspection and then monitored for a 14 months period seemed to be affected most of all by temperature and seasonal variations, and didn't show remarkable opening trends
- dynamic tested tie rods were not working as structural members, they were only supporting the chandeliers
- the façade's masonry was not subject to non uniform stress distribution or to flexural stresses symptomatic of eccentric loads due to rotation, as pointed out by flat jack tests.

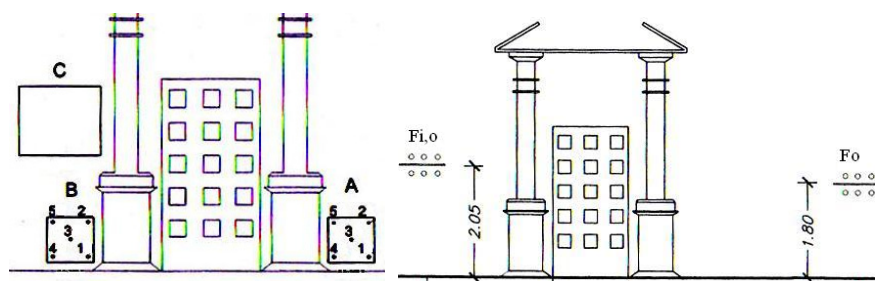
Sonic tests, endoscopy and single flat jacks have been carried out on the façade's masonry, at different levels. Sonic tests provide a preliminary detection of masonry characteristics and can suggest the choice of the area for flat jack tests, whilst endoscopy allows the inspector to check masonry characteristics in single points by direct vision. For these reasons the masonry qualification has been obtained by the complementary use of the above mentioned NDTs. Tested areas are shown in fig. 5.

Figure 5: Left: areas A, B, C tested by sonic technique; points 1A-5A and 1B-5B tested by endoscopy. Right: areas F<sub>1,0</sub> and F<sub>0</sub> tested by flat jacks.

The stress of the façade masonry has been determined by single flat jack test applied in two different parts of the surface, as shown in fig. 5-right. Test  $F_{i,o}$  has been performed both in- and outside the wall so to examine possible non uniform stress distribution and consequent flexural stresses. The flat jack testes highlighted the following outcomes:

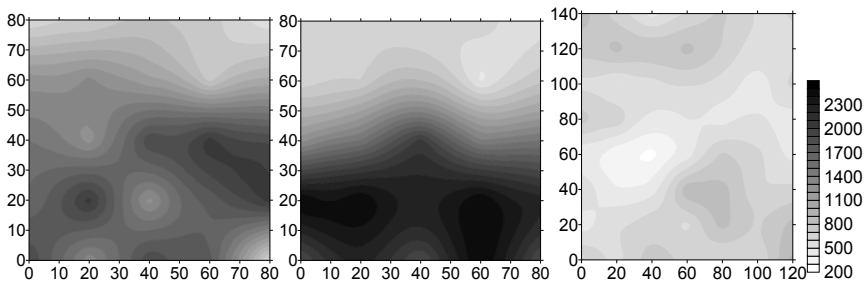
Figure 6: Distribution of sonic velocity (m/s). From left to right: area A, area B, area C (length is in cm).

The velocity maps of tested areas are shown in fig. 6.

The analysis of sonic velocity distributions pointed out the following results:

- areas A and B showed  $v$  values within the range 500-2500 m/s, with mean value of about 1400 m/s and standard deviation of about 600 m/s
- area C showed  $v$  values within the range 300-900 m/s, with mean value of about 600 m/s and standard deviation of about 150 m/s
- sonic velocity of areas A and B decreased from bottom to top, while in area C the distribution is quite uniform.

- sonic tests and endoscopy pointed out that stone quality decreases from bottom to top and towards the inner layers of the masonry
- endoscopy highlighted that masonry non-homogeneities consist mostly of irregular stones and sporadically of potting compost, and sonic test didn't detect any meaningful void or macro cavity that has to be assumed as relevant discontinuity in masonry fabric
- flat jacks provided values of compressive stress quite uniform, and consistent with numerical evaluations.

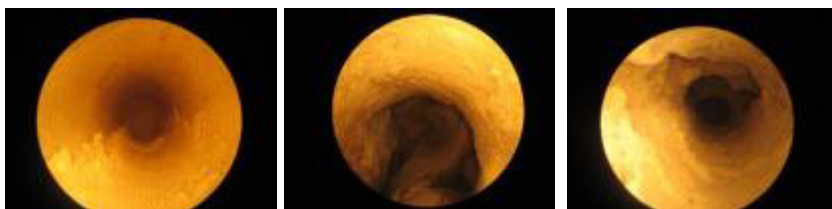
Ten endoscopic surveys have been carried out on previously sonic-tested areas A and B, using a modular rigid endoscope. Inspections have been run through holes drilled in points located at the edges and in the centre of the areas, as shown in fig. 5-left, aiming at correlating discontinuities in the  $v$  maps and masonry inner characteristics. During the test 181 pictures have been acquired by a camera connected to the endoscope. These pictures showed a quite regular masonry and highlighted that the non-homogeneity level increases towards the masonry core. Some pictures acquired during the surveys are shown in fig. 7.

Figure 7: Endoscopic pictures. Left: survey 4B, high regularity. Centre: survey 1A, high non-homogeneity. Right: survey 1B, high non-homogeneity.
