Infrared thermograph image analysis for the identification of masonry coatings in historic buildings, in relation to several samples prepared as patterns

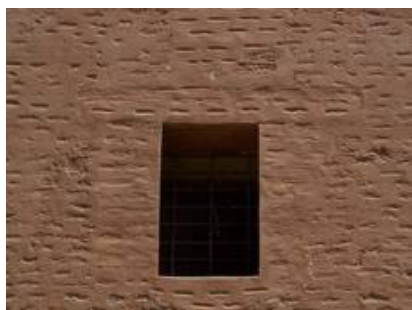
Figure 1: Existing window.

This device was able to capture images of the building walls, presenting thermal images showing lintel elements as in Figures 1 and 2, also previous repairs and the signals of demolished walls on the existing ones, as in Figures 3 and 4. A previous window that had been walled up was also identified, as in Figures 4–6.

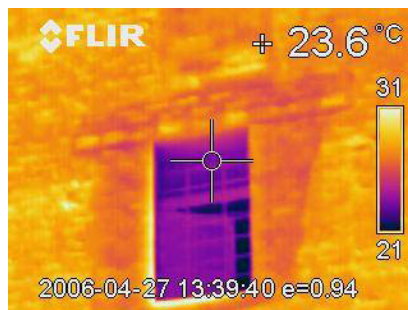
Figure 2: IRT image showing the lintel.

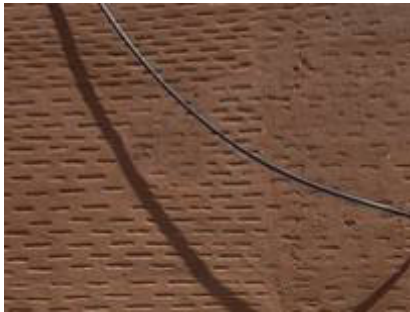
Figure 3: Image of the wall.

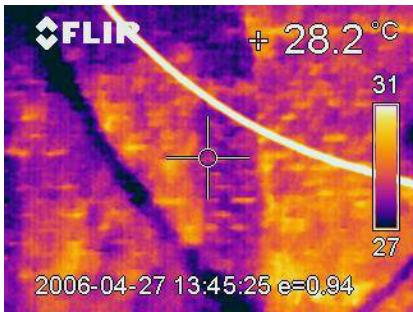
Figure 4: IRT image showing a previous transversal wall, today demolished.

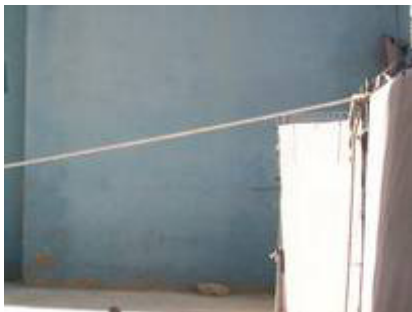
Figure 5: Image of a wall.

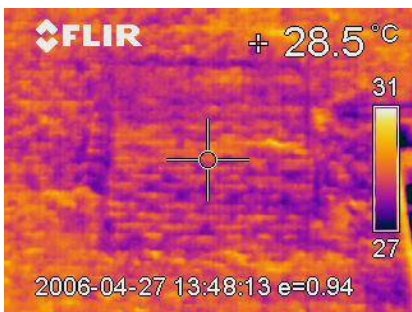
Figure 6: IRT image showing a walled up window.

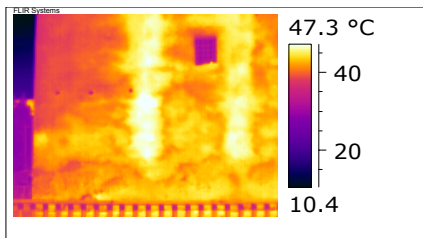
Figure 8: IRT image of the same area, showing a previous opening.

A medieval tower was surveyed by means of IRT images, with promissory results, so the research group aimed to improve the applied method. In this tower, located at Torrent village, close to Valencia City [7], different IRT images were captured in the same day, at different hours, in order to detect the best time

Images were compared, and it was determined that the best hour of the day to take the IRT images was from 20,00 hours onwards, in summer time, when the building materials were cooling down after a sunny day. It was possible to identify walled up hollows and to determine humidity presence.

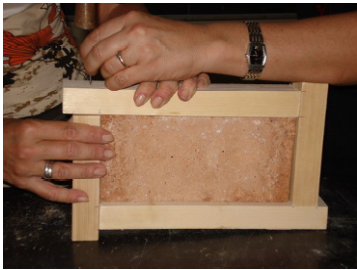
Figure 10: Wooden frame preparation.

Iron plates were introduced beneath the mortar coatings in nine of the mortar samples (1 to 9), with the aim of detecting their presence thermographically. The preparation of the samples can be seen in figures 10–15.

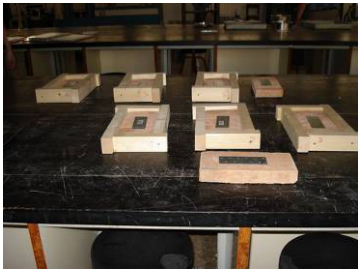
Figure 11: General view of the samples with the bricks and iron plates presented.

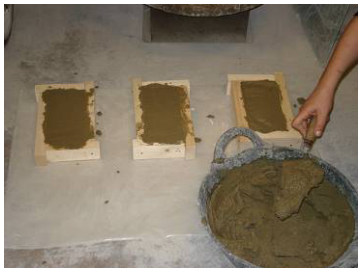
Figure 12: Cement mortar samples.

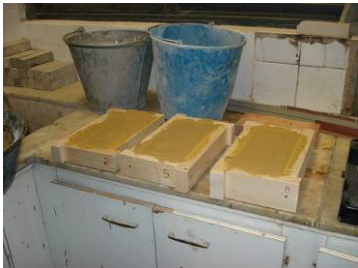
Figure 13: Lime mortar samples.

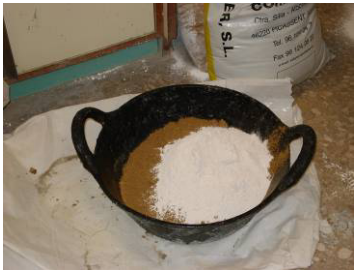
Figure 14: Gypsum mortar preparation.

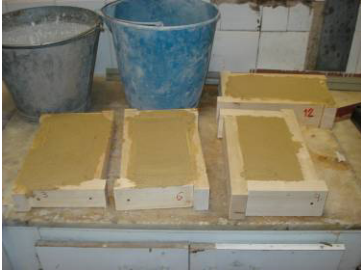
Figure 15: Gypsum mortar samples.

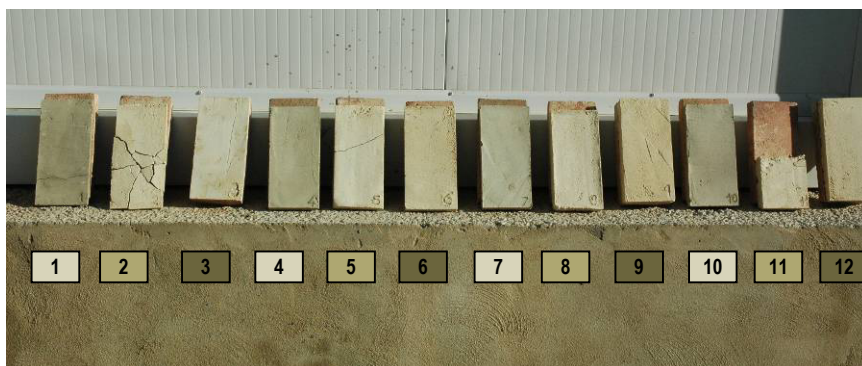
Figure 16: General view of the mortar samples.

The samples exposure to sun radiation is shown in figure 16, and the corresponding IRT images at 16:30 hours are shown in figures 17 and 18.

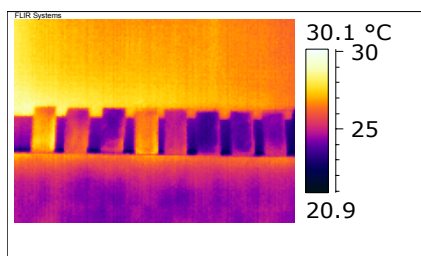
Figure 17: IRT images, samples 1–8.

of samples, numbered 1 to 3; the sample with the higher emissivity is the cement mortar type (n° 1) and the sample with the lesser emissivity is the gypsum mortar type (n° 3). The same behaviour is clearly observed in samples n° 4–6, where the thickness of the mortar coating is 2 cm. For samples n° 7–9 and 10–12, the differences between emissivity are not detectable.

Considering that all of these six samples are coated with 3 cm mortar thickness, its temperature is inferior to the first six samples, n° 1–6, with 1 and 2 cm coating thickness.

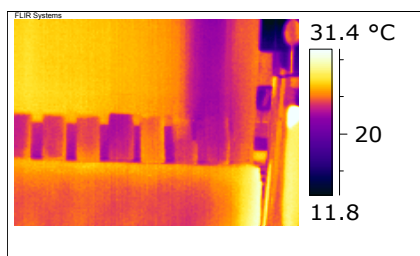
Figure 18: IRT images, samples 6–12.

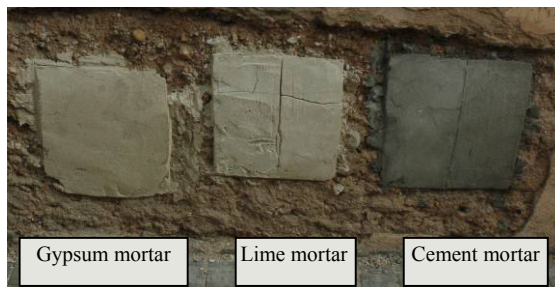
Figure 20: Mortar samples at the south façade.

As the wall coatings were deteriorated, we were able to prepare “in situ” samples, 30 x 30 cm, 1 cm thick, using the same proportions of those prepared in the laboratory. A small coin was introduced at the centre of each sample, in order to detect them with the IRT images.

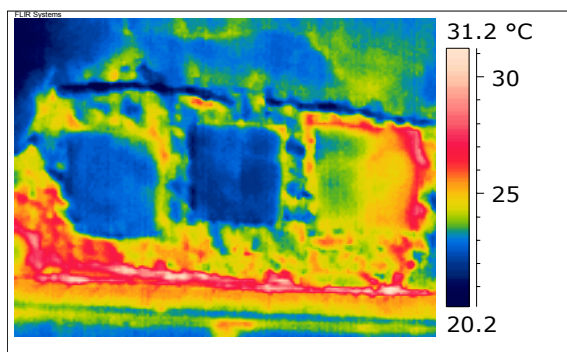
Figure 21: IRT image of the mortar samples at the south façade.

The emissive behaviour of the different mortar types can be observed in these ITR images of the samples as before, so that the *conclusion* established previously can be applied to the mortar coatings applied to the walls. When the building materials present a high emissivity in the same temperature intervals, the different composition can be clearly detected by IRT images.

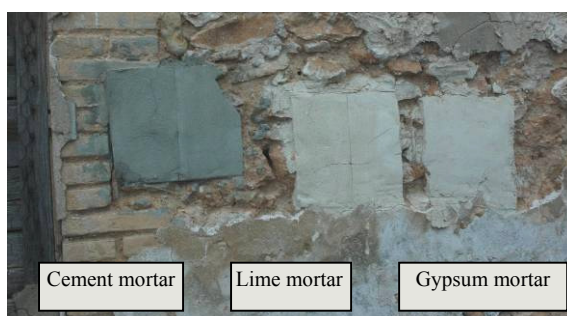
Figure 22: Samples at the west façade.

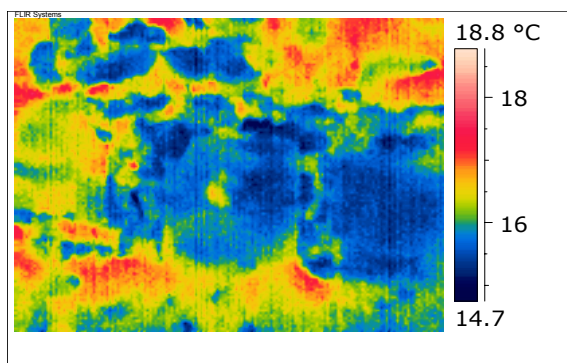
Figure 23: IRT image of the mortar samples at the west façade.
