Seismic vulnerability of historical adobe buildings in the coast of Peru

Abstract

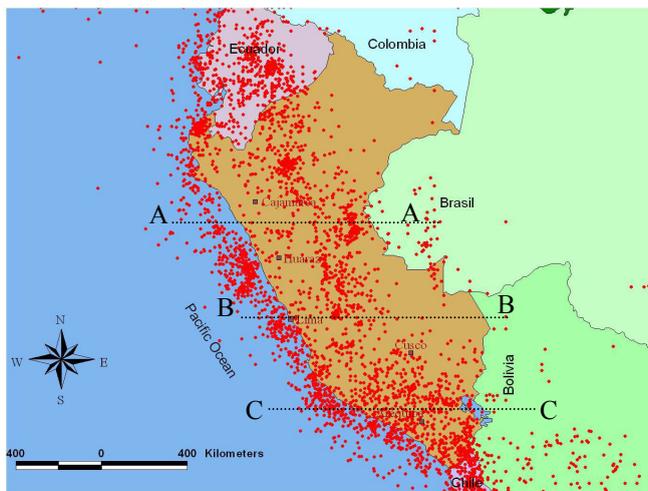
Figure 1: Earthquake distribution near the coast of Peru.

The west coast of South America is affected by frequent earthquakes, originating mainly from tectonic interaction between the Nazca plate and the South American plate. The Peruvian Institute of Geophysics (IGP) has published the catalogue of historical earthquakes in this region, consisting of information from the year 1471. Old records of this earthquake catalogue have information of probable magnitude and estimated location inferred from historical reports on damages in affected zones. Moreover, earlier records prior to instrumental measurement cannot be expected to be representative of the actual distribution of hazard, since at earlier times only earthquakes occurring around populated areas seem to have been reported. If only records with complete information of location, magnitude, depth, etc are selected, the distribution of these instrumental recorded earthquakes appears as can be observed in Figure 1. It can be noted that there is a concentration of epicentres along the coastline. Also it can be observed that the southern part of Peru presents more activity than the north and central parts. To analyze the nature of earthquakes in the northern zone, the central zone and the southern zone, sections that show the earthquake distribution in elevation were constructed. The location of these sections are indicated in Figure 1 as section A-A for the north part, section B-B for the central part and section C-C for the south part of Peru. In all cases, earthquakes located inside a band of 200 km with the centre at the correspondent section line were considered.

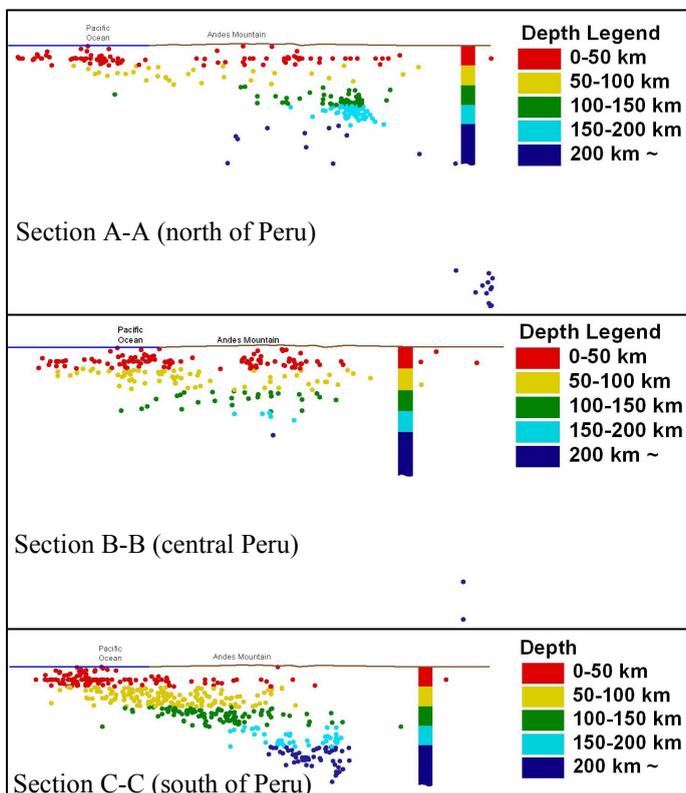
Figure 2 shows the distribution of earthquakes in elevation for each section described in the previous paragraph. Although the distribution pattern presents the same tendency for each zone with shallow earthquakes near the coast and deeper inland earthquakes, the depth distribution and amount of earthquakes for each zone are quite different.

Figure 2: Distribution of earthquakes in elevation.

Section A-A shows the shallow earthquake distribution near the coast. The concentration of epicentres at focal depth from 100 km to 200 km can also be observed here.

Additionally, the concentration of deep epicentres is observed in the zone of the Amazon jungle (east part) with depths of the order of 500 km.

In the section B-B the distribution of the earthquakes shows that in this zone the earthquakes have less than 200 km of depth. The shallow earthquakes near the coast are closer to the coastline, which means that the epicentres are closer to inland cities.

The section C-C shows more clearly the typical earthquake distribution of the subduction action of the marine plate, with deeper inland earthquakes. It can be noted that the number of earthquakes is larger in comparison with the north and central part of Peru.

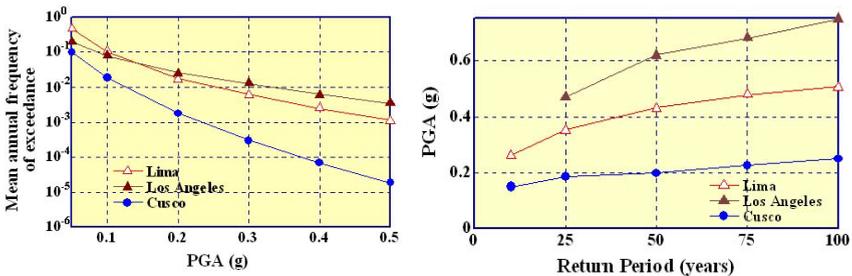
Seismic hazard analysis for representative sites of the Andean region of Peru (Cusco city), and the coast of Peru (Lima city) was performed by Cuadra et al [3] and are shown in Figure 3. Hazard curve for Los Angeles city is included for comparison. Results of the probabilistic seismic hazard analysis can also be expressed in terms of the return period shown in Figure 3, where peak ground acceleration (PGA) for different return periods with 10% probability of exceedance are plotted. It may be noted that the PGA for 100 year return period is around 0.25 g for the considered Andean region and for Lima (Coast of Peru) the PGA is 0.5 g. This higher level of peak acceleration may produce failure in buildings in general and the situation become critical for weak material like adobe constructions. In addition, the PGA levels in Figure 3 represents rock or stiff soil conditions, while the actual level of shaking depends on local site conditions at specific heritage sites where the local site amplifications and other effects may be important.

Figure 3: Hazard curve and PGA versus return period for representative sites.

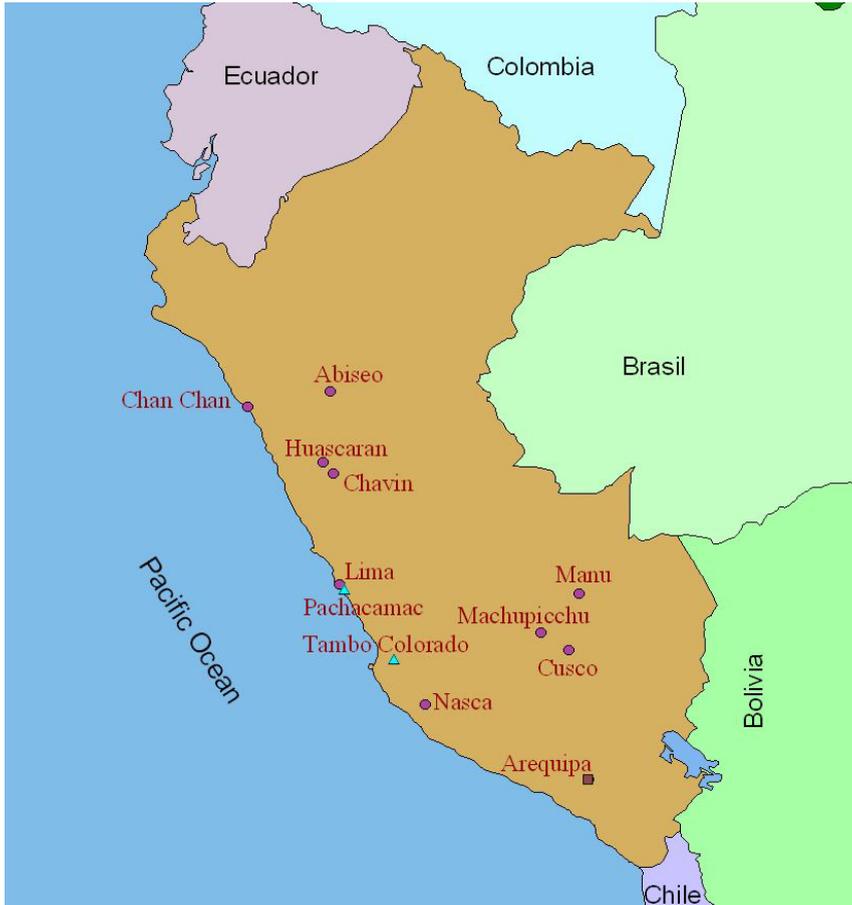
Figure 4: Peruvian world heritages distribution.

Peru has many sites of cultural and natural heritage reflecting the pre-Inca era, Inca era as well as the subsequent era following Spaniard conquistadors in the 17th century. The distribution of these heritages can be observed in Figure 4 and includes the world heritages declared by UNESCO which are marked by circles. Of the ten Peruvian heritage sites in the UNESCO world heritage list, six are

considered cultural and two are considered natural. The remaining two are considered mixed category, meaning that the sites reflect the cultural as well as the natural heritage. Additionally to this UNESCO list, other architectural heritages located in the coast of Peru are included in Figure 4 and are marked by triangles. These selected architectural heritages correspond to structures made of adobe and are describe in the following sections.

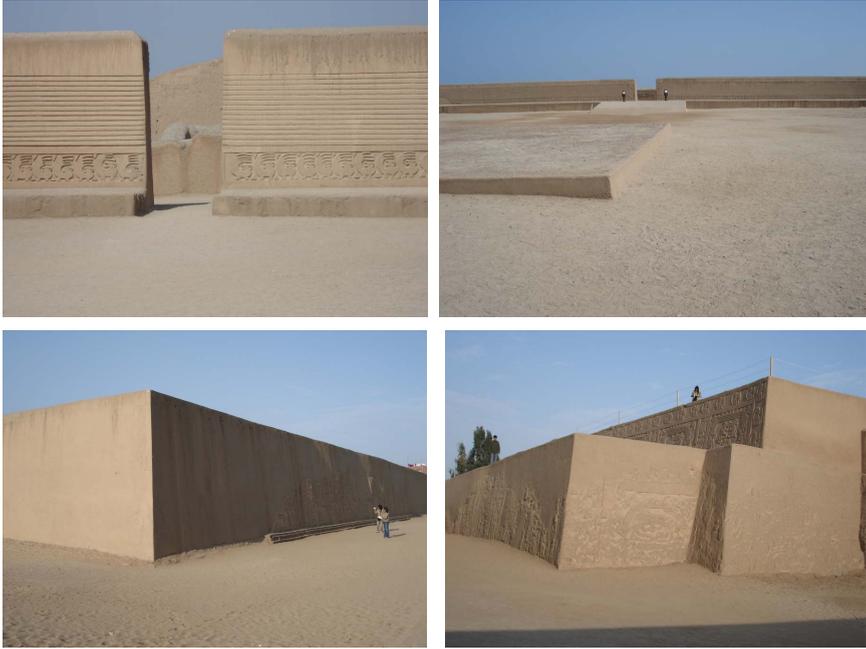
Chan Chan is considered the largest old city of South America that was made of adobe. Chan Chan was the capital of a pre-Inca kingdom of Chimú. The remains of the city can be found in nine parts that are considered separated units or palaces because only around these places can be appreciated remarkable constructions. In Figure 5 some views of adobe constructions can be observed.

Figure 5: Some views of Chan Chan adobe city.

The adobe constructions are quickly damaged by natural erosion due to the air, salt, humidity and rain and they require continuous conservation efforts. This zone is also subjected to the impact of El Nino current which affects climate world-wide. Some years like 1983 and 1998 this phenomenon was unusually strong, leading to torrential rain and flooding. As was shown previously the seismic activity in this north part of Peru are smaller in comparison to the southern and central parts. However, historical earthquakes distribution and hazard analysis shown that this area is not free of earthquakes and on the contrary occurrence of rarely earthquakes could strike and damage earthen structures like Chan Chan.

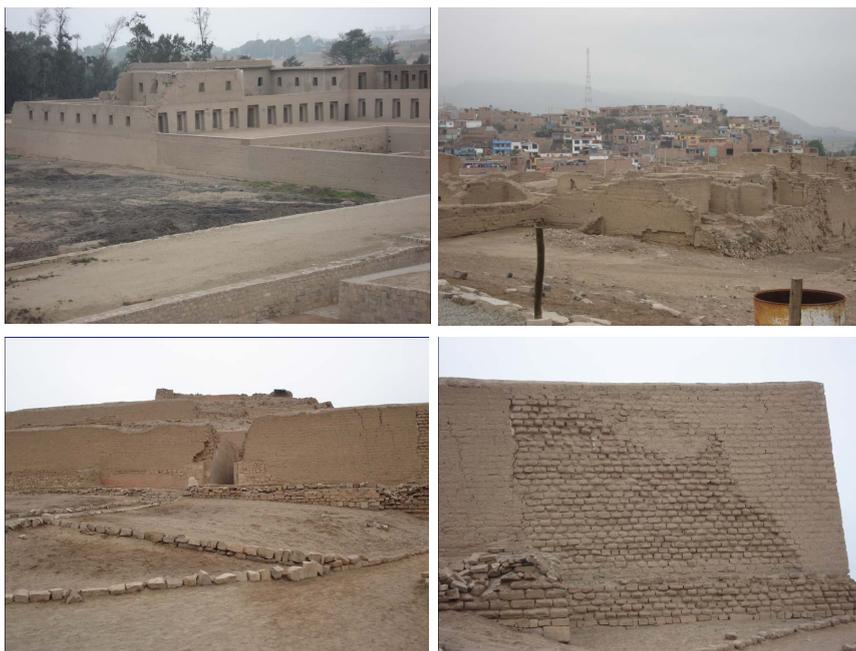
Figure 6: Some views of Pachacamac archaeological complex.

This complex was one of the main centres of religious cult, an oracle centre of ancient civilization in the central coast of Peru. It is a pre-Inca heritage which origins date from 200 a. c. It is believed that one of the deities of this temple was the god of earthquakes. Their constructions are made of adobe which present condition shows the fragility of this kind of material to the action of natural hazards. Figure 6 shows some view of the Pachacamac complex. The buildings in general are affected by the erosion due to the sand and also by the movement of the sand dunes that in some cases has destroyed and cover completely the buildings. It is difficult to infer the action of past earthquakes because the

damage condition of the building could be the result of the action of earthquakes and the lack of appropriate maintenance. Another hazard to this complex becomes the rapidly development of the urban area near the complex that affect not only the landscape of the zone but the architecture heritage itself since construction materials are obtained from the historical place.

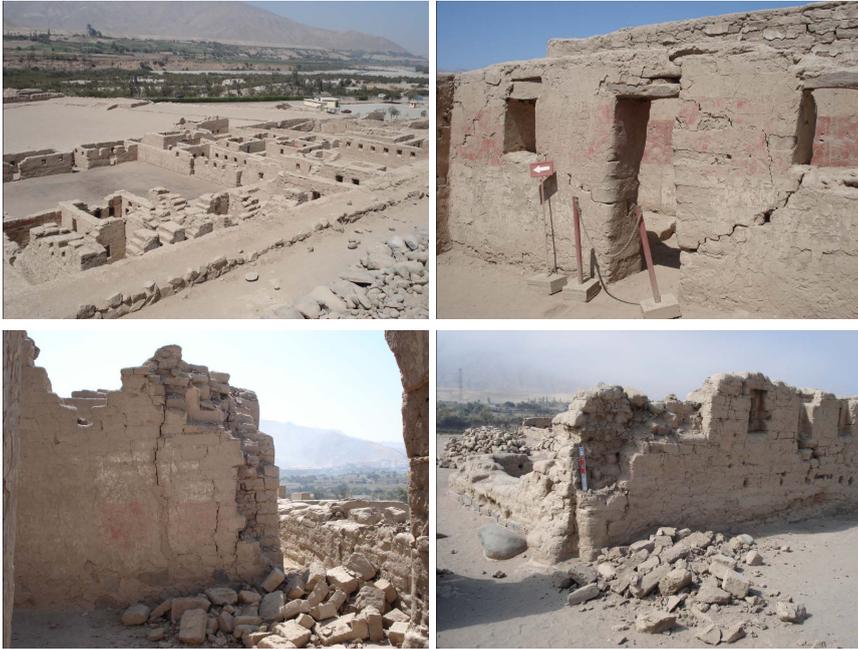
It is believed that Tambo Colorado was one of the administrative centres of the Inca Empire. It is strategically located at the entrance to the Pisco valley, just 35 km inland from the port city of Pisco on the southern coast of Peru, and dominates access to the Inca road leading to the highlands and eventually to Cusco. All constructions are made of adobe and some of them have a coloured plaster with horizontal, alternating, ribbons of white, red and yellow. During the recent earthquake of Pisco of July 2007 many walls were affected and some of them fall down producing not only the failure of the structure itself but also the destruction of the coloured plaster. Some of these damages can be appreciated in Figure 7. In this case, together with the seismic vulnerability analysis it is necessary to analyze the plaster material to try to reconstruct the painted walls. It is obvious that it also has suffered considerable deterioration and damage during the years and urgent conservation measures are required to preserve this monument.

Figure 7: Some views of Tambo Colorado affected by earthquake motion.
