Earthquake behaviour of a reinforced concrete building constructed in 1933 before and after its repair

G. C. Manos & E. Papanas

*Laboratory of Strength of Materials and Structures,
Department of Civil Engineering,
Aristotle University of Thessaloniki, Greece*

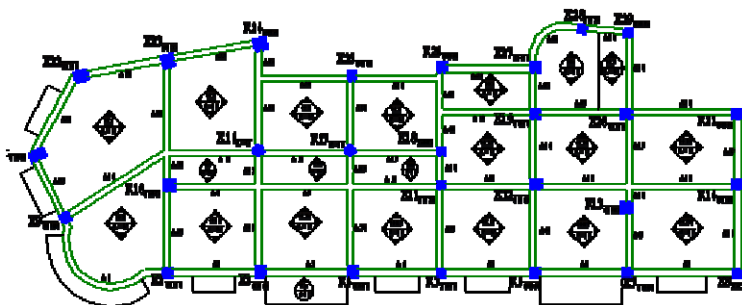
Figure 1: Plan of the typical floor showing the R/C columns, beams and slabs.

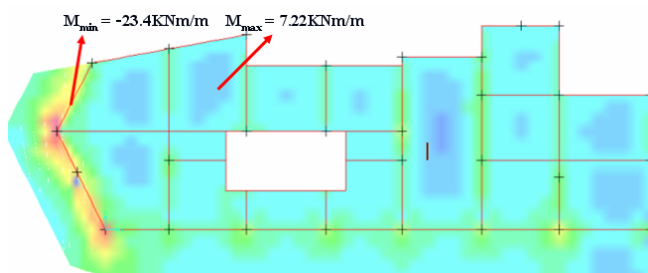
For this purpose an F.E. analysis was performed for all the slabs with predominant loading the combination of dead and live loads as specified by the Greek Code. Figure 2 shows the results of the ground floor ceiling that is one of the most-stressed slabs due to the relatively large exterior balconies and internal verandas as well as from its live load requirements. The extreme values of some of the demands in terms of bending moments are shown in the same figure. The structural detail of this slab is shown in figure 3.

Figure 2: The flexural demands for the ground floor ceiling.

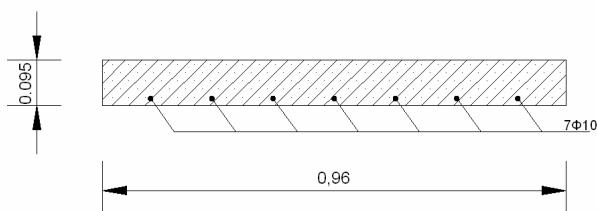
Figure 3: Structural detail of the R/C slab.

One piece of the slab with dimensions 1.30m x 0.96m was removed from the building and was tested under controlled conditions in pure flexure at the Laboratory, resulting in a bending moment capacity $M_{Rd} = 9.18$ KNm/m. The corresponding estimate based on the structural detail (figure 3) and the relevant calculations is equal to $M_{Rd} = 11.78$ KNm/m. This non-conservative estimate must be attributed to the long term corrosion that reduced the effective cross-section of the reinforcing bars. Comparing the experimental bending slab strength with the numerical analysis maximum demand (figure 2) for positive slab flexure a safety factor equal to 1.27 is found, that indicates an acceptable limit-state performance. However, the demand for negative slab flexure yields a minimum bending moment that is approximately three times larger ($M_{min} = 23.4$ KNm/m), which indicates a non-acceptable limit-state performance for the large exterior balconies. The retrofitting addressed this requirement as will be presented in section 3.1.3.

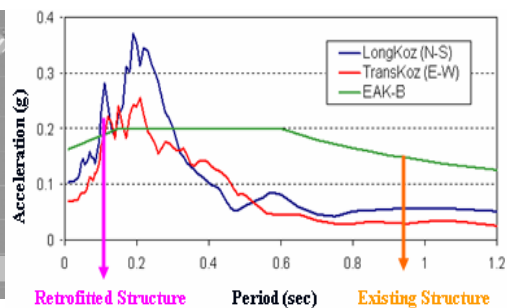
Figure 5: Acceleration response spectrum for the Kozani Earthquake of May 1995.

As can be seen from figure 8, the flexural demands resulting from the Simplified Spectral Method are 2 to 6 times larger than the corresponding demands resulting from the Dynamic Spectral Method based on the design spectrum specified by the Greek Seismic Code. This must be attributed to the torsional sensitivity of the old existing structure, which is penalized by the provisions of the Greek Seismic Code when the Simplified Spectral Method is applied. When the results of the Dynamic Spectral Method based on the response spectrum of the 1995 earthquake are compared with the corresponding results based on the design spectrum included in the Greek Seismic Code it can be concluded that the former are 1.25 to 1.75 times smaller than the latter. This must be attributed to the difference in the amplitude of the corresponding design spectral curves when combined with the dominant Eigen-period values of the existing old building (see figure 5).

the flexural strength capacities of the columns of the old existing building are compared with the flexural demands, predicted as explained before, the demands by far exceed the capacities when these demands are based on the Simplified Spectral Method; when these demands are taken from the Dynamic Spectral Method based on the design spectrum specified by the Greek Seismic Code they exceed the flexural capacities of almost all the Ground Floor columns. The flexural capacities satisfy the demands for the columns of the structure only when the predictions are resulting from the Dynamic Spectral Method based on the response spectrum that resulted from the 1995 Kozani Earthquake. As pointed out, this is due to the frequency content of this particular ground motion combined with the Eigen-frequencies of the old existing structure (figs. 4 and 5).

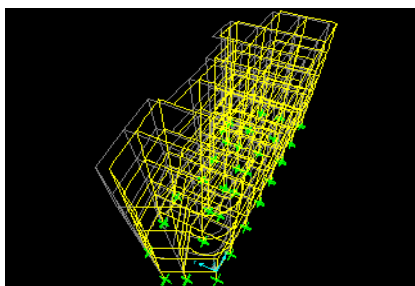
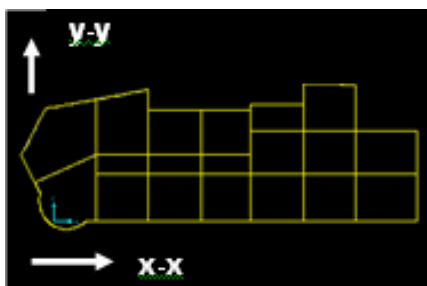
Figure 6: $T_2=0.96$ sec (70% mass participation along y-y).

From the modal analysis it becomes apparent that there is a degree of coupling between mode 2 and mode 3n with modal participation factors that correspond to nearly 75% of the total mass (see figures 6 and 7).

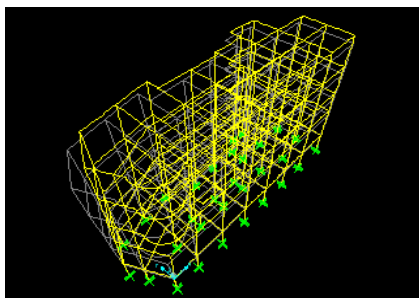
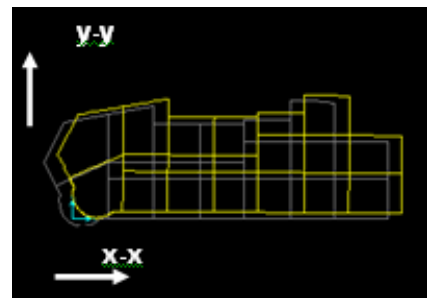
Figure 7: $T_3=0.94$ sec (70% mass participation along x-x).

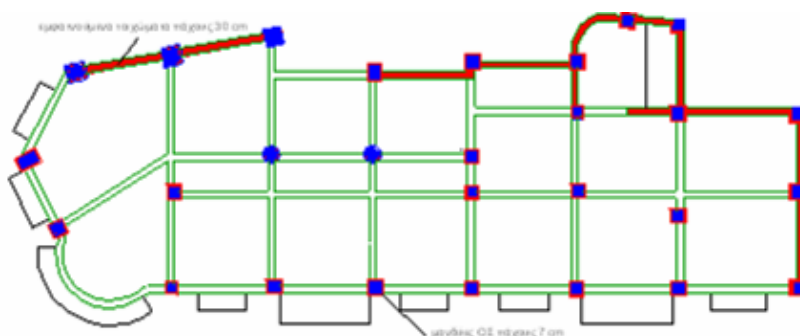
The structural retrofitting (figure 9), aimed to upgrade the earthquake performance of the building, included jacketing of all the columns and beams (with a thickness of 75mm for the columns and 50mm for the beams) as well as the construction of shear-walls (with a thickness of 300mm), within the bays of the old structure at the North and East perimeter of the building that were not obstructing its functioning that could be served from the other two sides (South and West) facing the main square of the city. This retrofitting scheme could serve to increase the torsional stiffness of the structure as well as upgrade the capacities of all the columns; it extended all the way from the foundation to the top of the building. The specified retrofitting materials are C20/25 for the concrete and S500s for the steel. Moreover, the retrofitting included the upgrading of the flexural capacity of the slabs by applying Carbon Fibre Reinforcing Plastic sheets (see section 3.13).

Figure 9: Studied retrofitting scheme.

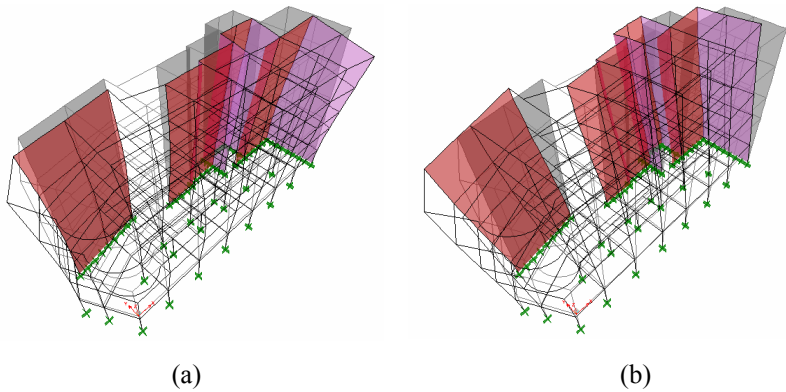
Figure 10: (a) $T_2=0.15$ sec (54% mass participation along y-y); (b) $T_9=0.09$ sec (56% mass participation along x-x).

In figures 10(a) and 10(b) the dominant Eigen-modes of the retrofitted structure are shown together with the corresponding Eigen-periods, which are also listed in Table 3. As can be seen, the retrofitting scheme resulted in a significant increase of the lateral stiffness of the structure.

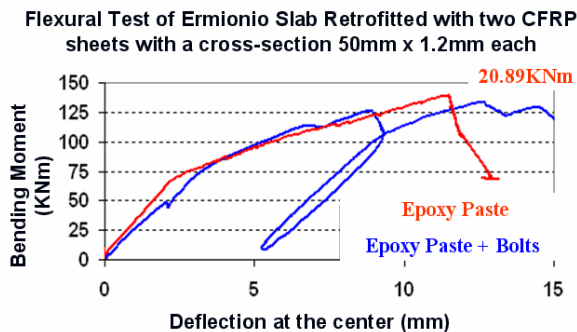
Figure 11: The flexural behaviour of an Ermionio slab specimen retrofitted with two CFRP sheets. In the first case the CFRP was attached only with epoxy paste, in the second case the CFRP was attached with epoxy paste and bolts.

As described in section 2.2.1. the assessment of the expected performance of the slabs revealed that they were in need of being upgraded regarding their flexural capacity. Towards this objective, a retrofitting scheme was investigated to be applied to these slabs. This scheme was planned to make use of a certain type of Carbon Fibre Reinforcing Plastic sheets (CFRP) with a cross-section 50mm x 1.2mm. These sheets were of the hardened type and they could be applied on the upper or lower surface of the concrete slabs with the use of a special epoxy paste. Figure 11 depicts the obtained flexural behaviour of an Ermionio slab specimen tested at the laboratory being retrofitted with two sheets of the previously described CFRP's. Initially, the CFRP sheets were attached to the specimen only with the epoxy past and the specimen was loaded up to its limit-state (figure 11, 20.89KNm/m), which appeared in the form of the unbonding of the CFRP sheets (figure 12) and the loss of the bearing capacity of the slab. Next, the two CFRP layers were reattached to the concrete slab specimen; this time epoxy paste was used again together with bolts penetrating through the slab and securing the attachment of the CFRP layers. An extensive parametric study was performed on this type of attachment by testing a series of specimens prior to applying the best attachment detail to the slab specimen. The bearing capacity of the slab specimen reached the same limit-state levels as before, despite its previous loading history; however; this time the attachment of the CFRP sheets was satisfactory and the flexural behaviour of the slab exhibited a much larger range of deformability.

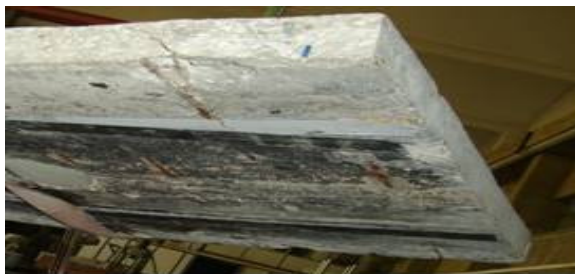
Figure 12: Failure of the flexural behaviour of an Ermionio slab specimen retrofitted with two CFRP sheets. The CFRP sheets were unbonded from the concrete slab.
