Conservation philosophy in action: examples of structural intervention in the United Kingdom and the export of national practices

J. D. Miller

Historic Structures, Gifford - Part of Ramboll, UK

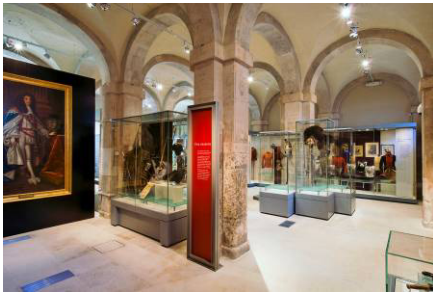
Figure 1: Existing masonry vaults in Household Cavalry Museum.

up to 150mm. Therefore plans to restore the internal space by removing an intrusive 1920's concrete mezzanine floor from within the vaulted ground floor were rightly regarded with alarm by the engineers, as the inserted floor was almost certainly providing lateral restraint to the vaulting at the spring point of the arches. The easiest solution might have been to restrain the tops of the columns with visible steel ties, but in practice there was just sufficient depth within the vaulted floor to direct the lateral ties down at an angle from the first interior column line, thus providing a stable system of wall restraint (figures 1 and 2). This solution kept faith with the original design and was the least visually intrusive. However, the tied column solution would almost certainly have been adopted in a seismic environment.

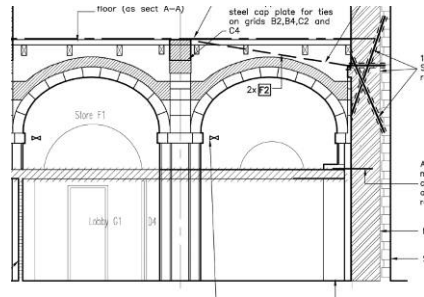
Figure 2: Lateral tying of external walls.

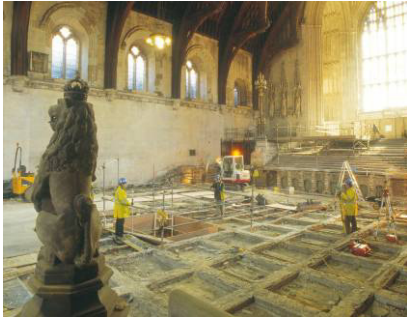
Figure 3: Dismantled fabric in Westminster Hall.

ground whilst providing local support to the stone floor. More intrusive systems such as piling or low-viscosity grouting were unacceptable on the grounds of intervention. Even so, a large part of the floor and steps at the south end of the Hall had to be dismantled and later re-assembled to achieve the solution (figure 3). This was a project whose success was built on robust investigations, diagnosis and the range of options put forward, which enabled clear and transparent discussion with English Heritage [3].

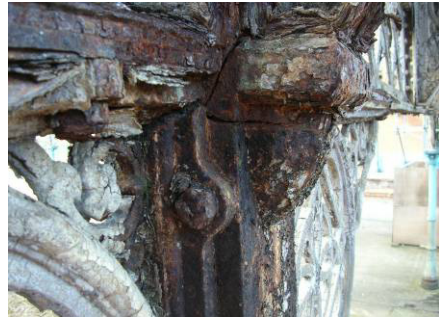
Figure 4: Cracking to cast iron columns at Tynemouth Station.

A detailed structural survey revealed cracking through almost all the cast iron columns, at a level just above the impost, or seating, of the roof structure itself (figure 4). The cause of this is likely to have been jacking of the upper section by corrosion deposits on the impost, made worse by horizontal thermal racking movement along the 150m canopy structure. However, by making a detailed consideration of all actions to which the canopy might be subjected, including accidental ones, the engineer was able to show that alternative load paths would exist provided that the supporting brackets and bolts were replaced to ensure that the connections were structurally sound (figure 5). In this way, the cracked columns would be maintained without repair, thus saving the historic fabric from considerable trauma by the unnecessary replacement of columns. This was a

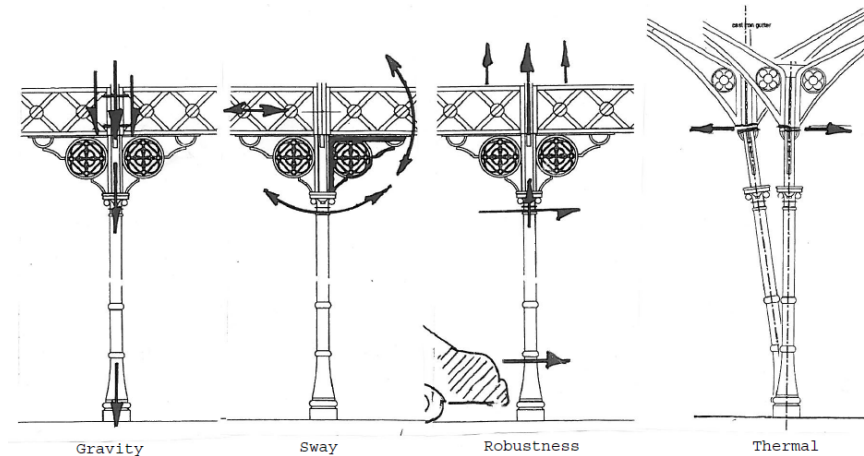
Figure 5: Structural actions on Tynemouth Station columns.

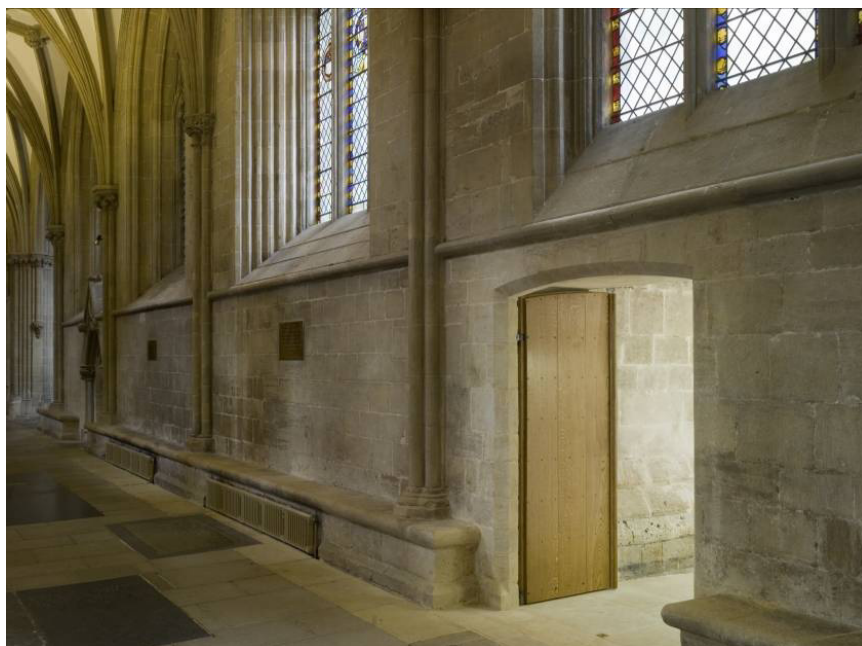
Figure 6: New opening in Thirteenth Century wall at Wells Cathedral.

The new facilities recently completed at Wells Cathedral in Somerset show the respect of the new works to the old fabric in both foundations and masonry superstructure. At Wells, one new building has been constructed with a 300mm thick concrete raft foundation that sits over the archaeological record of a fourteenth century medieval school. Another building foundation cantilevers out over a medieval water culvert, avoiding placing load on it. Load paths are kept distinct wherever possible, so that the fabric interventions are clearly legible and reversibility is maximized. A major intervention in terms of philosophy is the creation of the new opening in the side of the Thirteenth century wall to the Lady Chapel, behind the Choir, which allows access to new store and the undercroft to the Chapter House, previously closed to the public. This provides significantly greater functionality, and is highly significant in that it is the kind of intervention that William Morris would arguably have opposed (figure 6).

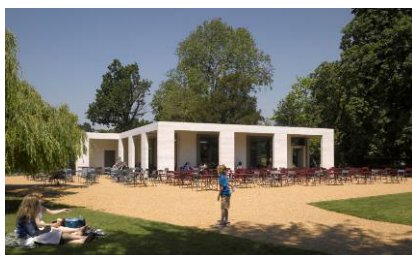
Figure 7: New café at Chiswick Gardens.

The new café at Chiswick is similarly respectful of the existing archaeology, a 250mm thick concrete raft being founded less than 400mm below the previous ground level in order to avoid disturbing the surviving foundations of a Tudor mansion that once used to occupy the site (figures 7 and 8). This minimal founding depth challenges UK practice, as it is shallower than the generally accepted frost zone, but was justified by local meteorological analysis.

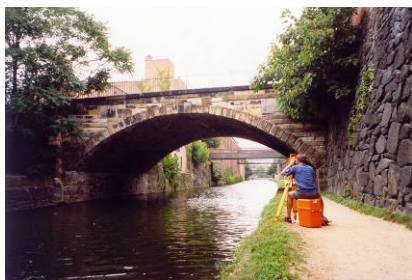
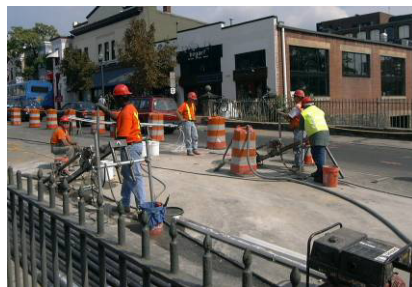
Figure 9: Wisconsin Bridge, Washington DC. Figure 10: Drilled anchor installation at Wisconsin Bridge.

For example, the Arctec™ solution of using drilled anchors, tested and in widespread use on highway structures in the UK, was in 2004 extended for use in the US on Wisconsin Bridge, built in 1833 and the oldest masonry arch structure in Washington DC (figures 9 and 10). More familiar solutions to this problem might have included the creation of a relieving arch or secondary beam structures above the existing masonry but in this case, by concentrating on an understanding the of performance of the existing fabric, the existing load path could be maintained and capacity enhanced.

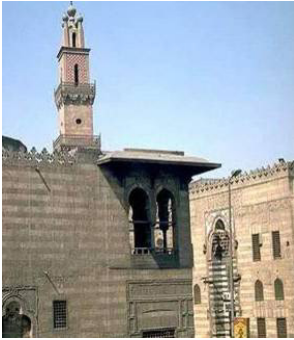
Figure 11: Al Ghuri Mosque.

The basic component of Arctec – the grouted stainless steel Cintec Anchor™ has been widely used elsewhere. In the strengthening works on the Al Ghuri Mosque in Egypt in 1999, anchors were initially specified to provide simple stitching across substantial vertical cracks in the masonry (figure 11). However, there was concern over the interaction of stiff masonry box of the main enclosing walls and the minaret. Through development of non-linear discrete element analysis the simple conclusion was obtained that rigid stitching of minaret back into the walls would exacerbate damage during seismic activity (figure 12). The outcome was that the additional effort to understand behaviour had reduced the scope of the fabric intervention. Thus the power of modern computing techniques helped avoid over-zealous strengthening, which in previous generations have sometimes made up for lack of understanding of structural dynamics [4].

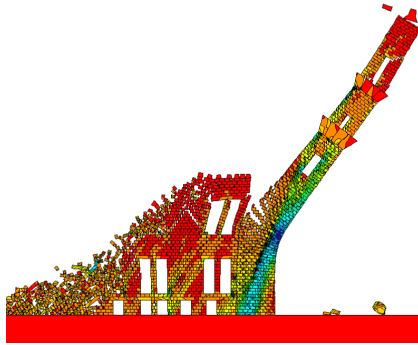
Figure 12: Discrete element analysis of Minaret.

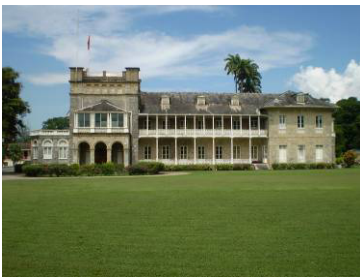
Figure 13: The President's House, Port of Spain, Trinidad.

The confidence placed in grouted anchor technology and the analytical methods related to such strengthening has enabled a number of more advanced retrofitting schemes to be recommended for various projects. The President's House in Port of Spain, Trinidad, is a colonial style building dating from 1874 which suffered partial collapse of a wing after a seismic tremor in 2010 (figures 13 and 14). The structural inspection of the standing fabric recommended various fabric repairs, such as timber truss ends, joist replacement due to termite infestation, repair of masonry cracks and installation of horizontal tying at eaves level. In addition, the possibility of seismic retrofitting was discussed, using anchor technology. The cellular nature of the building, the high quality of the blue limestone in the walls and the successful use of anchor technology for simple tying in nearby restoration works means that this is a viable option. Trinidad lies just west of the West Indies Arc tectonic zone: a 475 years return period earthquake is likely to have intensity VIII (Peak ground acceleration of approximately 0.5g) and 2475 years period an intensity X. A preliminary assessment concluded that retrofitting for life survival using a combination of drilled wall anchors for tensile masonry capacity and floor diaphragms for stiffness is certainly feasible for the 475 years return. At lower intensities the building would be expected to respond well with good fabric survival.

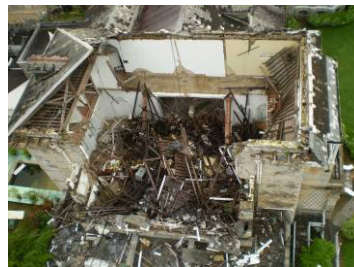
Figure 14: View of collapse of Western Wing.
