The impact of different philosophical approaches towards the conservation of ancient monasteries in Cyprus

M. Philokyprou¹ & E. Petropoulou²

In this paper, two case studies are presented regarding the conservation of two historic monasteries (monastery of Ayios Nicoalaos in Orounda and monastery of Panayia tou Sint in Paphos), showing the positive and negative consequences of different philosophies and approaches followed in each monastery.

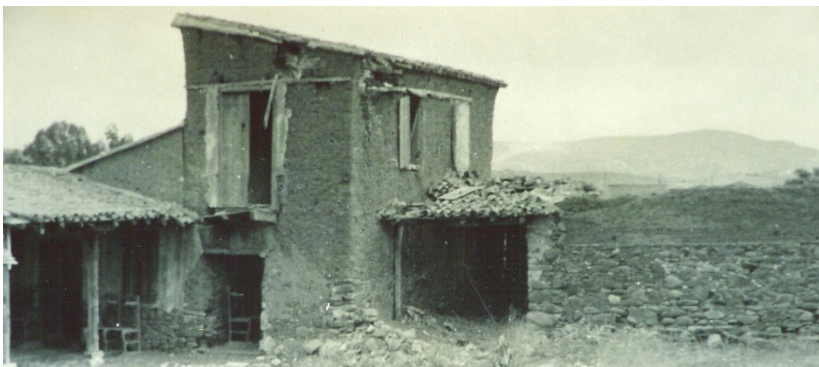
Figure 1: The ancient monastery of Ayios Nicolaos before conservation works.

The old monastery of Ayios Nicolaos, situated on the west bank of the Serrachi River, is dated back to the early 16th century and it has been declared an ancient monument. The church is a single-aisled domed building with a crude stone carving of the lion of St. Mark over its west entrance (Gunnis [1]). The monastery buildings are located around a central courtyard. The monastery was abandoned during the Ottoman times and reused in later times as a farmhouse (Goodwin [2]). In 1733, repairs are recorded but since then, the monastery was completely abandoned (fig.1). Small scale conservation works were carried out by the Department of Antiquities in 1977, and later in 1990, a restoration project was carried out in order to reuse the complex as a monastery.

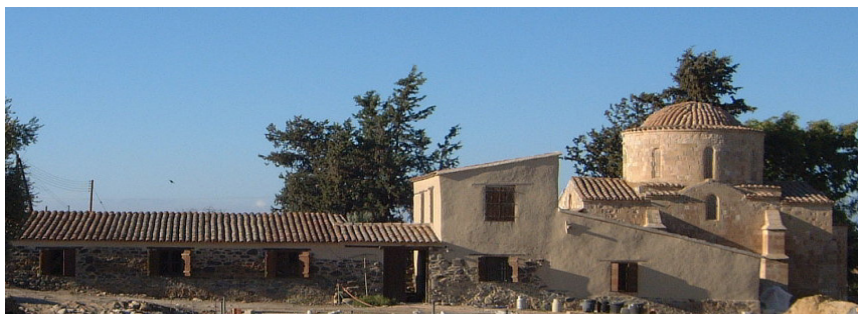
Figure 2: The historic monastery of Ayios Nicolaos after conservation works and before the erection of the extensions.

The restoration study was based on *in situ* evidence and historical information. The buildings of the monastery were restored to their original form and architectural character using traditional materials and building methods (fig. 2). The individual rooms were conserved and the complex was reused as a monastery. The complex was successfully rehabilitated by an active sisterhood, which gave life to the abandoned monastery. Soon the existing buildings proved to be too small and new additions were necessary, in order to fulfil the needs of the sisterhood (fig. 3).

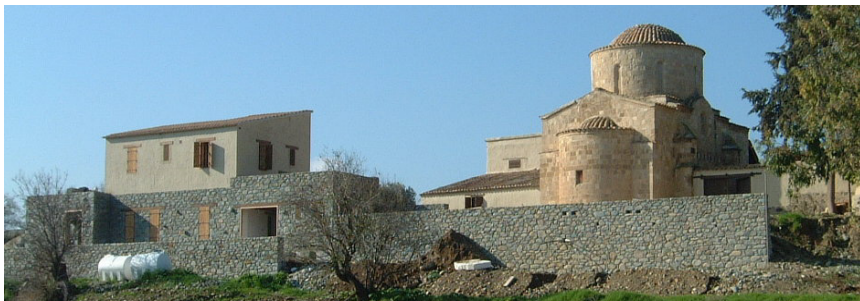
Figure 4: East elevation of the new additions of the monastery of Ayios Nicolaos.

The complex was built with load-bearing walls, with a rubble stone base and a mud-brick superstructure. The mud-bricks were made on site by the villagers on a voluntary basis. The exterior façades of the stone walls remained uncovered, enhancing the prevalence of human scale, while gypsum plaster was introduced in the interior. The mud-brick superstructure was mud plastered on the outside. Simple structural solutions were designed for bridging small and large spans. Ceramic tiles covered the inclined roofs, while flat roofs were covered with special insulation materials and a final course in the colours of the surrounding environment.

The architectural forms, related to the materials and techniques used were successfully integrated into the existing complex, but at the same time revealed their contemporary character. The new section was built to the south of the existing monastery, aiming to be invisible when approaching the monastery from the nearby village of Orounda. The scale of the existing monastery as well as the simple and humble natural built environment in the vicinity were completely respected by using one and two-storey buildings with inclined and flat roofs defining the upper line of the elevations and creating unity in the whole design (fig. 4).

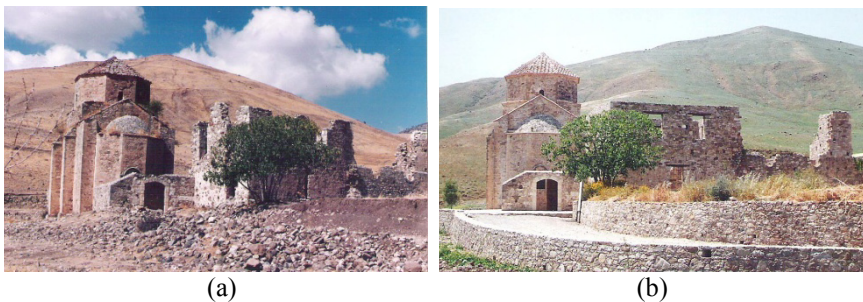
Figure 6: The monastery of Panayia tou Sinti from the east before (a), and after (b) conservation works.

The approach of the study was to preserve the ruins and to restore those parts of the monastery which conserved evidence of their original character and form (figs. 6(a) and (b)). Any hypothesis would endanger the integrity of the monument which was one of the very few in the island that had not undergone any modern intervention and alteration of character. In the framework of this approach, the main purpose of the project was clearly the consolidation and protection of the monument from decay and deterioration with minimum interventions. In addition, every effort was made to preserve old textures and surfaces. The cracks and lacunae of the walls were filled in. Missing quoins and wooden lintels were replaced, and the rubble masonry over the lintels was rebuilt for structural reasons. Traditional construction methods with local stone and lime mortar were used. Modern materials were restricted to a minimum.

Rebuilt areas and elements were defined by small pieces of brick or tile set in the mortar joints. This follows article 9 of the Venice Charter which states that “any extra work which is indispensable must be distinct from the architectural composition and must bear a contemporary stamp”. According to Camille Boito “caution is recommended in reconstruction”. He agreed to accept reconstructions exceptionally when there was clear evidence to justify them. “All new elements should be marked and dated in order to be recognizable and subject to criticism by scholars”.

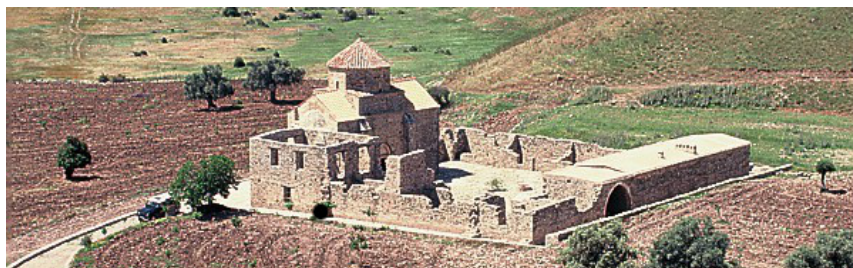
Figure 7: General view of the monastery of Panayia tou Sinti after conservation works.

The walls of the north wing of the monastery were presented at their full height. Thus it was decided to restore the former refectory and the two adjacent rooms of this wing. The original gothic pointed arch that internally subdivided the refectory and its roof were reconstructed (fig. 7). The refectory is now used as a small museum where objects related to the history of the monastery are exhibited. As the bases of three pointed arches were revealed during conservation works, and with the aid of old photographs, the original arcade in front of the north wing was reconstructed. The original north entrance of the monastery, which had been blocked, was restored to its original form by demolishing the later additions (fig. 7), following article 11 of the Venice Charter which stated "When a building includes the superimposed work of different periods, revealing of the underlying state can only be justified in exceptional circumstances and when what is removed is of little interest and the material which is brought to light is of great historical, archaeological or aesthetic value, and its state of preservation good enough to justify the action".
