The reuse of the detention centre of Vilvoorde (Belgium): three centuries of convicts' graffiti

Abstract

The Detention Centre of Vilvoorde (Belgium) dates from 1773-1779 and is designed by *Laurent Benoît Dewez*, the royal architect of *Charles-Alexandre de Lorraine*. After some decades of lack of occupancy, the complex is to be reused for multiple purposes.

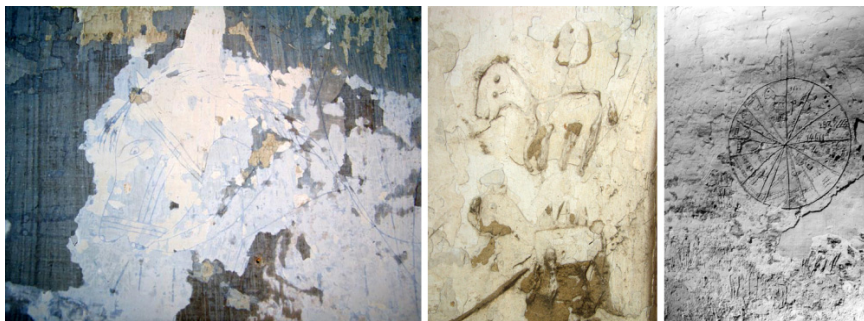
Figure 2: Horses scratched into the lime layer (left and middle), medallion scratched into the lime layer (right) [photos ©Ann Verdonck, 2005].

In 2005 an architectural paint research was executed in the cells of one of the 18th century wings of this former prison [10]. On the walls of these extreme small vaulted cells (ca. 3,5 m²), graffiti was exposed on different levels of the thick lime wash packet (up to 15 layers). With their fingernails or with instruments at the disposal of the prisoners, most drawings were gouged into the surface. Also traces of pencil and paint were discovered. A striking collection of figures, animals, text, inscriptions, names, dates, doodles, countdown stripes, etc., decorates the cell walls. These long-hidden inscriptions show a funny, elegant, melancholic, hopeful, hideous, robust, aggressive and often shabby message. The graffiti became remarkable architectural ornaments these days.

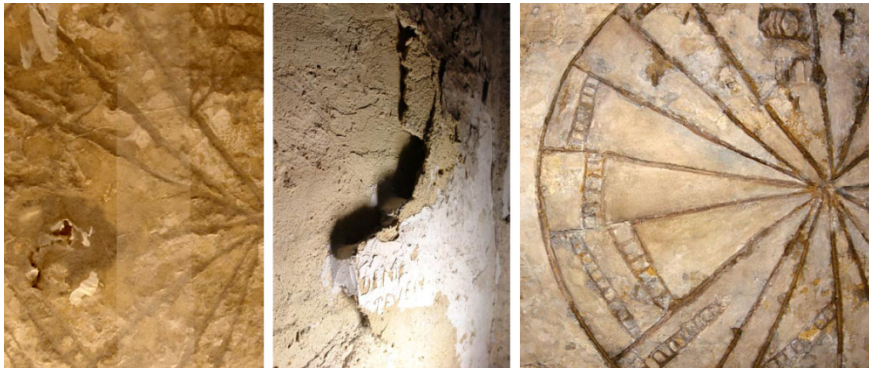
Figure 4: Facing with Japanese paper (left), implementation of a ‘bridge’ in preparation to the injection of casein (middle), after consolidation and retouching (right) [photos ©Ann Verdonck, 2007].

In order to consolidate the lime wash packet and the lime mortar, small ‘bridges’ were implemented before the injection of casein lime wash and liquid lime mortar. Subsequently on the surface two layers of Japanese fixation paper were pasted on the surface with methyl cellulose glue (type Tylose). The casein lime wash and liquid lime mortar were injected through the paper into the flaking lime wash.

The methodology and products used in the restoration test-strips were extrapolated to the other walls of cell n° 15. Considering the fact that the flaking of the lime wash layers of the medallion was about five centimetres, wheat starch and water were used instead of Tylose to hold the Japanese fixation paper to the wall. Only the white lacunas in the area of the medallion were retouched with aquarelle, with the idea to integrate the new fillings without being conspicuous.

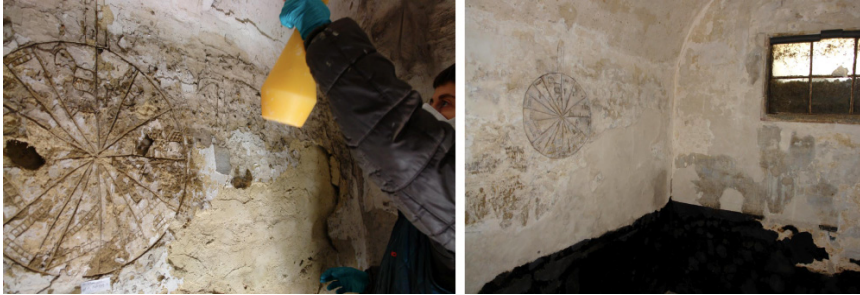
Figure 5: Fixation and consolidation of the surface of cell n° 15 by spraying Primal (left), cell n° 15 after consolidation (right) [photos ©Ann Verdonck, 2007].

After several restoration test-strips, the fixation and consolidation methods were stipulated and modified. Fixation and consolidation of the surface was achieved by spraying Primal (0,5% concentration in water) repeatedly on the wall. Small slivers of the lime wash were fixed with Mowilith (2% concentration in water) and, when necessary, pressed with a hot spatula.

Salt contaminations in the plinth, especially on the wall below the window, were brushed off and cleaned up. The black plinths (bitumen-paint) were

originally painted in white lime wash. A black lime mortar was chosen to complete de lacunas of the plinth to get a visual total concept. The idea of reconstructing the plinths painted black in bitumen-paint would result in a very raw image, which doesn't follow the philosophy of maximal conservation and which doesn't show the history of the cell's walls.

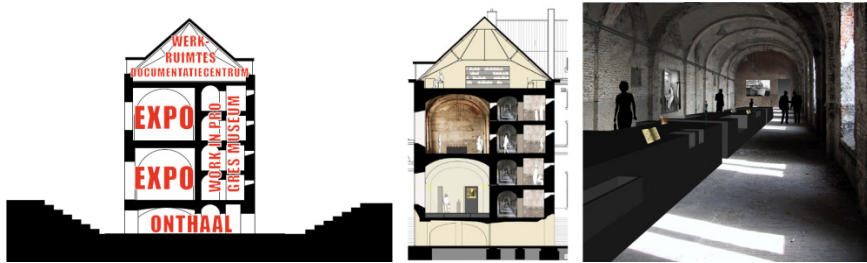
Figure 7: Organisation chart of the museum wing (left and middle), transformable plug-in furniture in the former workshop (right) [design ©Grontmij-L'Escaut, Brussels 2010].

The approach of a fundamentally 'light' restoration methodology was chosen in order to preserve the original disposition and characteristics of the future museum block and to consolidate its historic layers and finishes. The retrofitting of this particular wing also had to deal with technical, stability and programming issues, and the release to the public was of major importance. New additions were designed as contemporary transformable plug-in furniture respecting the

historic interior [15]. The completion of the museum program will be guided by suitable exploitation partners.
