Evolution of the dwelling pattern in Urla: case study – Zafer Street

B. Şengün Erturgut

Department of Architecture Yasar University, Turkey

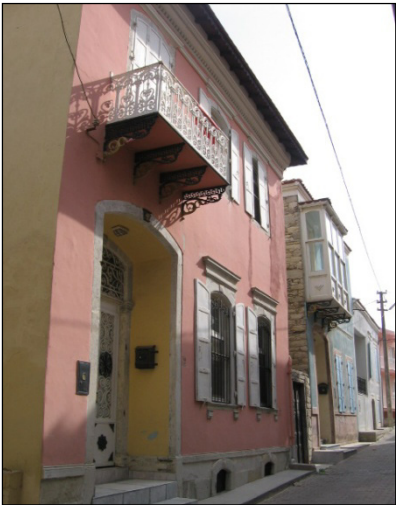
The houses are densely populated on top of the hillside and they are mostly from 19th century, fig. 2. Apart from the houses mainly used for living, ground floors of some of them on the street are used as shops and first floors of these houses are used as residences. Even though the houses where Turks and Rums live resemble one another in terms of their plans, still they differ in workmanship and

Figure 2: Historical houses in Urla.

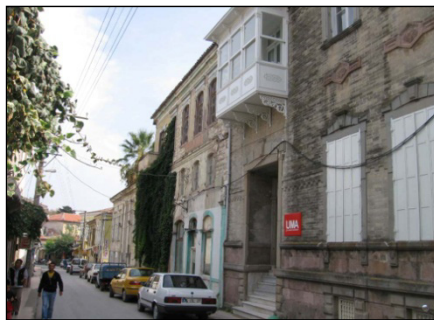
Figure 3: Zafer Street.

Zafer Street's Greek name was "Fardi Street" on the 19th century, figs. 3 and 4. It has a rich cultural heritage and also commercial functions (Milioris [13]). Since it was the main commerce center of the town, the street preserves the house types that have both housing and commercial functions all together. On the street, aside from two-storey, centered-hall house types, four typology and typology-out house samples are listed. At the present time, twenty-five houses on the street are protected by Board of the Conservation of the Cultural and Natural Heritage. Eleven of them are shops, two of them are houses and twelve of them are house-shops.

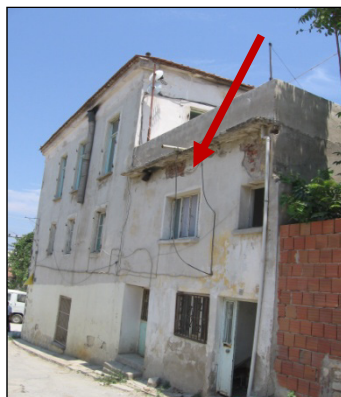
The basic factor that affects the physical changes in the spatial characteristics of the houses is related to the needs and restoration desires of the owners. While scanning the inner structures of the fourteen houses, some physical changes such as mass additions, fig. 5, adding-dropping partition walls and omission of the stairway have been detected, fig. 6. Mass addition has been seen in nine houses, partition wall is added to five houses. Partition walls have been demolished in.

Figure 5: Mass additional.

Since the Republican Period, there are several problems that can be noted on Zafer Street. Mass addition is determined in nine houses on Zafer Street. Mass addition is especially for wet spaces and generally these are seen at the back side of the houses which worsen the original appearance of the houses. It has also been observed that some of the houses on Zafer Street are broken by partition wall additions or eliminations in order to create extra or wider spaces. Wooden stairs that enable circulation between floors have been eliminated in two two-storey, side-hall houses having commercial function and one typology-out house. This causes a breakdown in both circulation axle and spatial orientation of the building. Two-storey, centered-hall houses having commercial functions are used as shops and the space left on the first floor is inadequate to the use of the dwellers today. Since the dwellers prefer comfortable new houses, historical buildings are deserted or not preferred. Alongside with the abandoned buildings, there are some out-of-use houses too on Zafer Street. They are either worn-out or deserted by their owners. While repairing the houses, wooden stairs are exchanged for concrete stairs, original ceilings and slab materials are changed. In the structural elements of the houses some cracks on the walls and rotation on the wooden materials occur due to the oldness or earthquakes. This causes destruction in the original structure system of the houses. Facade changes cause transformations in the visual sensations of the houses and elimination of the original cause problems.

The basic purpose of the suggestions is to protect the houses on the street and to expose the historical and architectural values of the street. In addition to protect these values, the transfer of these houses to the next generations and modifications of them to modern life is also aimed. While making these suggestions, the changes in the spatial orientations of the houses, structural and facade changes have been taken into consideration. The houses that have commercial functions are the ones that need most mass additions on Zafer Street. Inner design of these houses should be handled. It is suggested that partition wall additions that are made improperly should be turned into their original forms. Wooden stairs that have eliminated in three houses for different reasons should be changed into their authentic forms. The houses that will have functional changes should be transformed in accordance with plan typologies and spatial orientations. In houses that having commercial functions, when the house no longer serves the needs of the dwellers the family should be moved to an empty historical house. Four out-of-typology houses on the street should be nationalized before they lose their historical heritage. These houses should be allocated to the families in need or should be served as the social and cultural centers after agreeing with the first owners of these houses. Wooden stairs that have been changed with concrete stairs, renewed ceilings and slabs should be repaired if possible and used. If they cannot be fixed, old and new materials should be separated. The houses should be strengthened with additional supportive elements. Cracks that are observed in the structural elements should be clamped and sewed. Conservation of the original facade characteristics of the historical houses is vitally important. The original facade characteristics enable a fullness of visual aspect and original architectural features of the facade are well seen.

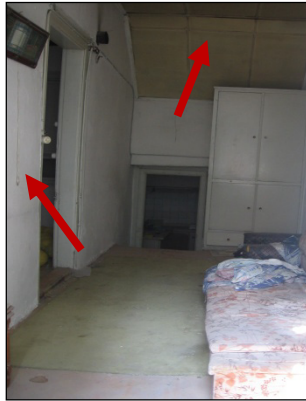
Figure 6: Addition of a partition wall and eliminated wooden stair.

one house. Original wooden stairs have been eliminated in three houses, fig. 6. Also in ten houses some areas have been become out-of-use spaces like kitchen, fig. 7.

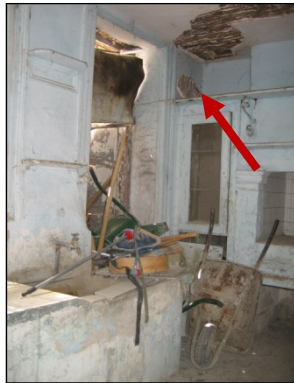
Figure 7: Out-of-use space and deterioration of the wall.

In the study based on the structural and material changes of the fourteen historical houses, deterioration in structural elements resulting from oldness, fig. 7, addition of concrete system and changing of ceiling/slab materials have been determined. During the repair processes of the two houses, the wooden stairs which provided the circulation between floors are changed to concrete stairs as a result of the owner's desire, fig. 8. In ten houses ceiling and slab materials are renewed because of oldness and owner desires.

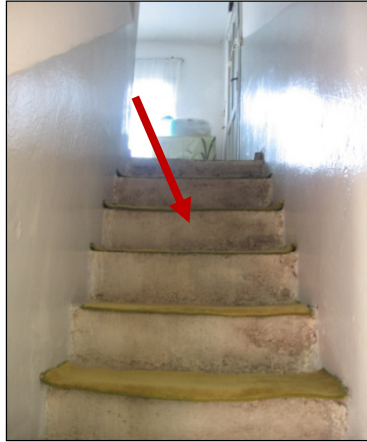
Figure 8: Concrete stairs.

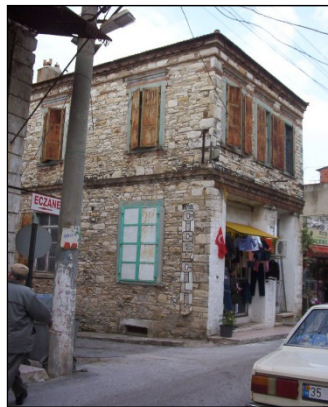
In the studies carried out on the street, it has been observed that in the facades of the houses, elements are changed according to the desires of the house owners. These changes are addition of new hardware, change in roofing tile, material and color change, bay window-balcony change, woodwork change, deterioration of the plaster. In the houses, it has been seen that sign, electrical

cable, illumination members and shutters are added into the facade, fig. 9. Two houses which had shops on the ground floor have been changed their windows to vitrines. In the repair of the eight structures, Marsilian roofing tile is used instead of Turkish style roofing tile. Color change is observed in seven houses. Material changes are detected in two bay windows and one balcony. Wooden windows or doors have been replaced with plastic or aluminum windows in ten houses, fig. 10. Some deterioration has been observed in plaster surfaces of the twelve houses.

Figure 9: Addition of new hardware.

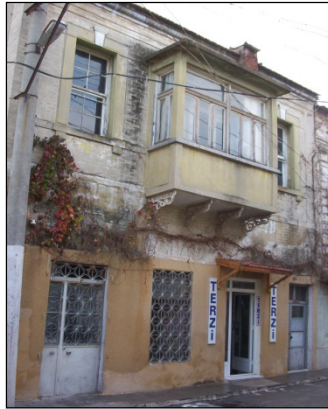
Figure 10: Change of the ground floor wood work.
