The use of optical and infrared techniques for the restoration of the frescoes damaged by earthquake: a case study – the fresco of Giacomo Farelli in the Church of Santa Maria della Croce di Roio (L'Aquila, Italy)

S. Sfarra¹, C. Ibarra-Castanedo², D. Ambrosini¹, D. Paoletti¹,
A. Bendada² & X. Maldague²

Keywords: ESPI, IRT, fresco, earthquake, restoration.

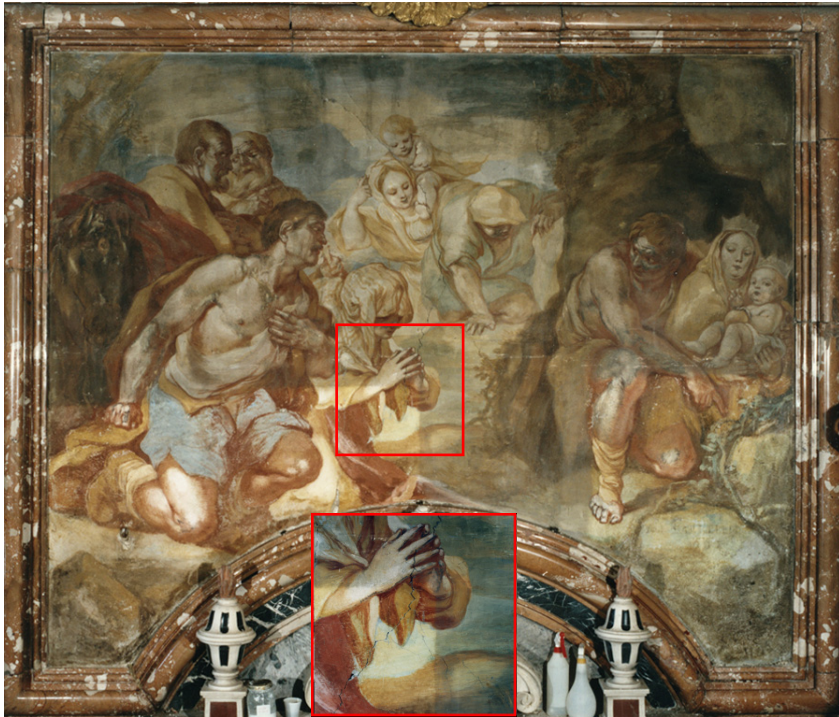
mentioned, there was a chapel. In 1667 Farelli painted the fresco object of our study (Figure 1).

It represents with a *plasticity enveloping*, the discovery of the Statue in a niche of the Three Saints Wood in Ruvo di Puglia.

Figure 1: Fresco, “Discovery of the Statue” by G. Farelli (1667) before the restoration of 1994, and magnification of a particular area with cracks.

The case of Giacomo Farelli fresco in the *Santa Maria della Croce di Roio* Church, is unique in its kind because it combines aspects of structural instability, mistaken for insufficient cohesion of the fresco layers during the restoration of the years 1993 and 1994, with an excessive mechanical load due to the earthquake of 2009, which reopened the previously healed cracks.

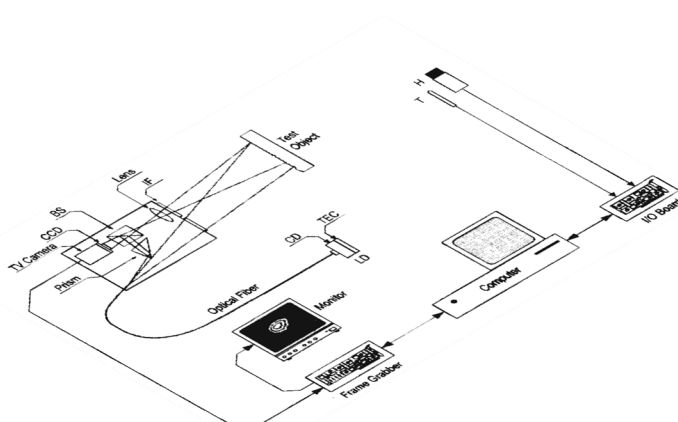
In this section we give only a brief practical description of the portable system used for the measurements; the full theory is well covered in the literature (Lokberg and Malmo [11], Paoletti and Schirripa Spagnolo [4]). Figure 2 shows, schematically, the experimental configuration for *in situ* diagnostics. Other configurations can be retrieved in literature (Paoletti and Schirripa

Spagnolo [12], Kato *et al.* [13], Zanetta [14], Albrecht [15]). A laser diode ($P=15$ mW) is used as the light source. The laser diode junction is temperature stabilized by a thermo-electric controller. Furthermore, the laser system includes a very low-noise current driver. The laser source is coupled to a polarization maintaining single mode fibre.

Figure 2: Experimental set up. BS: beam splitter cube; CD: current driver; H: humidity sensor; IF: interference filter; T: temperature sensor; TEC: thermo-electric controller.

The laser light emitter by the output end of the optical fibre directly illuminates the surface under investigation. A small part of the spherical wavefront, caught by a prism, serves as reference beam. A beam-splitter cube reflects the reference light onto the CCD sensor, where the object image is focused by an objective lens. An interference filter centred at the laser diode wavelength is introduced in front of the imaging lens to prevent external light from reaching the CCD camera. The images captured by the CCD camera are recorded by a PC-based frame-grabber. Besides, the PC system is equipped with temperature and relative humidity transducers. The short exposure time (1/30 s) of the ESPI technique provides a greater stability and tolerance of external disturbances with respect to traditional holographic techniques, therefore, the ESPI system can be used outside the research laboratory (Lokberg and Malmo [11]). To obtain a good quality ESPI interferogram, the system as well as the surrounding environment must remain stable, during the exposure time, to at least $\lambda/8$.

A solution, which can mitigate these problems, consists of assembling all components in an optical head mounted on a high stiffness tripod (Thomson [16]). However, the effect of residual relative rigid displacement between the object and the optical head will be to reduce the fringe contrast, which can be partially recovered by image enhancement techniques, as shown in this work.

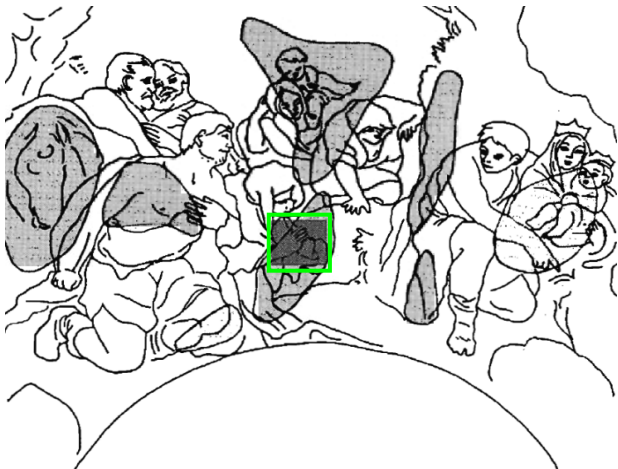
There are two steps in the examination of fresco damage: first the location and, second, the evaluation of the evolution of the defect with time. A simple visual inspection is the most straightforward method; the naked eye can be helped by magnification techniques. This method is widely used, economical and simple but can be time-consuming and may not give an identification of problems beneath the surface, defects can easily be over-looked. The ESPI method overcomes many of these shortcomings. With this technique the fresco under restoration has been studied. The fresco was interlaced by micro-cracks, evidence of forces at work in the wall. Without removing the fresco from its normal exhibition environment, the whole surface was analyzed; only some meaningful results are reported here. The map of some detachments between priming layers and the support is presented in Figure 4.

With current methods of inspection, some detachments were not easily detected by the unaided eye. A particular area of the wall, which contained regions separated by cracks, was selected (Figs. 4 and 5). The same cracks, shown in Figure 1, were reproduced by the earthquake of 2009 (Figure 5).

Figure 4: Drawing of the fresco “Discovery of the Statue”, with highlighted zones of detachment, and the area studied by the integrated approach.

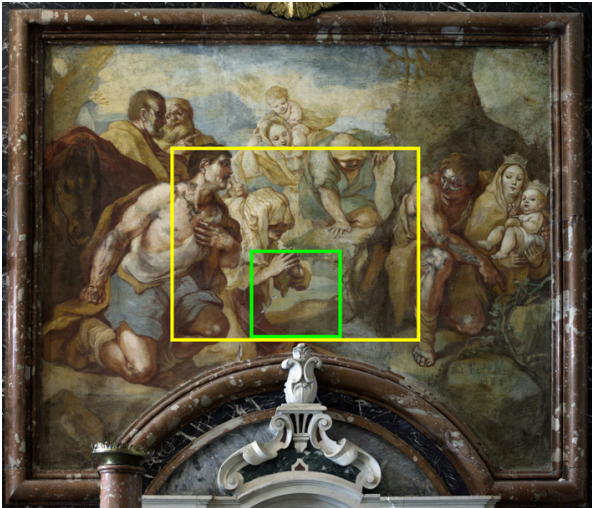
Figure 5: Fresco, “Discovery of the Statue” by G. Farelli (1667) after the earthquake of 2009 and with the areas studied by ESPI (green rectangle) and by IR thermography (yellow rectangle). (See online for colour version.)

Figure 5, highlights both the zone studied by ESPI (green rectangle) and the area evaluated by thermography (yellow rectangle), which incorporates the previous area. The area covered with the green rectangle, measures 20 cm² and was subjected to a brief thermal irradiation using a 150 W infrared lamp at a distance of approximately 1 m.

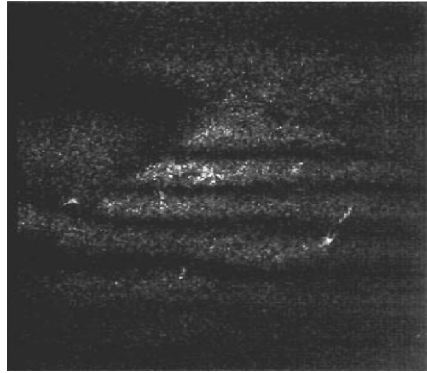
Specklegrams were recorded continuously during the cooling process. Figure 6 shows a deformation map of the selected region, without any processing; the same fringe pattern filtered, enhanced, in false colour and with the indications of the final design, is shown in Figure 7.

Figure 6: Specklecorrelogram without processing showing a crack (courtesy of the authors [4]).

Abrupt deviations along the trend of some correlation fringes are evident. These discontinuities correspond to the presence of cracks. A three-dimensional

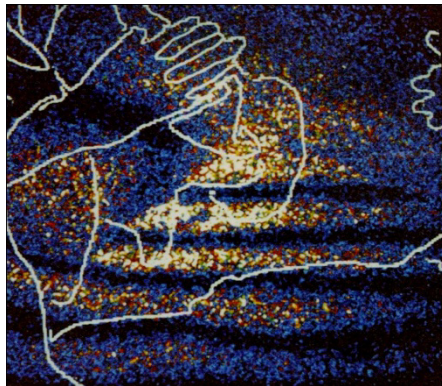
Figure 7: The same specklegram as in Figure 6 after processing and in false colour with the indication of the final design. (See online for colour version.)

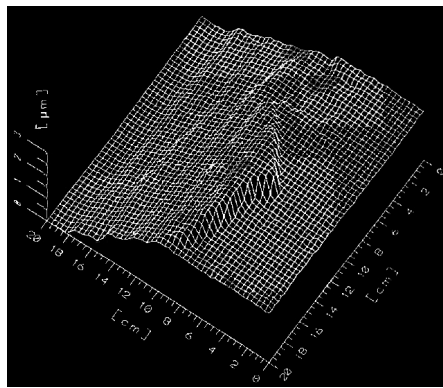
representation of the cracking area was obtained using the method proposed by Kreis (Figure 8) (Kreis [26]).

Figure 8: Three-dimensional representation of the deformation in the cracking area shown in Figure 6 (courtesy of the authors [4]).

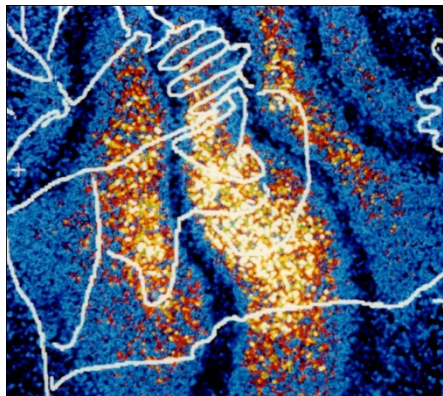
For this purpose some tests were made at the same location after the fresco has been restored. The restoration work is shown to be quite successful. Figure 9, which corresponds to the area reported in Figure 5 (green rectangle) shows how the cracks and the surrounding area have been repaired. Figure 10 shows some results obtained by infrared thermography after the earthquake.

Figure 9: The same area as in Figure 5 after restoration. Specklegram filtering, enhancement and in false colour with the indication of the final design. (See online for colour version.)

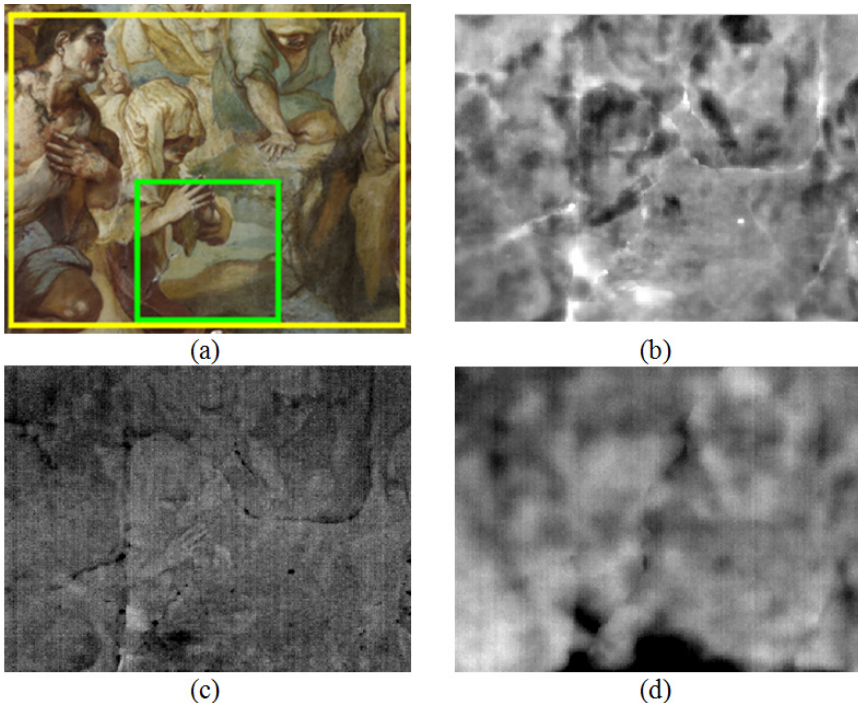
The inspected region with IR thermography corresponds to the area delineated by the large (yellow) rectangle in Figure 10(a).

Figure 10(b) is a phasegram obtained by pulsed phase thermography on the whole data sequence, i.e. including heating and cooling phases. It is possible to see here different kinds of cracks, the same detected before the restoration, and also some surface features, such as painting traces (note the hand at the centre).

Principal component thermography was applied to the heating and cooling phases separately. Results are shown in Figure 10(c) and (d), respectively. During the heating phase, which lasts for 180 s, the thermal signature of surface and near to the surface features is very high. Hence, features in Figure 10(c) are located at the surface or close to it, for instance, the lady's hand and cloths painting traces near the centre of the image. In the case of the cooling phase,

Figure 10: Active thermography results: (a) Photograph of the inspected area; (b) phasegram obtained by pulsed phase thermography; and principal component thermography results for (c) the heating phase and (d) the cooling phase of the sequence.

deeper features are seen since heat has the time to propagate through the material.

The choice of using the thermographic technique instead of the ESPI technique after the earthquake, is due both for a security issue and to capture by a single frame a larger area. In fact, IR thermography is a telemetric monitoring technique and for working with the ESPI it would have been necessary to mount a scaffold with a significant increase in the inspection costs.

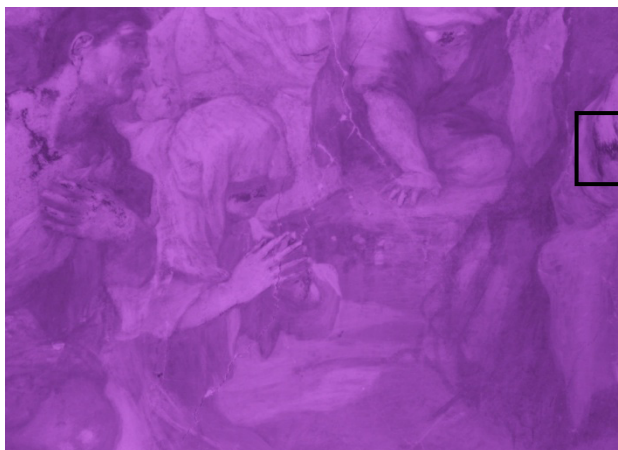
In order to detect underdrawings and show more clearly the surface defects that occurred after the earthquake, the NIR (Near-Infrared Reflectography) technique was also used on the same area analyzed by IR thermography (Figure 11). It was shown that most pigments are transparent in 0.7–2.5 μm band and, thus, underdrawings can be viewed by using a NIR camera such as vidicon, or CCD-based cameras introduced in 1990s (Obrutsky and Acosta [27]).

As can be seen from Figure 11, there were no underdrawings, but this technique enhances the surface and subsurface cracks, as we compare this result with the photo of the same area shown in Figure 10(a). The emissivity of a pigment, highlighted with a black rectangle (Figure 11), is enhanced by NIR technique. This pigment was analyzed in a laboratory and identified as white lead (Figure 12).

Figure 11: NIR result on the same area analyzed by IR Thermography reported as (yellow) rectangle in Figure 10(a). (See online for colour version.)

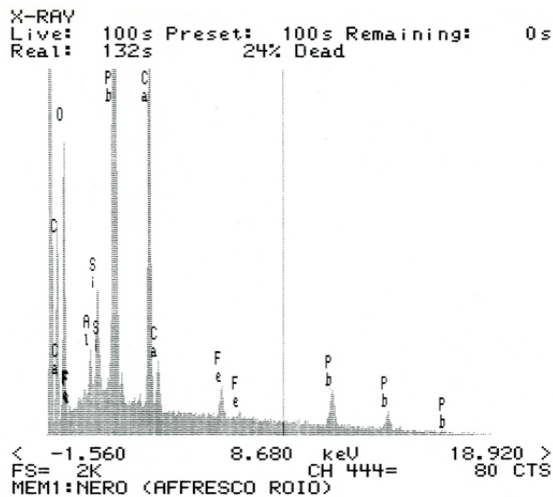
In fact, white lead has a measurable radioactive trace with appropriate tools, which can roughly determine the age and disappears completely after a minimum period of 160 years. Drying is fast enough and produces a very elastic film, robustness cannot be reached with any other white, but tends to lose coverage, over the years. It tends to darken, due to the action of hydrogen sulphide traces in the air; in fact, oxidized, it turns into lead oxide, brown in colour. This tendency to become dark is much more evident when it is used with binders (mural painting, tempera) and in the presence of moisture (Piva [28]). Note how the relative humidity measured during the thermographic acquisition was 58.9%.

Figure 12: X-ray diffractometer of the particular pigment highlighted with a black rectangle in Figure 11.
