Modernization of historical houses in Sopot: a case study

J. Poplatek

Faculty of Architecture, Gdansk University of Technology, Poland

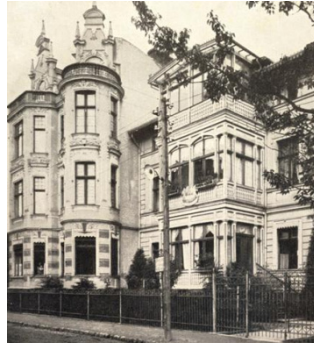
Figure 1: Façade of Villa Germania, ca. 1912, photo courtesy: archives of the Museum of Sopot.

Sopot, beautifully situated on the Baltic Sea, is the best-known summer resort in Poland. The city is unique with regard not only to its location and natural values, but also to its outstanding residential architecture, which dates back to the end of the 19th and the beginning of the 20th century. Influences of Art Nouveau and Neo-gothic styles predominate in historic residential architecture of the city. We can also find houses built in the Romantic style, as well as examples of summer architecture with characteristic wooden verandas, bay windows, balconies, and soaring turrets decorated with Art Nouveau details (figs 1 and 2).

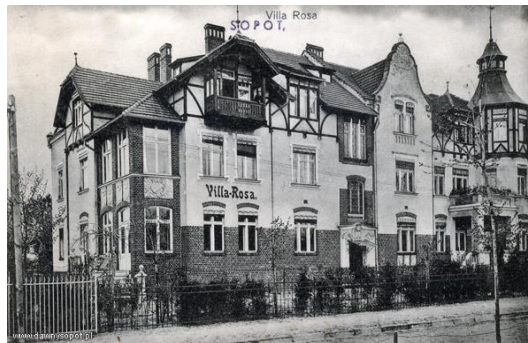
Figure 2: Façade of Villa Rosa, ca. 1910, photo courtesy: archives of the Museum of Sopot.

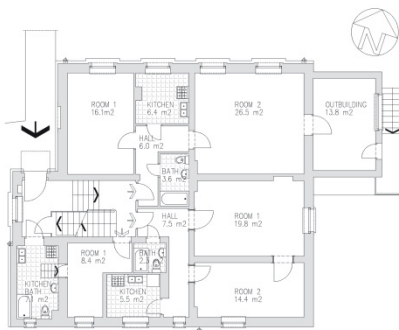
Figure 3: Functional layout before modernization, ground floor plan.

On each floor of the analysed building there was originally only one flat. The flats located on the ground and first floor occupied their entire usable area, while in the attic, apart from a flat, there was also a garret accessible from the staircase. After the Second World War all the flats were divided into smaller ones. In the end there were seven flats in the building, and all of them, due to the division, had significant functional defects. The layout of the flat located on the first floor

was peculiar, seeing that it had one bathroom and two kitchens and was occupied by two families which were not related to each other. It was also difficult to accept the layout of a very small flat situated on the ground floor, where there was only one room and a space which served both as a kitchen and a bathroom.

Another problem was caused by the fact that the functions of the building were not adapted to compass directions, but only to its location in relation to the street. The front façade, which faced the street, had been designed as a representative one and, consequently, the most important rooms were also located on that side of the building. This was usual practice at the turn of the 19th and the 20th century. Unfortunately, in the case of the described building it meant that those rooms were facing north, while on the south side (facing the garden) there were support spaces with small window openings. Lack of access to the garden from the ground floor flat and lack of balconies or terraces on higher storeys was also a significant disadvantage.

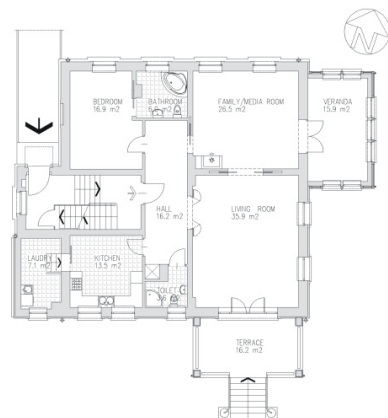
Figure 4: Functional layout after modernization, ground floor plan.

At present the building has one owner. It resulted in a possibility to perform comprehensive correction of the functional layout which, in most cases, cannot be done in the situation where there are a few owners. The original functional layout has been restored, i.e. there is only one flat on each floor. In the case in question the “original layout” means only that each storey is now designated for one flat, whereas the functional layout of each flat has been adapted to modern requirements, to the extent made possible by technical-constructural and spatial limitations. It has been assumed that spatial layout of a historic building should determine the possibility of including a certain function in the structure of the building, and not vice versa. This results in the necessity to reach a compromise which, on the one hand, would respect the spatial layout of the building, and on the other hand would find the most advantageous functional solutions, appropriate for the present level of civilisation development and fulfilling the investor’s expectations (figs 3 and 4).

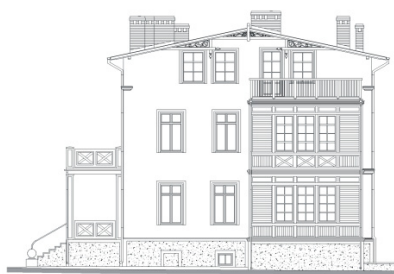
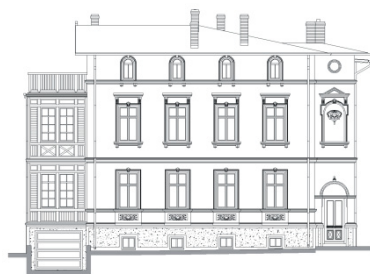
Figure 5: East façade with veranda. Figure 6: Front façade with veranda.

With regard to the second case – construction of a veranda in the side façade – the architectural form was designed together with an integral structure. Structure of historic verandas in Sopot was made entirely of wood, with wooden filling of spandrel-beam framework. The old verandas did not have thermal insulation, hence their utility values were limited. In the case described here, it was decided to use a modern design solution, i.e. a steel frame structure with reinforced concrete floors. The outer wooden walls of the veranda were designed as shell walls, and thermally insulated in compliance with currently binding norms. Their ventilation was ensured, to prevent out-dropping inside the partition (figs 5–8).

In the years following the Second World War a single-storey lean-to was built on original basement walls in the side façade. That part of the building did not have any aesthetic value, and therefore a decision was made to demolish it. The preserved basement walls, as well as the layout of window openings in the side façade evidenced that, in the past, there existed in that place a part of the building, whose dimensions corresponded to those of a veranda. Unfortunately, there were no archival drawings or photographs which would make it possible to

obtain information on the historic composition of the side façade. Having taken the above into consideration, the pre-design works started with the analysis of historic tenement houses characteristic for Sopot, their architectural form, proportions, division of façades and the details applied. Analyses of historic objects were supplemented with examination of composition and proportions of the side façade in the described building, as well as of forms and materials, which it would be possible to use, and which would be appropriate with regard to architectural, urban and socio-cultural context [2]. In the end a two-storey wooden veranda was designed. Its dimensions and articulation of divisions are characteristic for historic architecture of the city. A terrace with a wooden balustrade, functionally connected with the flat in the attic, was designed for the top of the veranda.

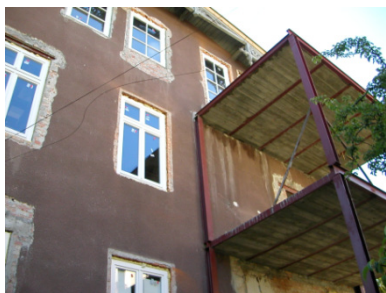
Figure 7: Veranda under construction.

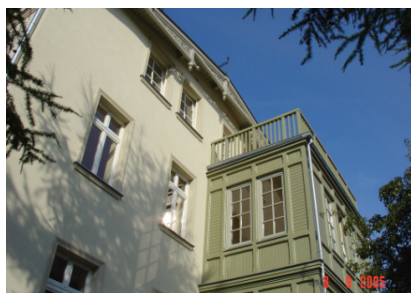
Figure 8: Veranda at present.

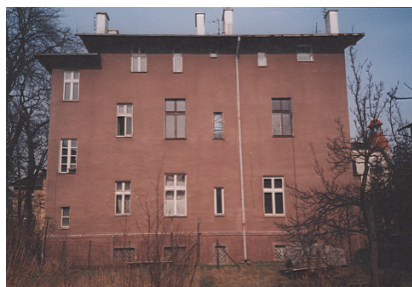
Figure 9: South façade before modernization.

In respect of the rear elevation such works would not have proved satisfactory. Therefore it was decided to tidy up the entire composition of rear elevation, at the same time ensuring improvement of lighting of residential spaces with natural light. Appropriate lighting of rooms was even more important due to the fact that the rear elevation faces south. Variant research was performed, taking into consideration the size, shape and layout of window openings, as well as their relation to functional layout of the rooms. In the end a

clear composition of the rear elevation was obtained, with the division between the main part of the façade and the attic emphasised by the horizontal line of cornice. A terrace with steps leading to the garden was designed for the flat on the ground floor and, for the first-floor flat, a terrace supported with poles,

which made it possible to meet current requirements for residential buildings and, at the same time, break single-planeness and symmetrical layout of the façade. Although full wooden balustrades had been designed, the investor decided to install forged steel balustrades – characteristic for historic architecture of the city, yet, on the whole, too delicate in relation to the entire façade. The illustrations show the architectural design of the rear façade and subsequent stages of its reconstruction (figs 9–12).

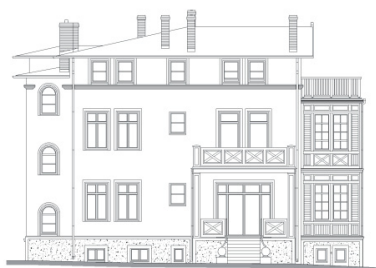
Figure 10: South façade.

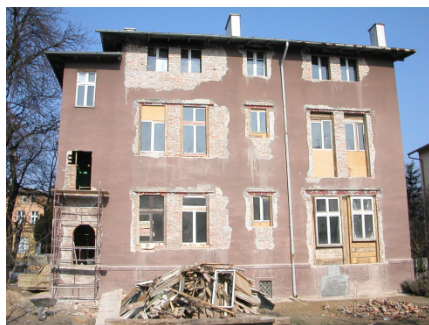
Figure 11: South façade under construction.

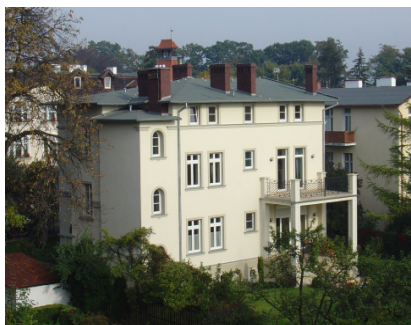
Figure 12: South façade at present.

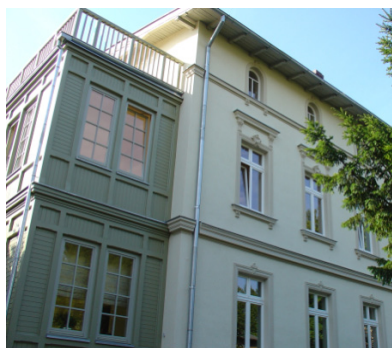
Figure 13: Front façade with veranda at present.

Colour is an immanent feature of architecture and, similarly to façade articulation and details, determines its character. In the case described here it was decided to use harmonised light colour scheme, well suited to the urban context of the district. The scheme was based on natural, unsaturated colours, which were applied to façade elements in such a way as to expose façade composition and architectural details (figs 13 and 14).

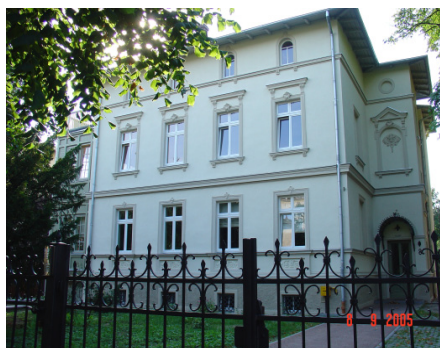
Figure 14: Front façade at present.

With regard to the front elevation of the described building, renovation works consisted in repair of façade elements (plaster, stucco-work, profiled window trims) or their replacement (window woodwork, flashing, rainwater pipes). The valuable historic composition of the façade, which is under conservation protection, has remained unchanged.
