# Numerical investigation of the influence of earthquake forces and foundation settlement on the performance of Post-Byzantine churches

G. C. Manos, L. Kotoulas & V. Matsou

*Laboratory of Strength of Materials and Structures,  
Department of Civil Engineering, Aristotle University of Thessaloniki,  
Greece*

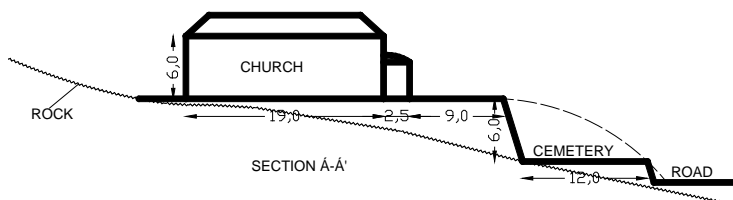
The outlay of this church is shown in figure 1 by a cross-section in the longitudinal direction. Its basic dimensions are 21.5m long (together with the apse of the East wall) 11m wide and a maximum height to the top of the wooden roof 10m. With the dashed line the hard-soil is indicated.

Figure 1: The layout of the church of Virgin Mary.

As can be seen, the West part of this church is founded on hard soil (weathered flysch layers) whereas the East part is founded on relatively soft soil that was deposited on top of the layers to compensate for the natural slope at this location. Apart from the relatively soft soil deposits at the East part of this church the malfunction of the drainage system at this point initiated considerable settlement of these soft soil deposits. The unequal settlement of the foundation of the stone masonry walls as well as of the internal columns that supported the vaulting system, which covered this church, caused considerable damage. The extensive damage that developed at the South-East corner is depicted. A very wide crack initiates at the top of the East peripheral wall near the apse and propagates towards the bottom of this wall being inclined to the South-East

and the relatively soft soil at the North-East part of the church (see figure 1). For quantifying the stiffness of these soil layers use was made of the data from three boreholes drilled at the vicinity of the church relevant to the constitution of the soil deposits at a depth up to 10m. For the load combination  $0.9G+1.4(+Ex)$ , the maximum deformations at the top of the central dome were found equal to  $U_x=21.33$  mm,  $U_z=-14.80$  mm, a considerable increase in the deformation at the top of the church from the previous case where the soil was considered non-deformable. Figure 4(b) depicts the distribution of stresses  $\sigma_{11}$  parallel to the bed joint; the maximum tensile values were found equal to 0.64 MPa, at the bottom face of the masonry walls. As can also be seen in this figure, high tensile stresses parallel to the bed joint develop both at the top of the North wall and at the South-East corner of the East wall. The increase in the tensile stresses for the deformable soil is of the order of 30% to 50% when compared to the corresponding maximum tensile stresses when that the soil was considered non-deformable. As could be seen from the preceding numerical study, the uneven deformability of the soil under the foundation of such structural formations, as Post-Byzantine Basilica churches, can introduce an increase in the critical tensile stresses. The regions of such tensile stress concentration correlate reasonably well with the areas of observed damage.

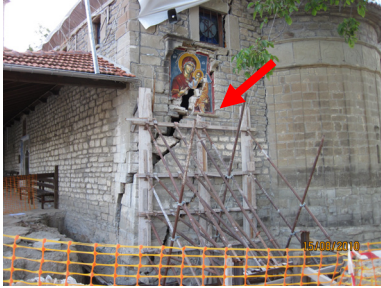
Figure 2: Partial collapse of the central dome.

corner (figure 2). Furthermore, a similarly wide crack propagates through the North peripheral wall from top to bottom. It must be noted that the thickness of these masonry walls varies from 750mm to 800mm. From this extensive peripheral wall damage, the vaulting system that is supported by these peripheral walls also suffered extensive cracking that eventually caused the partial collapse of a part of the central dome, as shown in figure 3.

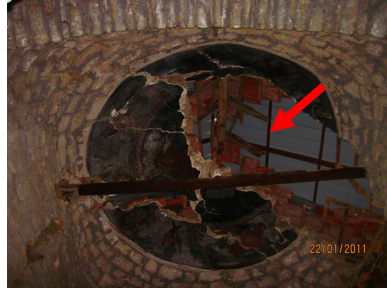
Figure 3: Damage to the South-East corner.

All the supports were assumed to prohibit the translations along all three axes but not to restrain the rotations. It was found from previous studies that full fixity of the masonry walls at the foundation level leads to the development of considerable bending moments that correspond to tensile stresses, which cannot be sustained by the weak stone masonry used to construct these churches. For the load combination  $0.9G + 1.4(+E_x)$  the maximum deformations at the top of the central dome were found equal to  $U_x = 6.81$  mm  $U_z = -1.51$  mm. For this load combination the maximum tensile stresses parallel to the bed joint  $\sigma_{11}$  were found equal to 0.51 MPa, at the bottom face of the masonry walls. High tensile stresses parallel to the bed joint develop both at the top of the North wall as well at the South-East corner of the East wall (figure 3(a)).

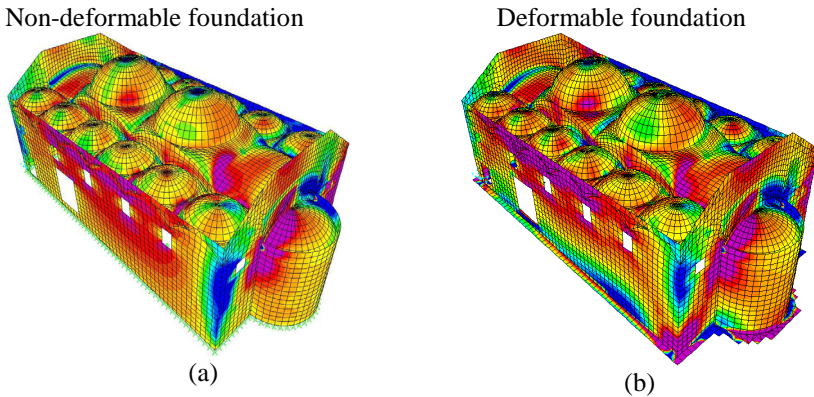
Figure 4: Out-of-plane behaviour, Load Combination  $0.9G+1.4(+Ex)$ . (a)  $\sigma_{11}$  bottom face,  $\max\sigma=0.51$  MPa; (b)  $\sigma_{11}$  bottom face  $\max\sigma=0.64$  MPa.

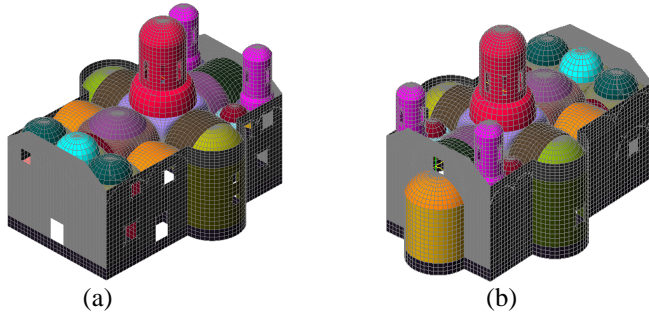
Figure 5: (a) View from the South-West; (b) View from the North-East.

This is a Post-Byzantine church of the cruciform type with three domes (figures 5). The central dome rises at the highest elevation to 15.75m from ground level; the length of the church in the longitudinal East-West direction is 17.60m and its width in the North-South direction is 9.85m. The construction of this stone-masonry church was completed in 1797 AD using local natural stone.

The vaulting system that supports the three domes is depicted in figures 5(a) and 5(b), as can be seen from the top by removing the wooden roof. The numerical simulation considered two distinct models. The first model assumed non-deformable foundation where the translations along the three axes ( $x$ ,  $y$ ,  $z$ ) were restrained to zero. The second model tries to account for the deformability of the foundation by using as supports linear springs with stiffness properties that were estimated taking into consideration the quality of the underlying media as well as the thickness of the foundation and the discretization employed.

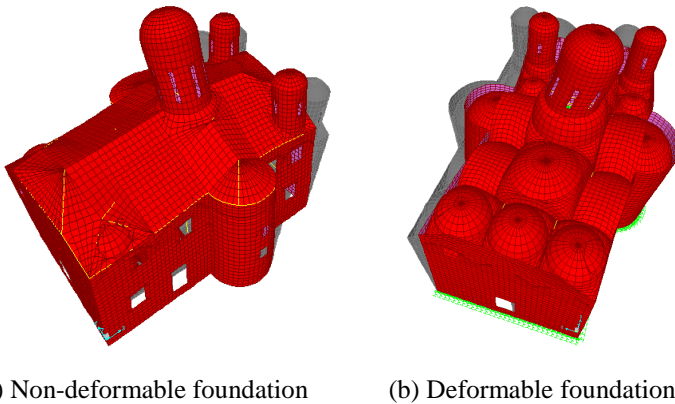
Figure 6: (a) 1<sup>st</sup> Translational eigen-mode  $y$ - $y$ ,  $T_y = 0.154$  sec modal mass ratio  $U_y = 44.67$  %. (b) 1<sup>st</sup> Translational eigen-mode  $y$ - $y$ ,  $T_y = 0.197$  sec modal mass ratio  $U_y = 60.26$  %.

The modal analysis results, depicted in figures 6(a) and 6(b), demonstrate the first effect of the deformable foundation which is the lengthening of the eigen-periods of the most significant translational modes as well as the mobilization of larger modal mass ratios for these eigen-modes when the foundation was considered as deformable as compared to the corresponding values of the non-deformable foundation.

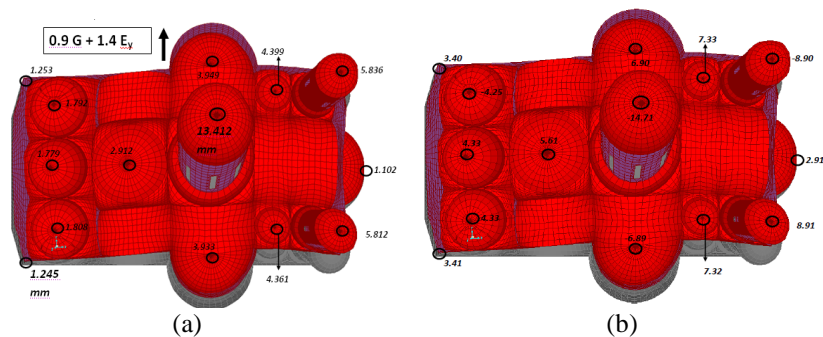
Figure 7: (a)  $0.9G+1.4E_y$ . Non-Deformable Foundation Max. Disp. Top central dome 13.442mm; (b)  $0.9G+1.4E_y$ . Deformable Foundation Max. Disp. Top central dome 14.640mm.

Next, the deformations of the structural system were obtained for both the non-deformable and the deformable foundation model. These were obtained for two sets of load combination: the first is designated as  $0.9G + 1.4E_x$  and signifies the combination of the gravitational forces (G) with the seismic actions in the East-West (x-x) longitudinal direction. The seismic action was enforced by applying the dynamic spectral method with a design spectrum specified by the current Greek Seismic Code and for seismic Zone I and soil category A [4]. The second load combination is designated as  $0.9G + 1.4E_y$  and signifies the combination of the gravitational forces (G) with the seismic actions in the North-South (y-y) transverse direction (figures 7(a) and 7(b)). Due to the foundation deformability the seismic actions combined with the gravitational forces result in an increase of the horizontal displacement response. This is more pronounced at the top of the peripheral wall where the vaults of the superstructure and roof are supported than at the top of the central dome level. At that level, the maximum displacement is equal to 14.710m for the deformable foundation and 13.779mm for the non-deformable foundation for the load combination  $0.9G+1.4E_x$ . For the load combination  $0.9G+1.4E_y$  the maximum displacement at the top of the central dome level is 13.442mm for the non-deformable foundation as compared with 14.640mm for the deformable foundation. Such influence of the foundation deformability is observed in the maximum stress values that develop at either the peripheral walls, the internal transverse wall or the vaults of the superstructure.

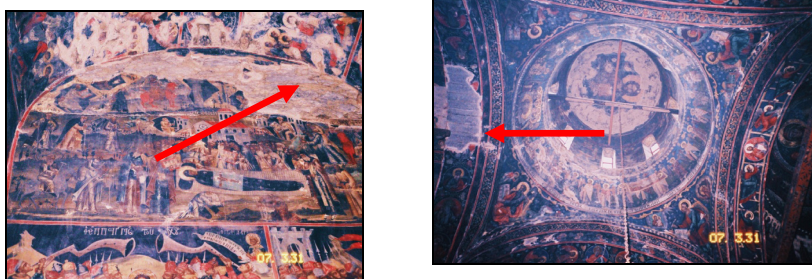
Figure 9: Damage of the internal transverse wall and the adjacent arch.

of damage to the masonry of the vaulting system and the internal transverse wall, as shown (figures 9).

church. This wall as well as the internal facades of all the peripheral walls, vaults and domes are decorated with very valuable frescos that bear signs of extensive damage (see figure 9). Figures 10(c) and 10(d) depict values of ratio  $R\tau$  for the North peripheral wall (0.9G+1.4Ex). Damage is predicted by these numerical analysis results as can be seen from the  $R\tau$  ratio values that are well below one ( $R\tau < 1$ ) in many locations. Moreover, the deformability of the foundation leads this ratio to obtain even smaller values than for the case of the non-deformable foundation, which demonstrates the detrimental effect of the flexibility of the foundation also for this church.

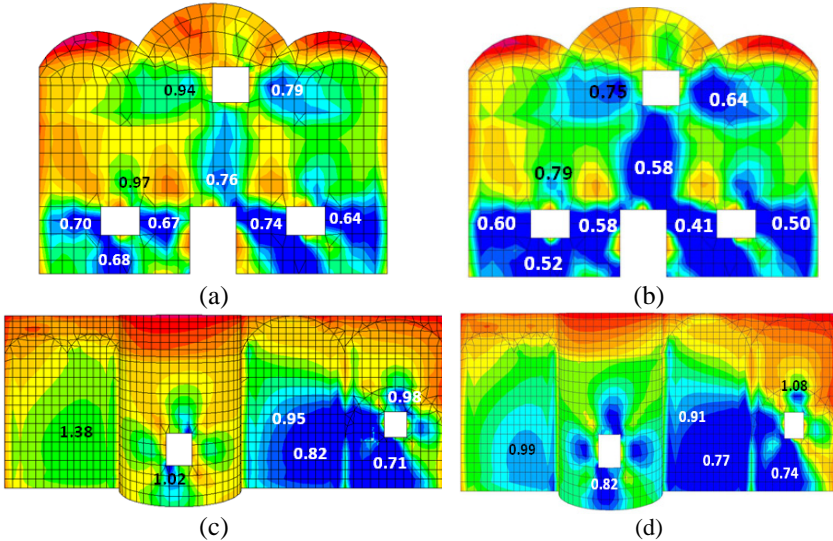
Figure 10: (a) Non-Deformable Foundation Internal Transverse Wall, 0.9G+1.4Ey; (b) Deformable Foundation Internal Transverse Wall, 0.9G+1.4Ey; (c) Non-Deformable Foundation North Peripheral Longitudinal Wall, 0.9G+1.4Ex; (d) Deformable Foundation North Peripheral Longitudinal Wall, 0.9G+1.4Ex.

ratio of the in-plane tensile or shear strength value over the corresponding demand is signified, whereas with  $R_M$  the ratio of the out-of-plane tensile strength value over the corresponding demand is denoted. Ratio values smaller than one ( $R_\sigma, R_\tau, R_M < 1$ ) predict a corresponding limit state condition. As can be seen, the followed methodology is based on combining numerical stress demands resulting from elastic analyses with limit-state strength values. A different approach is to incorporate these limit-state strength values in a non-linear push-over type of analysis (see Manos *et al.* [1]). It was shown that the methodology applied here correlates quite well with the non-linear approach in predicting regions of structural damage. Figures 10(a) and 10(b) depict the  $R_\tau$  ratio values of the in-plane shear strength / shear demand for the load combination 0.9G+1.4Ey for the internal transverse wall, which separates the main church from the women's quarters situated at the west portion of the

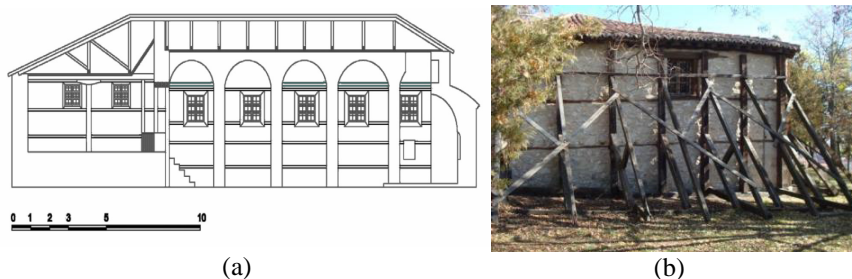
Figure 11: The church of Profitis Ilias at Siatista-Kozani. (a) Longitudinal cross-section; (b) Wooden shoring of South longitudinal wall.

The West part of the church is allocated to the women's quarters that are separated from the rest of the interior by a mid-transverse wall. The South longitudinal wall is supported by a system of wooden beams as is shown in figure 11(b). These were installed after the Kozani-1995 earthquake sequence. Additional wooden supports are also placed at the mid-transverse wall as well as at the mid-span of a longitudinal beam that spans the women quarters from East to West. According to past records, the structural system of this church showed signs of distress from soil-settlement sometime before the occurrence of this particular earthquake sequence. The records do not give information of any

countermeasures being taken in the past up to the point of the earthquake occurrence. The main structural damage, as recorded after this earthquake sequence, is described below. Inclination of the South longitudinal wall outwards that is accompanied with extensive cracking at its joints with the East and West exterior masonry walls as well as with the mid-transverse wall. Cracking is evident at the arches of the colonnades. Despite the fact that 18 years have passed since this earthquake damage, the counter measures so far are in the form of the temporary wooden shoring as well as the renovation of the wooden roof.

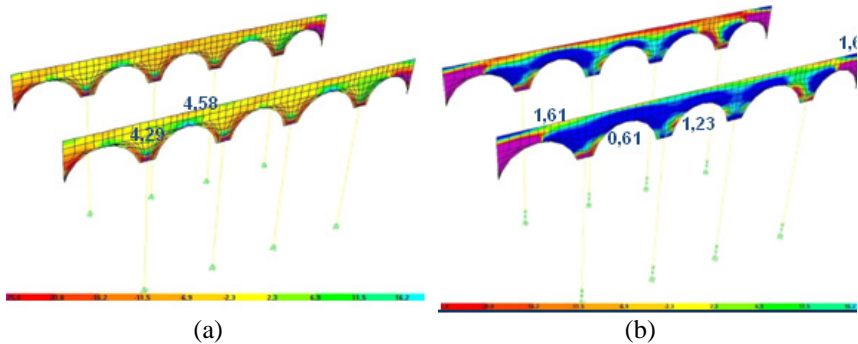
Figure 12: (a) G+0.3Q. Non-Deformable soil  $R_\sigma$  Ratio of in-plane strength / demand **F11** parallel to bed joint. (b) G+0.3Q. Deformable soil  $R_\sigma$  Ratio of in-plane strength / demand **F11** parallel to bed joint.

Figures 12(a) and 12(b) depict  $R_\sigma$  ratio values for the masonry arches above the internal colonnades. These  $R_\sigma$  ratio values of in-plane strength / demand were found by applying the limit tensile strength scenario parallel to bed-joint (**F11**). The demands in these figures were obtained for the load combination G+0.3Q. As can be seen from the above figures, the  $R_\sigma$  ratio values are smaller for the deformable than the non-deformable foundation, which demonstrates the detrimental effect of the foundation deformability for this church even only for the gravitational forces. For the load combination 1.3G+1.5Q, that dictates the design for the gravitational forces under current code provisions, the above ratio values will become even smaller, which signifies that the colonnades cannot withstand the maximum gravitational forces. This is verified by the observed damage which is quite evident for these structural elements in this church as it stands today being supported after the earthquake event of 1995 by temporary wooden shoring internally as well as externally.

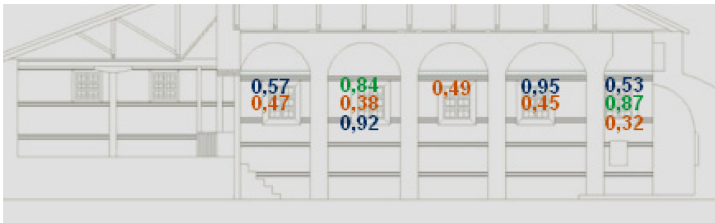
Figure 13: Internal colonnade. Regions with small values of the strength / demand  $R_M$  out-of-plane tensile behaviour (orange color),  $R_r$  in-plane shear behaviour (green color),  $R_\sigma$  in-plane tensile behaviour (blue color).

the same methodology the effectiveness of a potential retrofitting scheme. In order for such retrofitting scheme to be effective the resulting strength / demand ratios should attain values larger than the corresponding values without this retrofitting scheme and, if possible, larger than 1. Such an evaluation has been performed for the most vulnerable structural elements of this church; that is the internal colonnades, the South peripheral wall and the East peripheral wall with the apses. The existing or potential damage is predicted by the numerical analysis results when the strength / demand ratio values are well below 1. This is shown in figure 13 for the internal colonnade. In almost all structural elements the out-of-plane tensile behaviour results in strength / demand ratios with values well below one ( $R_M < 1$ ). The internal colonnade has visible signs of out-of-plane displacements and extensive cracking that are in agreement to the distress predicted by the followed methodology.
