Several notes on technical modernization of a historical building

J. Bakowski

Faculty of Architecture, Gdansk University of Technology, Poland

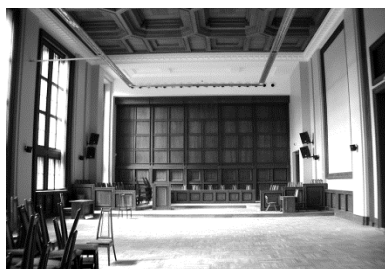
Figure 7: The main assembly hall, 2006 (during the refurbishment).

rely on maintaining the post-war modernization (fig. 7) and the elevations would restore the original design concept of the Carsten project.

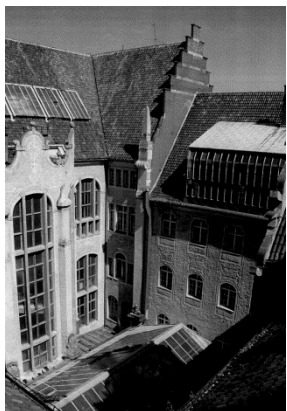
Figure 8: The southern courtyard, ca. 1995.

A much bigger problem arose from glazing and adaptation of both courtyards; they completely lost their character and had been gradually filled with inferior technical features and workshops. For many years the building occupants weren't even aware of their existence (figs 8 and 9). The decision on the courtyards revitalization was a key element in the modernization of the building and forced the introduction of other elements.

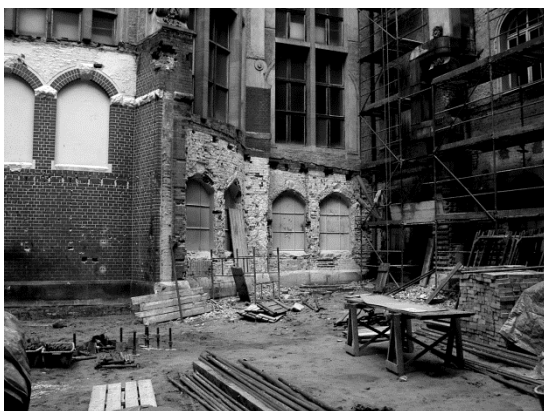
Figure 9: The southern courtyard, during the refurbishment, 2004.

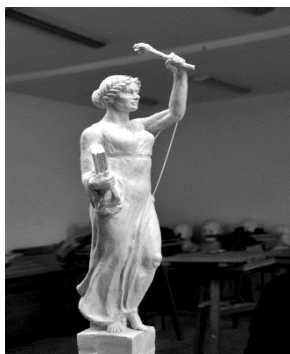
Figure 10: A model of the science allegory.

The next issue worth discussing was the reconstruction of the architectural elements of the building. Problems associated with the reconstruction can be divided into two categories: recreating formal and spatial solutions (shape and size of an element) and technical ones (structure, construction and finishing materials). One of the tools for the former method was restitution of perspective. Basing on descriptive geometry methods (and it did not matter whether the drawing construction would be created manually or using a CAD system) one could analyse a photographic documentation to restore dimensions of an element as well as decorative ornaments (if the quality of photographic documentation was sufficiently good). The method helped to reconstruct the clock-tower. The quality of photographs did not allowed to strictly project all the details, so the sculptor had been entrusted the task of preparing the new figure of science allegory (fig. 10). All the tower details had been modelled with the 1/10 scale before the final acceptance. The more, analyses of similar technology solutions, from the same period (the clock-tower of the main railway station in Gdansk was built at about the same time, using exactly the same technology) helped to prepare detailed drawings for the reconstruction (fig. 11).

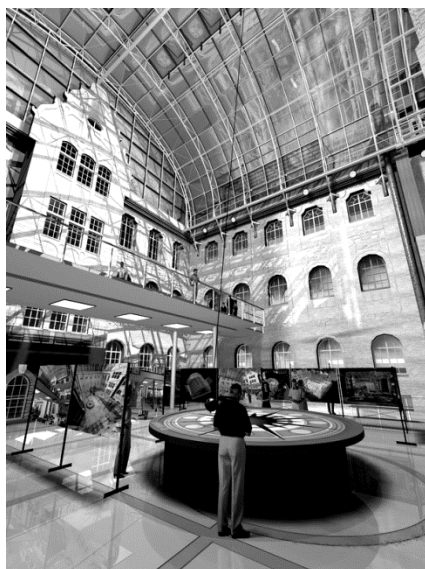
Figure 18: A vision of the further modernization.

The presented paper concentrates on the collaboration of all design participants, and their effort to gain the basic goal – the appropriate, diligent and thorough modernization and refurbishment. As there are several possible solutions, and there is no single “winning” strategy for a building refurbishment. All the taken actions have to be adaptive for the building purposes, nowadays as well as in the future (figs 17 and 18).
