Methodology for the cataloguing and recovery of archaeological remains of architectural heritage

The good results achieved during the study of the architectural remains of the recently reconstructed courtyard of the Ambassador Vich's Palace in Valencia suggests that the methodology used can be extended to other cases of similar characteristics, making a contribution to the complete reconstruction of lost architectural heritage.

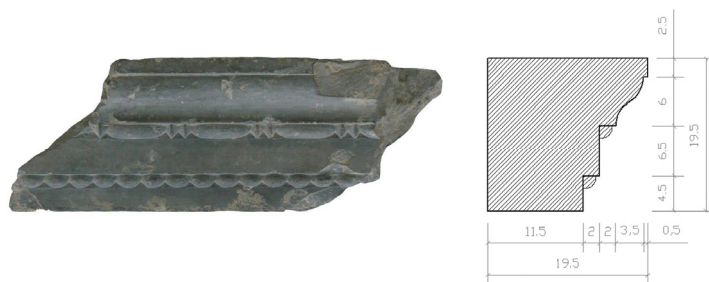
First group: 11 items, pieces which in cross section fit into a square with sides measuring 19.5 cm, and which have a moulded outer face decorated with two lines of beads (fig. 2). The carving was similar to the marble pieces. However, the carving was of a manifestly inferior quality, as it did not achieve the characteristic three-dimensional nature of renaissance ornaments, seeming more similar to Gothic bas-reliefs (fig. 2).

Figure 2: Example of a typical piece and cross-section from the first group.

This set of items were originally made as separate modules, measuring around 60 cm in length and with the mouldings demonstrating continuity. A deductive method let us to conclude that these pieces may have formed a linear cornice [8] (fig. 2).

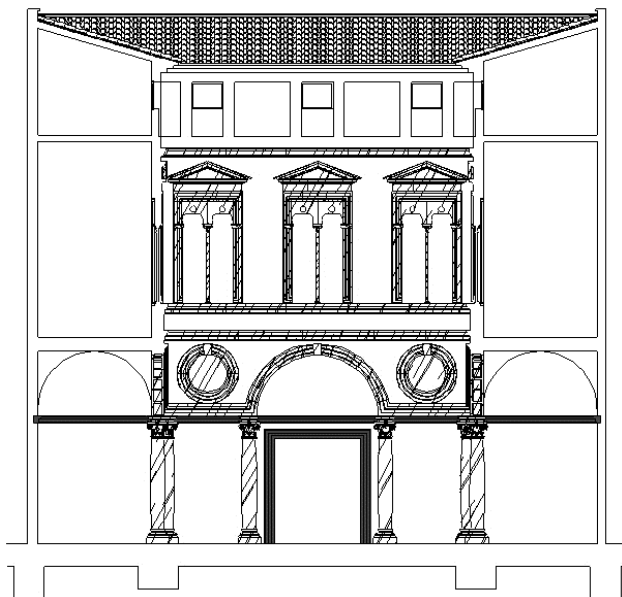
The result of this intervention would be the complete reconstruction of at least one side of the patio, enabling the complete and correct interpretation of its rich renaissance composition (fig. 6) [12].

Figure 6: Proposed reconstruction of one side of the renaissance courtyard.

To this end, the pieces of the cornice would be established as being modular and 60 cm in length, so that with the 11 original pieces and 13 reproductions, it would be possible to reconstruct the cornice of one of the lateral elevations at the Museum, measuring 14.4 m in length.

The 9 pieces of the frame were brought together around the central doorway to the rooms on the lower floor, given that this was present in present in Fornés's elevation and it coincided with the actual doorway to the courtyard from the inside of the Museum.
