# **The story and conservation problems of an industrial heritage building in Istanbul: the Sütlüce Slaughterhouse**

S. G. Kucuk

*Department of Architectural Restoration,  
Mimar Sinan Fine Arts University, Turkey*

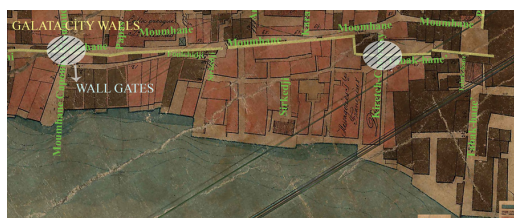
Figure 1: Galata city walls, gates and streets are in d'Ostoya Map.

The walls and gates opening to the street can easily be seen from the 1858-dated d'Ostoya map, figure 1. It is noteworthy that the gates of the walls in Mumhane Street were named the same in the 19<sup>th</sup> century as in the 17<sup>th</sup> century. Besides, the streets these gates opened onto were also namesakes with wall gates as Mumhane Kapısı Street and Kireç Kapısı Street. In this map, Tabakhane Street near Kireç Kapısı Street is also worthy of notice. The pier was not yet erected when this map was drawn.

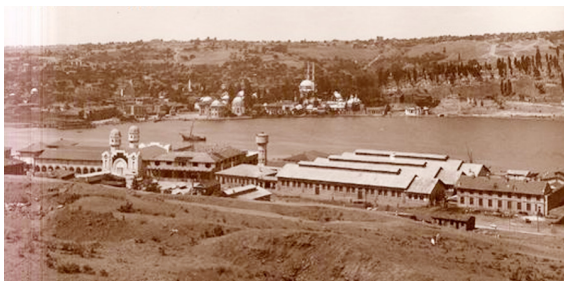
Figure 4: Sütlüce Slaughterhouse in 1930s. Three slaughtering pavilions at the right and ice plant building with two towers are at the left side [16].

Sütlüce Slaughterhouse is located in Karaağaç Street on the Beyoğlu shore of Istanbul, Golden Horn (figure 4), thus it is known as Karaağaç Slaughterhouse in a number of resources. However, the origins of the Sütlüce term reflected in the district name are uncertain. Sources reveal that Byzantines used to call this place "Galatyani". A number of historians attribute this word to "galatea" meaning "milk" in Romaic language [20], and relate its origin to the dairies located here during the Byzantium era [1]. 17<sup>th</sup>-century traveller Evliya Çelebi stated that the name of the region derived from "milk" in Arabic, Romaic and Turkish languages as can be explained by the purity of milk attached to the purity of vegetation and climate [20].

In the facility there existed three slaughtering pavilions each spreading to a 1000 m<sup>2</sup> area to contain four barns that enabled butchering 1500–2000 sheep and goats and 250–300 cattle per day, water pumps, pump machinery buildings, and a coffee house and cafeteria [16], see figures 4 and 5.

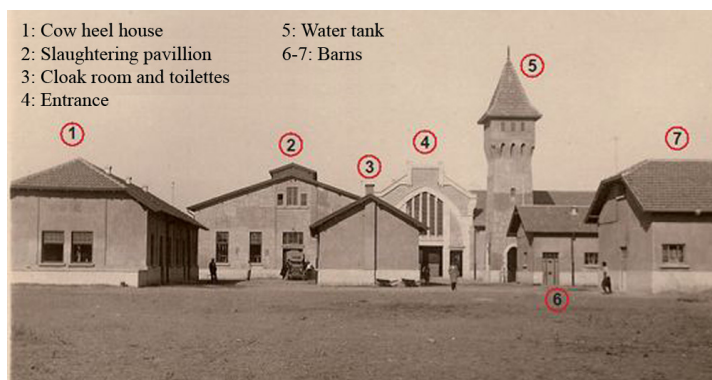
Figure 5: Buildings of the slaughterhouse [16].

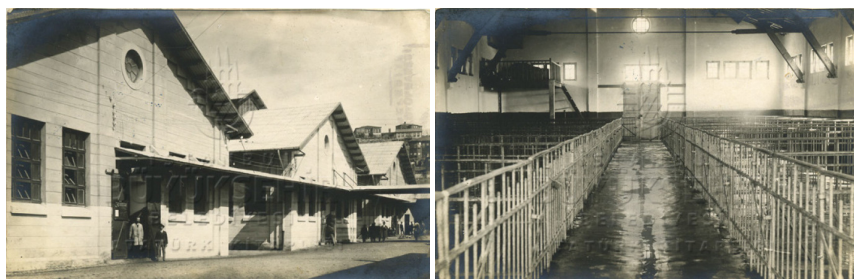
Figure 6: Slaughtering pavilions; façades on the left and interior at the right side.

Slaughtering pavilions situated parallel to the shore, were consisted of three rectangle blocks with the dimensions of 72 m x 20 m. Inside, there was a 12.7 m wide mezzanine which centres 7.1 m height internal volume. In reinforced concrete structure, columns were tied with gousset beams. The roof which was carried with I and U profiled trusses was lifted through the ridge so, the ventilation and lighting inside were ensured. On the facades for decorating, cement plastered surfaces were lined and column rows were adapted to the facade as engaged columns [19], see figure 6.

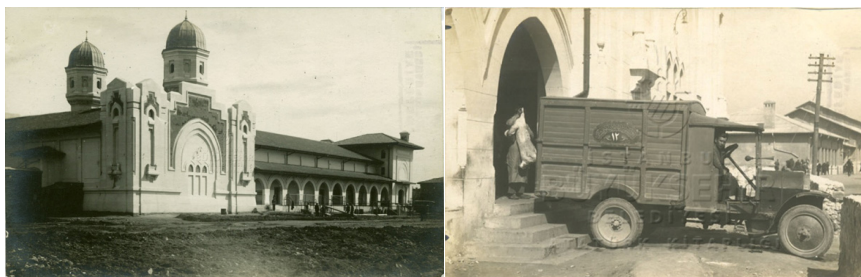
Figure 7: Ice plant building (at the left) and the trucks carrying meat from there [21].

Cold storage facilities and ice plant with the capacity of manufacturing 50 tonnes of ice per day were put into operation on 20 July 1925 by Şehremini Operator Emin Bey [16]. The most distinguishing building of the Sütluce Slaughterhouse is its tower ice plant building, in figure 7. This building with its

symmetrical face pattern, lancet windows, roof parapet downgrading in echelon and its divisions covered with blue tiles between pointed arches aptly reflects the style of the First National Architecture of its age [18]. In 1929, an additional facility manufacturing 25 tonnes of ice and a second one producing 50 tonnes of ice were added [16]. Steel structures and bricks or tiles used in the construction of the slaughterhouse were imported [18].

When the construction of all these facilities was completed, Sütluçe Slaughterhouse, including its meat-sharing facility, spread over 20 thousand square meters closed, and 31 thousand square meters open totalling 51 thousand square meters usage area, 80 tonnes of first meat cold storage plants conserving 300–350 cattle, 3–4 thousand sheep and goats, ice stores producing 100–125 tonnes of ice daily and preserving the same amounts of meat per day, 1200 cases of egg conservation storage and four large stores preserving a variety of food stuffs [16]. Meat transportation was the business of contractor companies till 1940 after which corporate trucks were used for transportation purposes [15], see figure 7.
