Assessment of the New Faliron steam-electric station in Greece

C. Maraveas^{1,2}, K. Tasiouli¹ & Z. Fasoulakis¹

Abstract

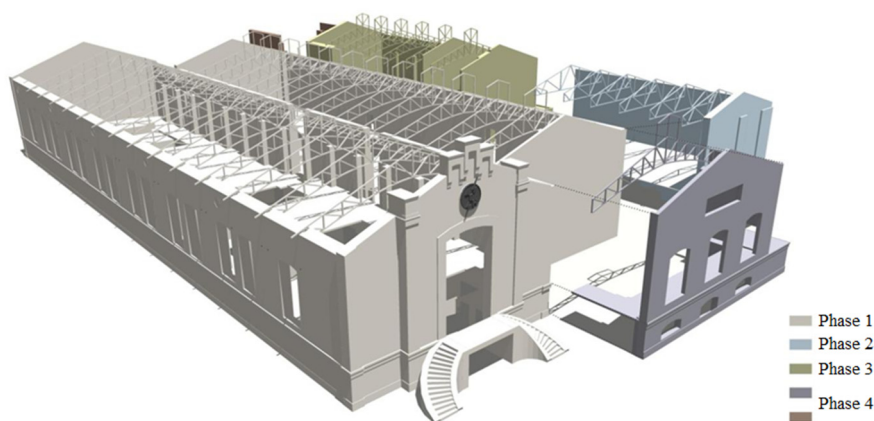
Figure 1: 3D representation of the structural interventions.

An important step in the process of assessing the pathology of the building is to understand its initial construction and its evolution in time. For the examined building there are four basic construction phases which are summarily described below. The initial structural system was modified during the 1930's and 1950's, while the last intervention a few years ago (removing the roof sheeting) contributed to the mechanical properties' deterioration.

In 1902, the initial building is constructed, consisting of buildings A and B and including the steel roof that exists nowadays. In 1926, the first part of building C is added and several modifications take place at the mezzanine level of buildings A and B (phase 2). In 1930, the second part of building C is constructed and masonry walls are added at the transverse direction of building B. The structural interventions are completed in 1952 with the extension of building C, necessitated by higher machinery demands. In addition, building B is extended through a reinforced concrete structure, while a part of the north wall is replaced by a reinforced concrete frame. The construction phases are clearly presented in Figure 1, with the corresponding buildings A, B and C illustrating from left to right, whereas views of the initial structure, depicted in 1902, are attached to the following figure.

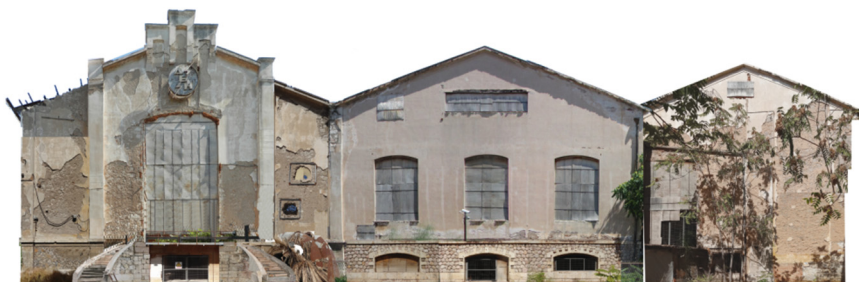
Figure 3: Exterior view of the existing structure.

The total plan of the existing building has a rectangular layout, consisting of three longitudinal parts (A, B and C) with a total surface of approximately 4187m². Both exterior and interior views are attached to the following figures (Figures 3 and 4). The mezzanine floor (which supports the machinery) and the roof level are 3m and 12m above the ground level, respectively. The thickness of the 12.5m high masonry walls varies from 0.8m at the top to 1.3m at the base, whereas the buttresses thickness is about 0.6m. Furthermore, the masonry walls contain large openings (covering areas up to 5.9m x 2.7m), at the top of which steel beams have been introduced for supporting reasons (Figure 5). The roof consists of steel trusses of varying height (1.3m at the edges and 2.55m at the middle) with fastened double-angle members. The lower flange of the trusses is arc-shaped and they are pinned on the masonry walls. Finally, steel crane bridges still exist at both A and C buildings.

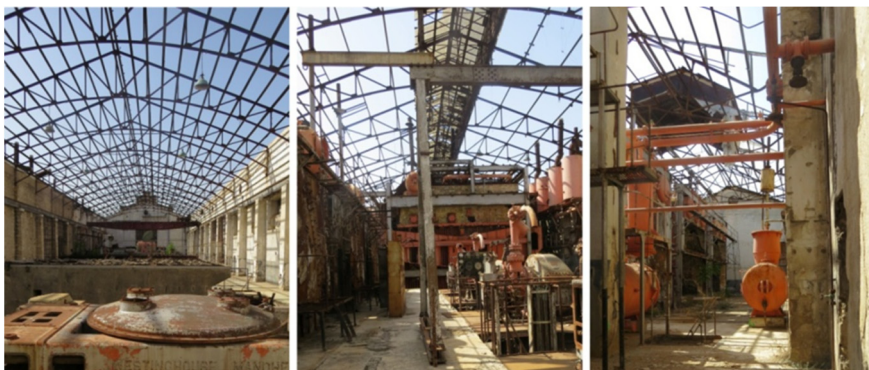
Figure 4: Interior views of the three buildings A, B and C2 (from left to right) on the mezzanine level.

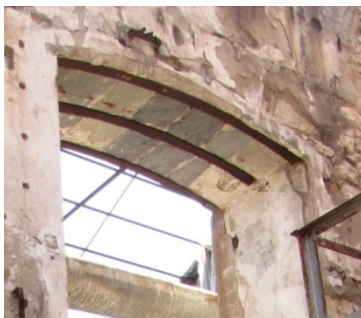
Figure 5: Configuration of a lintel supported by steel beams and concrete plates.

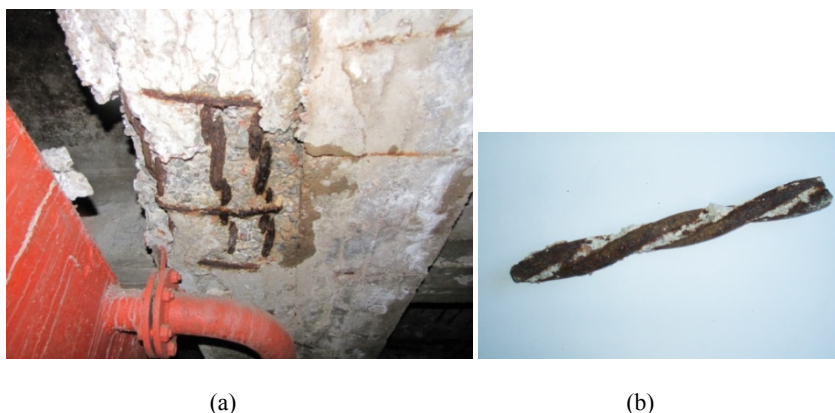
Figure 6: Views of (a) a structural member with twin twisted bars and (b) a twin twisted bar taken from the field.

It should be highlighted that parts of the concrete structure with high capacity demands had been reinforced with twin twisted bars, according to BS1144 [14]. These reinforcements were manufactured via cold-processing, using common steel rebars. An example of a concrete member reinforced with twin twisted bars is illustrated in Figure 6. An extended in-site survey was followed for the proper determination of the location and the number of steel rebars, using electromagnetic or destructive techniques. Finally, the visual inspection revealed that the concrete was in the most unfavourable condition due to environmental factors, while both the reinforcing and the structural steel had been extensively corroded.

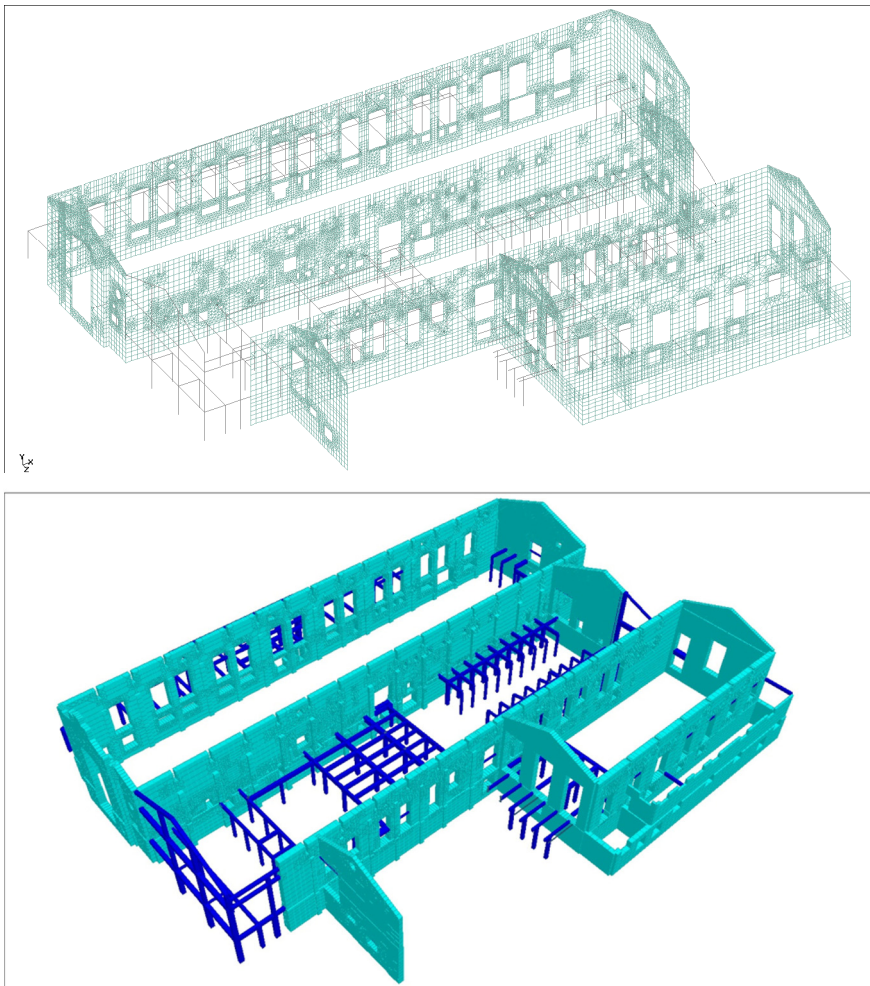
Figure 7: 3D views of the model used to simulate the existing structure.

of commercial software [7], as a spatial model, using plate elements for the walls and beam elements for the beams/columns, including concrete neighbouring structures. The basement and steel structures connecting with the main shell structure at approximately 3.1m height, provide partial lateral restraints, which were adopted at the model. In Figure 7, 3D views of the main model are presented, while the steel roofs were examined independently (Figure 8) and their reactions were introduced as forces acting on the corresponding masonry locations of the main model. The same procedure was followed for the steel structures supported on the masonry.

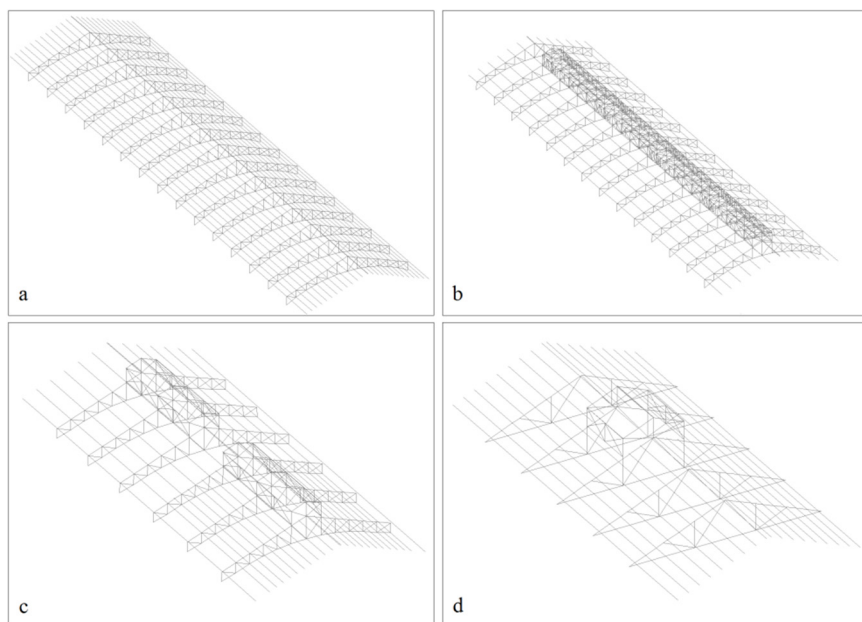
Figure 8: 3D views of the steel roofs of buildings: (a) A, (b) B, (c) C1 and (d) C2.

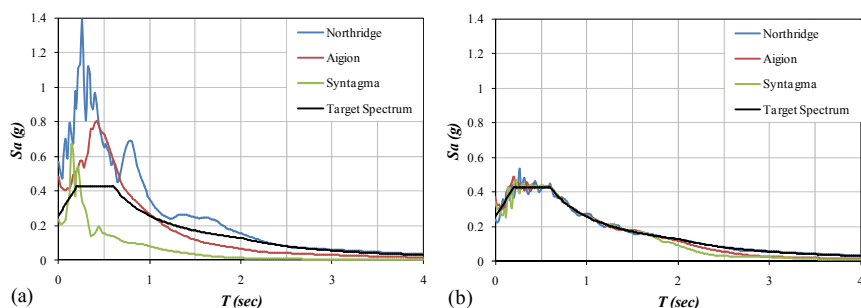
Figure 9: (a) Normalized and (b) matched response acceleration spectra compared to the corresponding one per EC8.

Modal response spectrum analysis was performed, considering the participation of 500 modes. The seismic action was also investigated through dynamic time history analyses, considering a variety of earthquake events, namely Aigion (1995), Athens (Syntagma, 1999) and Northridge (1994). The original accelerograms were scaled using SeismoMatch software [15], in order to adjust the ground motion records to the spectrum defined in the design code (target spectrum) [12]. Figures 9(a) and 9(b) display the response spectra of the normalized records and the matched spectra along with the target spectrum respectively.

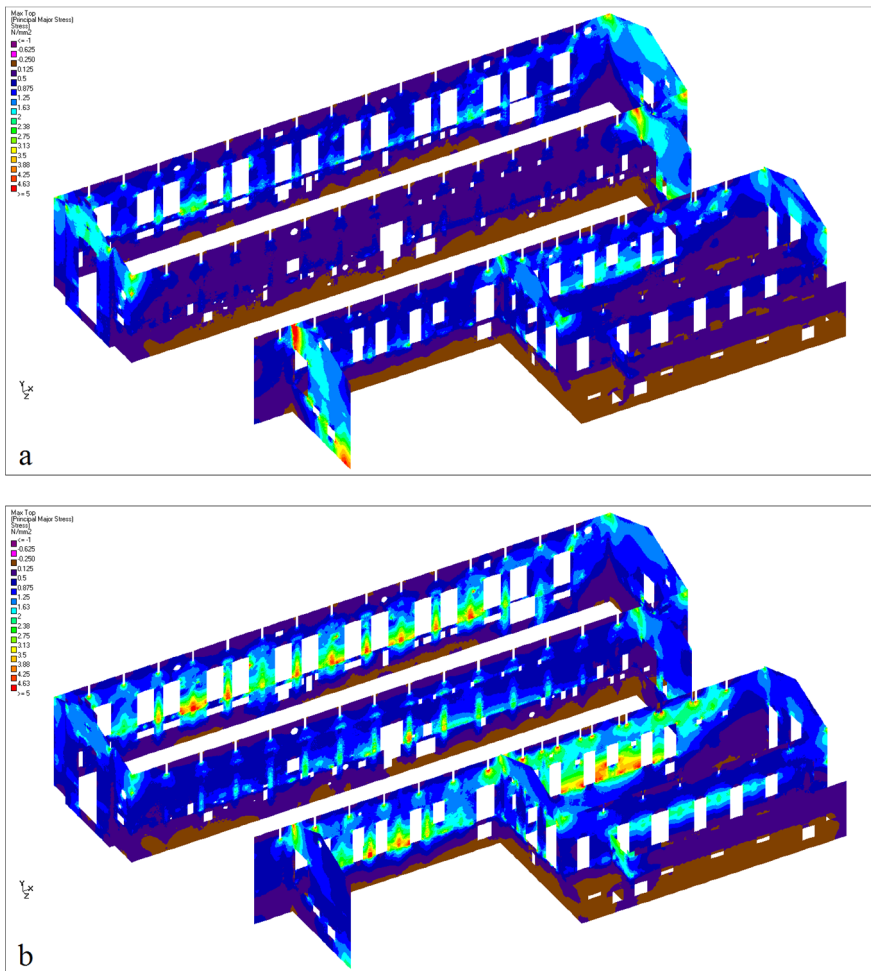
Figure 10: Maximum principal stress distributions under earthquake loading along (a) X and (b) Z directions.

Global stress analyses were carried out, the results of which are schematically presented in Figure 10. The existing structure analysis has confirmed the decisive role of the lateral restraints. For seismic excitation with maximum magnitude 0.45g, enormous tensile stresses are produced (up to 5 MPa), whereas the overall displacements of the masonry in the horizontal directions X, Z reach 200 mm and 130 mm, respectively.

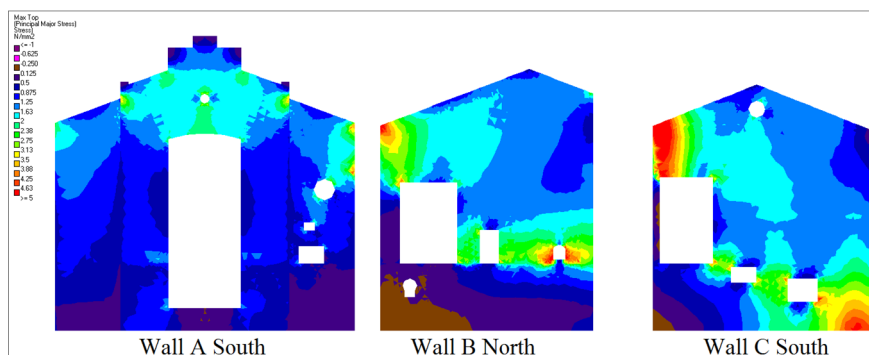
Figure 11: Maximum principal stress distributions for transverse walls under earthquake loading along X direction.

More specifically, regarding the transverse masonry walls, one can observe the maximum principal stress distribution under leading earthquake loading along X direction, in Figure 11. The exceedance of the tensile stresses due to the fact that the sidewalls are free standing, is easily observed. Quite notable is considered the fact that for the 1st mode, only the mass of the building C flexible southern wall participates, with a corresponding period of $T=1.01$ sec (Figure 12(a)). The 56th mode shape of the dynamic analysis is also presented in Figure 12(b).

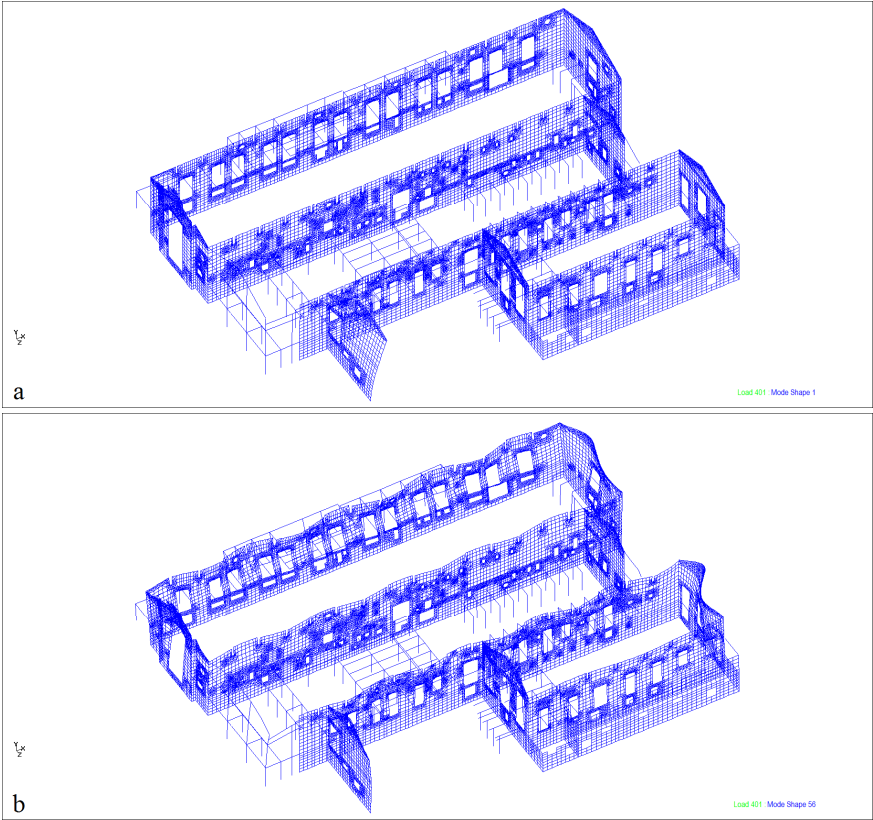
Figure 12: Shape deflections for the corresponding modes: (a) 1 (1.01 sec) and (b) 56 (0.16 sec).

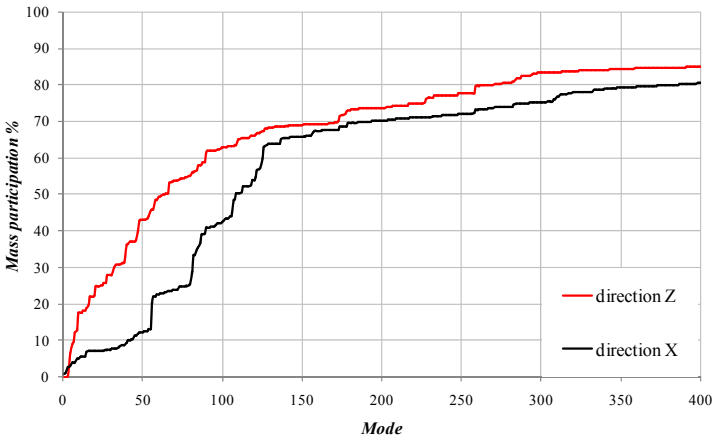
Figure 13: Comparison of mass participation between directions X and Z.

In Figure 13, the mass participation derived from the dynamic analysis is presented. One can observe that for direction Z the mass participates gradually rather than with significant notable steps, while for direction X 10% mass participation steps correspond to modes around 56, 82 and 125. The corresponding base shear forces are clearly illustrated in Figure 14.

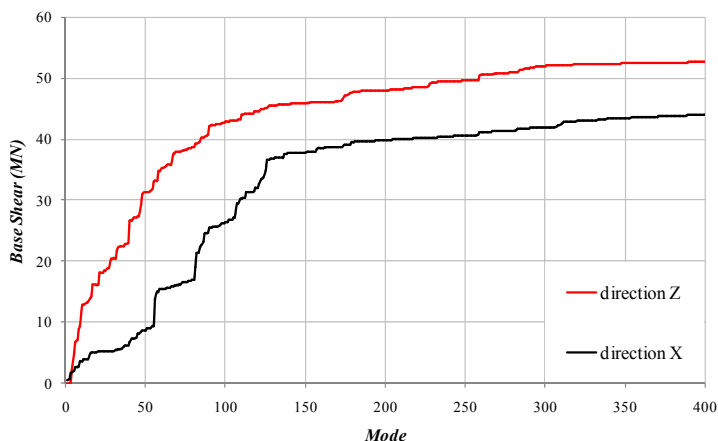
Figure 14: Comparison of base shear forces between directions X and Z.

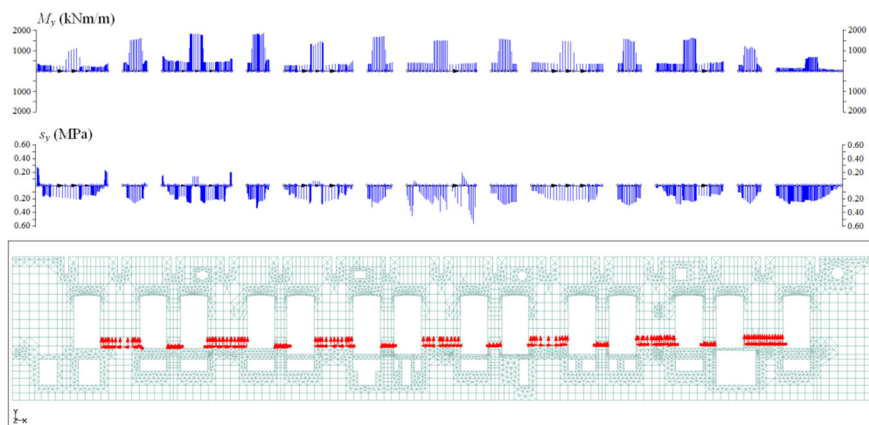
Figure 15: Out-of-plane moment (M_y) and stress (s_y) distributions of the western wall segments under earthquake loading along Z direction.

Results showed that, for seismic action, the masonry walls exhibit large bending moments with simultaneous low axial forces. That observation assigns the structural behaviour of the masonry walls to that of a 10m cantilever. An example is thoroughly illustrated in Figure 15 for the western wall of building A, where one can observe that the out-of-plane moment distribution is critical, considering the fact that the corresponding normal stresses are not sufficient. Remarkably, an 1860 kNm/m maximum out-of-plane moment is derived, which is compared to only approximately 50 kNm/m bending capacity. The examined segments are highlighted (red-coloured) in the figure below the corresponding diagrams.
