# **An innovative cathodic protection system for steel framed heritage structures**

R. Brueckner, R. Merola & P. Lambert

*Mott MacDonald, Materials & Corrosion Engineering, UK*

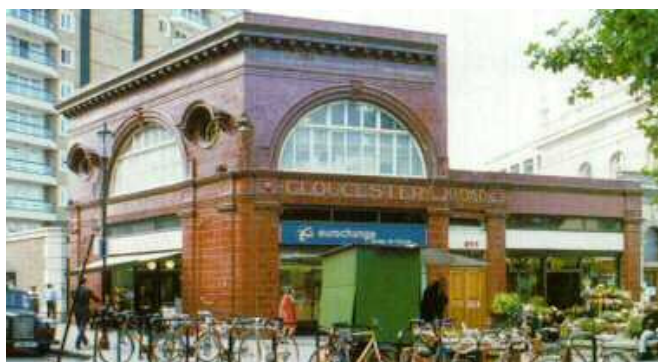
Figure 1: Gloucester Road Underground Station.

In 1997, Gloucester Road Underground Station [2] became the first full structure to be protected by such a system (see Figure 1). CP systems for steel framed buildings have developed considerably since 1997 but typically comprise discreet anodes installed into the joints at approximately 500mm centres to minimise the impact on the appearance of, often historic, heritage structures.

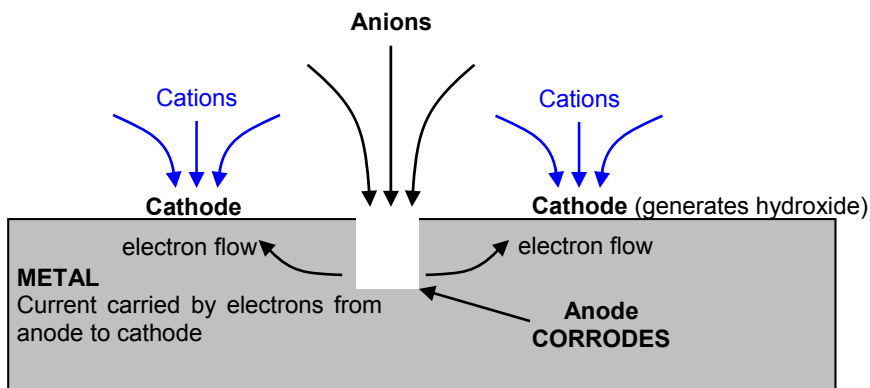
**ELECTROLYTE**

(Water in mortar,  
soil, or concrete)  
Current carried by  
ions

**IN THE ELECTROLYTE**

Anions move to the anode  
(hydroxide, chloride, sulphate)  
Cations move to the cathode  
(hydrogen, sodium, calcium)

Figure 2: The corrosion process.

In its simplest form the corrosion process can be represented by two dissimilar metals in an aqueous electrolyte, joined to allow electrons to pass from anode to cathode with an associated loss of metal from the anodic areas. In reality, when a metal corrodes, anodic and cathodic areas can be formed on a single surface in contact with the aggressive aqueous environment. This is shown in Figure 2. As a result, corrosion can occur at a large number of sites over the surface of the metal. Dissolved metal ions react with hydroxyl ions to form the corrosion products [3].

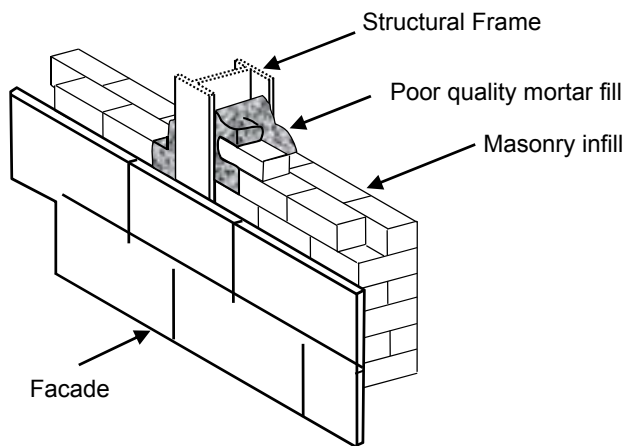
Figure 3: Typical construction detail.

In the case of steel framed buildings the protection against excess moisture and ingress of aggressive species was provided by its method of construction. The protection has typically consisted of a cement wash or thin bituminous coating followed by partial encasement in concrete or mortar as shown in Figure 3. Over its lifetime the joints, pointing and flashing gradually deteriorates allowing water to ingress. In conjunction with the carbonation of the cementitious encasement material that had originally provided a protective barrier, corrosion has been able to initiate. The mortar and masonry acted as a dense layer on the surface and, where Portland cement was also used, formed a stable passivation layer at the interface as a result of the high alkalinity.

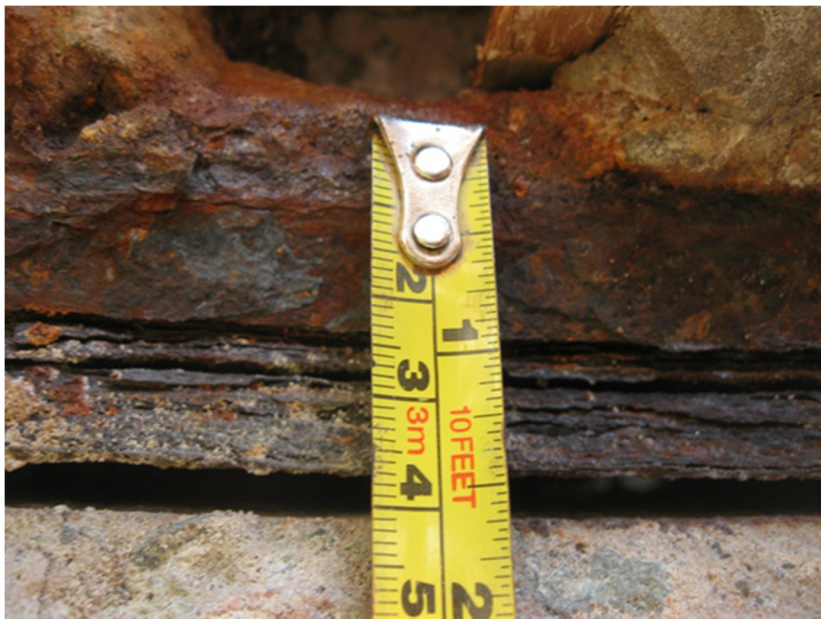
Figure 4: Corrosion of a masonry encased wrought iron beam.

Once corrosion has commenced, the more voluminous corrosion products cause cracking and displacement of the brick or stone cladding which can further open up joints and cracks, permitting more water to penetrate. Figure 4 shows the degradation of a wrought iron column encased in masonry cladding and Figure 5 the effects of corrosion on the cladding.

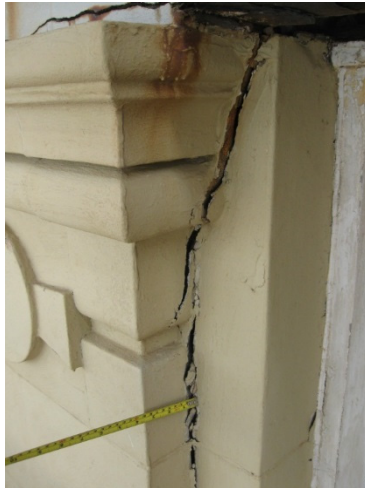
Figure 5: Damage due to steel frame corrosion.

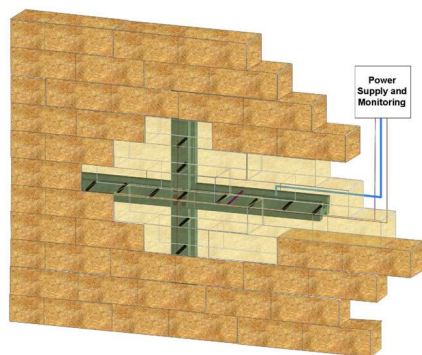
Figure 6: Schematic representation of a conventional CP installation.

Conventional CP systems for steel framed buildings typically employ ribbon or rod anodes installed in various grid patterns into the masonry as shown in Figure 6. To simplify the requirements for installation and to improve the durability of CP systems it became apparent that it would be a significant technical and commercial advantage if the role of the anode could be replaced by the mortar used in the repointing.

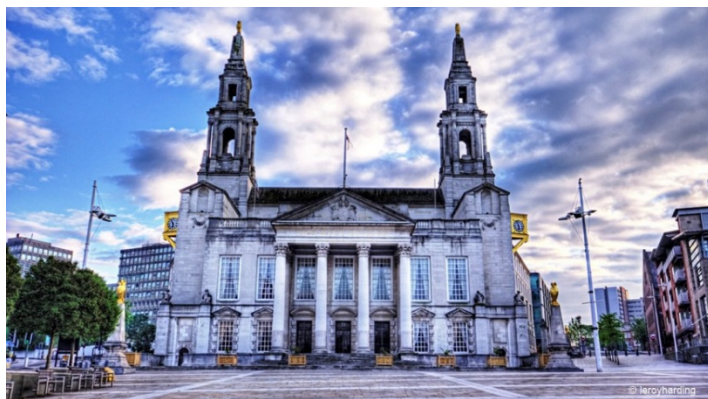
Figure 7: Leeds Civic Hall.

The new anode system was first assessed in a trial installation at Leeds Civic Hall, a magnificent steel-framed, Portland stone clad Grade II\* listed building that was designed by Vincent Harris and opened in 1933 (Figure 7). Areas of the structure were in need of repointing and showing early signs of steel frame corrosion.

A trial installation, comprising both the conductive geopolymer and a conventional rod anode CP system, was installed to part of the rear façade. In addition to the conductive geopolymer used to repoint the raked out joints, a conductive carbon chord was employed as a primary feed to supply and distribute the low voltage DC current. Monitoring of the two systems showed that the geopolymer CP system achieved equally effective protection to the steel frame as the conventional CP system.

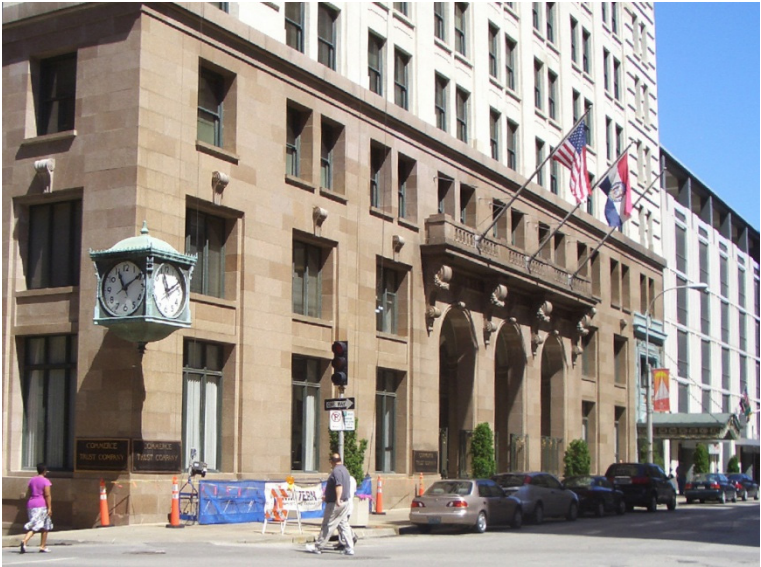
Figure 8: 922 Walnut, Kansas City.

The first commercial system was designed and installed at the main entrance to an historic Kansas City building, Missouri, USA that required a durable and invisible repair technique. The 922 Walnut building was constructed in 1906 by Fullers, who were also responsible for the Flatiron Building in New York. Upon its completion it was the tallest building in Kansas City and its first skyscraper. While the facade remained in good condition through the majority of the 20<sup>th</sup> century, by the start of the new millennium it was showing signs of corrosion to the steel frame and cracking of the granite used in the construction of its grand main entrance (Figure 8).

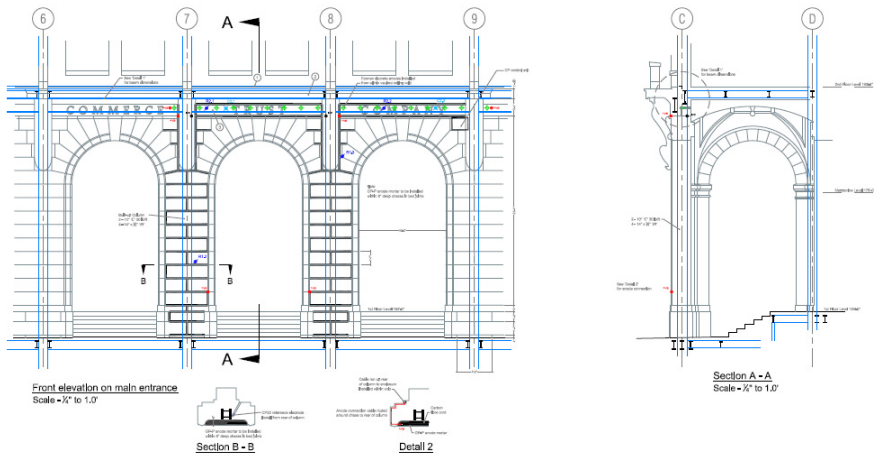
Figure 9: Areas repointed using the geopolymer anode mortar.

Due to the complex structure of the entrance, including integral vaulted ceilings, a 3D model was developed to assist with the design of the system in collaboration with C-Probe Technologies who provided the hardware and site support to the main contractor during installation. The only change from the system employed at Leeds is that the primary feed has been changed from a carbon chord to a mixed metal oxide coated titanium wire which can carry more current and is more durable. The areas of application of the geopolymer are shown in Figure 9 representing the location of the steel frame behind the cladding.
