## Knowledge and recovery of military architecture: the *urban* castle of Pomarico (Italy)

A. Guida<sup>1</sup>, A. Pagliuca<sup>1</sup> & G. Damone<sup>2</sup>

<sup>1</sup>*Department of European and Mediterranean Cultures: Architecture, Environment, Cultural Heritage (DiCEM), University of Basilicata, Italy*

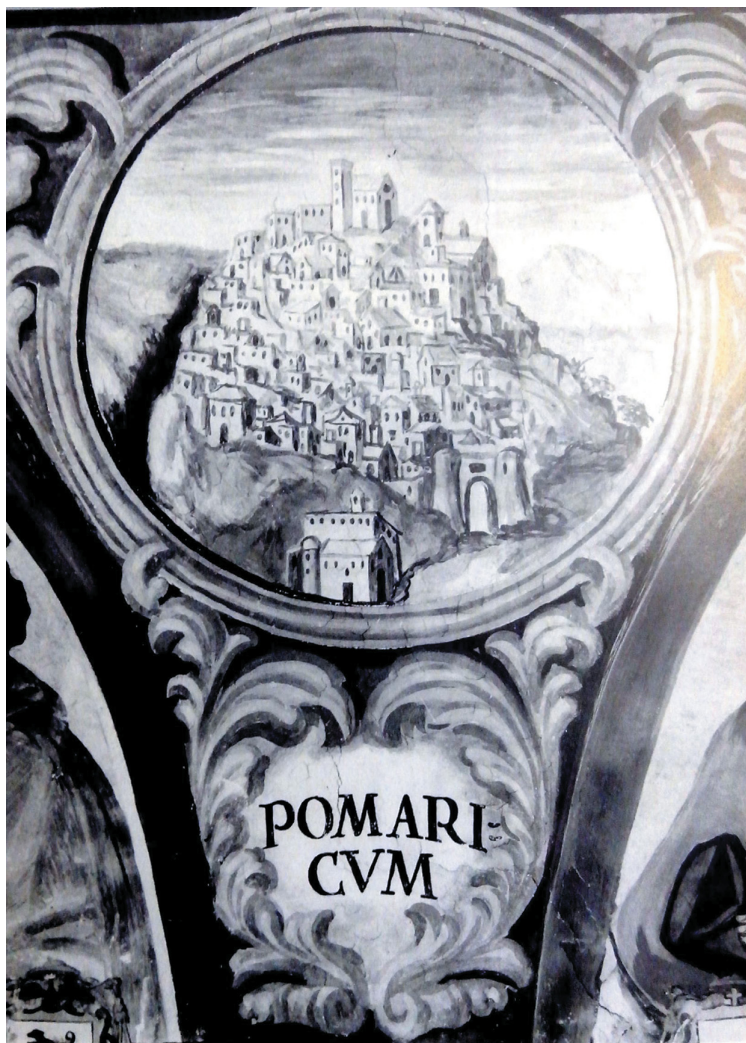
Figure 2: Pomarico, fresco at *Salone degli Stemmi* – Matera, 1709.

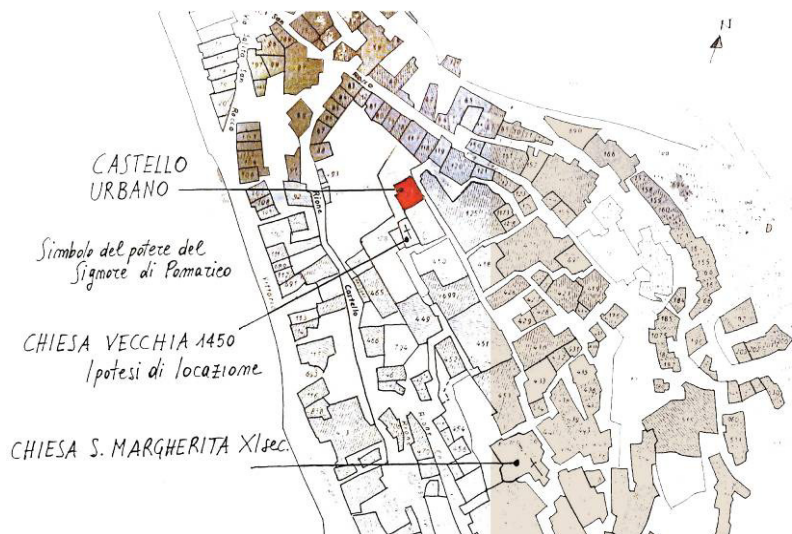
Figure 4: Historical plan of the city, 1911.

As said above, the Pomarico [5] castle is an *urban* castle situated in the oldest part of the city; it has had problems related to the stability of terrain so today it presents itself as a ruin (Figure 4).
