Vision-based monitoring of heritage monuments: Unmanned Aerial Systems (UAS) for detailed inspection and high-accuracy survey of structures

N. Hallermann¹, G. Morgenthal¹ & V. Rodehorst²

¹Modelling and Simulation of Structures, Institute of Structural Engineering, Bauhaus-Universität Weimar, Germany

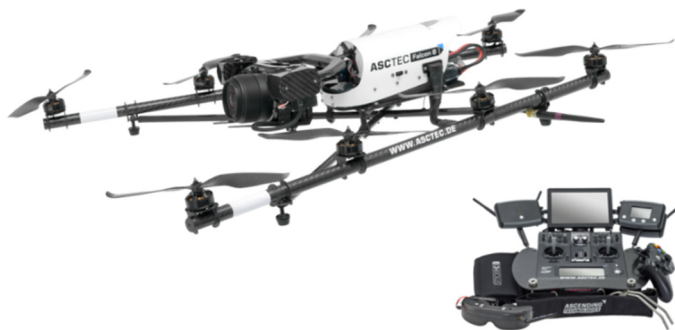
Figure 1: Flight system Falcon 8 (Ascending Technologies) of Bauhaus-Universität Weimar with Sony Alpha 7R and ground control station.

The flight system used for the investigations and case studies on heritage structures shown here was a *Falcon 8* developed and patented by Ascending Technologies (Germany) [6], shown in fig. 1.

This professional, very light (take-off weight 2.2 kg) high-end multi rotor platform with eight rotors, which are arranged on two arms in V-shape configuration, is an extremely wind stable flight system, for flights up to wind speeds of 15 m/s. The central flight control unit with the fully actively stabilised and compensated camera mount is placed in the centroid between both motor carrying arms, which allows for a horizontal angular freedom of 360° and a camera tilt of 90° up and down. This guarantees a unique field of view. The highly accurate stabilisation, positioning and orientation of the flight system is realised by a high frequency triple redundant computing unit *Autopilot Trinity*. The extreme position accuracy and stability, the redundancy of each motor-rotor combination and the *Autopilot Trinity* guarantee a maximum of safety and allow for complex outdoor and also indoor flight missions. With a payload of 750 g, it is possible to use high quality compact digital photo, video or infrared cameras. The specifications of the used camera equipment are summarised in table 1.

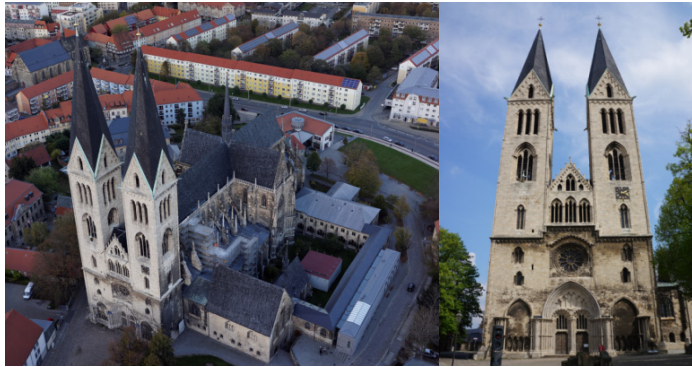
Figure 2: Aerial photo (southwest view) and ground photo (west view) of Halberstadt Cathedral.

The application of detailed visual inspection based on high quality aerial images and videos was investigated on the 1200 years old Halberstadt Cathedral, Germany, shown in fig. 2.

This cathedral with the 102 m long nave and the two 91 m high spires was built in gothic style and is situated in the historical centre of the city. The scope of investigations was split into outdoor and indoor and also in still image and live-video inspections, focussed on the roof and the façade of the spires and the interior like the wooden pipe organ or sculptures of the cathedral. The outdoor data acquisition was performed in GPS based flight mode in team operation. Each spire was recorded from bottom to top with overlapped images in a constant distance of approx. 12 m from all sides. The recording time for both spires was less than 2 hours. The data recording between both spires was the most critical part due to the short distance to the structure and the complex wind conditions (structure induced turbulences). The photos were used for aligning/generating rectified overview orthophoto mosaics of all side views for a first fast pre-check of the surface. Due to the high resolution of the several images the orthophotos allow a detailed check for even small damages on the surface. Fig. 3 top shows one sample image of these overview data recorded, left in original size and right the 100% resolution with detected damages on the slate roof. After analysing the overview orthophotos, critical parts with supposed or detected damages were investigated and recorded in detail with photos and videos in close proximity of only 3–5 m to the structure. Fig. 3 bottom shows thin cracks on the freestone masonry detected by detailed surface analysis.

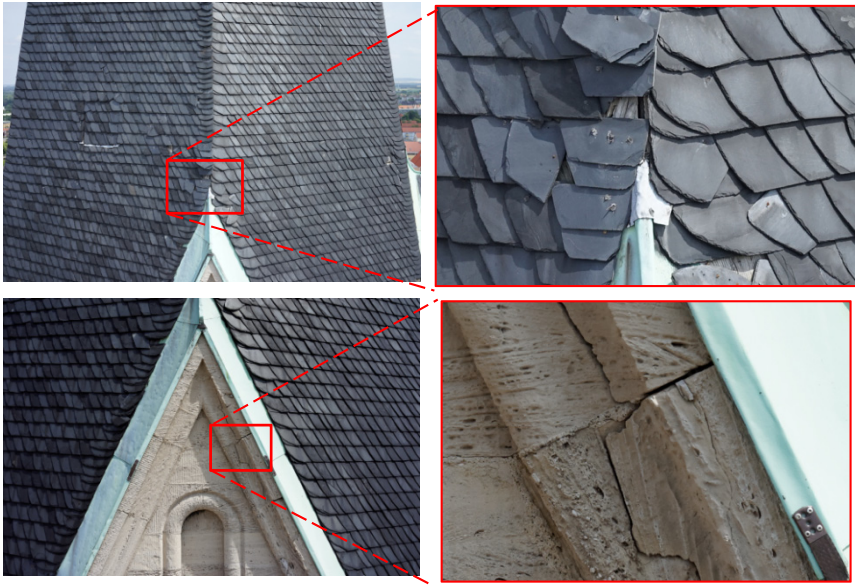
Figure 3: Roof and façade inspection results, left: original overview photo, right: detail of detected damages (100% resolution), missing slate plates and cracked freestone bricks.

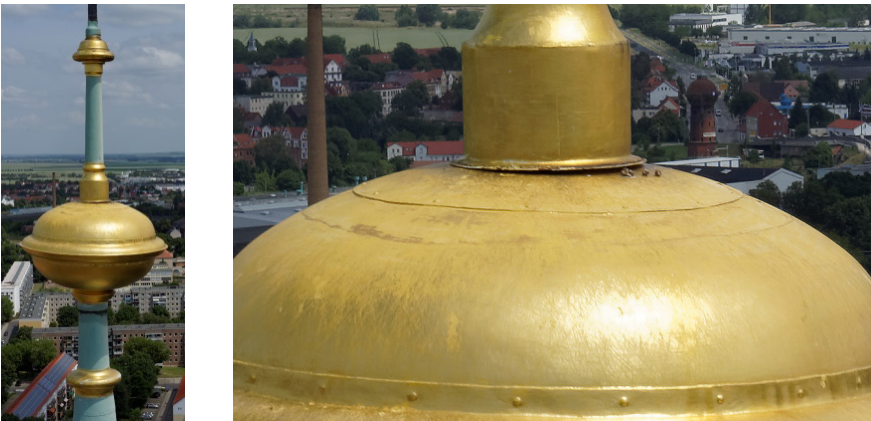
Figure 4: Spire inspection results: left sections of original photos, right: detail of detected damages (100% resolution), loose connection (uplift between bowl and cross) and damaged gilded surface.

With the use of UAS parts like the top of the spire that are otherwise extremely difficult to access can be inspected very easily and in high quality such that also restorers and conservators get helpful information for their condition assessment and restauration planning. Fig. 4 shows one result of the top spire inspection.

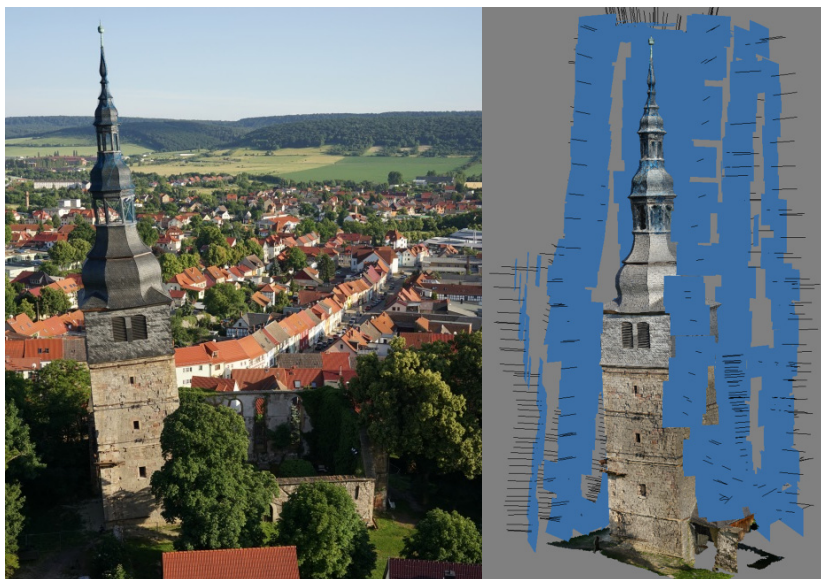
Figure 5: Left: leaning tower of Bad Frankenhausen (north view), right: reconstructed camera positions and flight path during data recording.

The image quality shown in section 3.1 leads to the assumption that such images can be used for photogrammetry, survey and 3D reconstruction of structures to obtain information about geometry parameters or deformations of the structure. This application was tested on one of the most inclined historical towers of the world, the leaning tower of Bad Frankenhausen, shown in Fig. 5 (north view).

monitoring the tower surface in detail by using dense point clouds. Conventional methods like terrestrial laser scans are limited to record the complete structure, e.g. roofs or shaded areas. The use of UAS allow for a complete data capture all around the structure. The tower was recorded in approx. 90 minutes in eight vertical flight paths with overlapped images in vertical and horizontal direction. Additionally a circle flight with vertical camera tilt to the ground was performed to capture the invisible parts of the roof. The reconstructed flight paths with the estimated camera positions are shown in fig. 5 right. The 525 images of the tower were used for UAS-Photogrammetry [8] for a geo-referenced 3D reconstruction of the tower using modern computer vision methods like Structure-from-Motion (SfM). SfM methods are used to estimate the motion of a single camera and the 3D structure at the same time. This approach allows a highly flexible image acquisition process. In a first step suitable imagery of the overlapped images of the structure must be selected by hand for the reconstruction. Based on the Scale Invariant Feature Transform (SIFT) and the RANdom Sample Consensus (RANSAC) approach robust tie points between the images are automatically extracted, described and matched to detect correspondence image pairs. The SfM algorithm is applied to recover the camera position and orientation parameters and the sparse 3D geometry. The Exif metadata were used to support the camera calibration, e.g. approximation of the focal length. All estimated parameters including the non-linear distortions are refined using a Bundle Adjustment algorithm that globally minimizes the reprojection errors within the whole image scene. Finally, a dense stereo image matching algorithm is required to recover a continuous and detailed surface. At first, the optimized interior orientation parameters are used to remove radial lens distortion from the images. Typically, a fast multi-view stereo algorithm is applied to recover dense surface models. Starting with feature-based patches as support, a polygonal mesh is iteratively computed as dense and continuous representation of the scene. Fig. 6 shows the results of the dense 3D reconstruction in the steps of sparse and dense point cloud generation and the polygonal point cloud meshing for reconstruction of the tower surface.

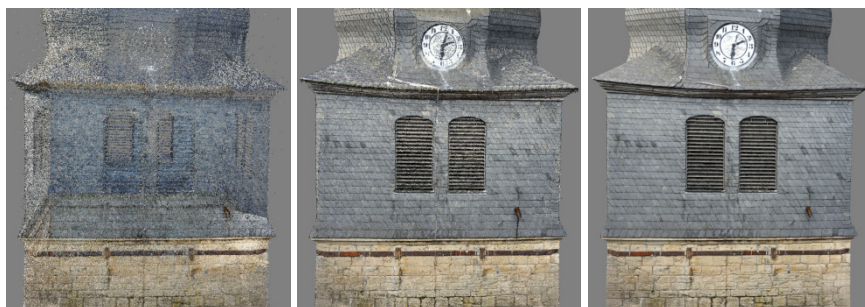
Figure 6: Detail of dense 3D reconstruction of the leaning tower using Structure-from-Motion (SfM), left: sparse point cloud (7 mio. points), centre: dense point cloud (300 mio. points), dense polygonal colour coded mesh of reconstructed surface (62 mio. faces).

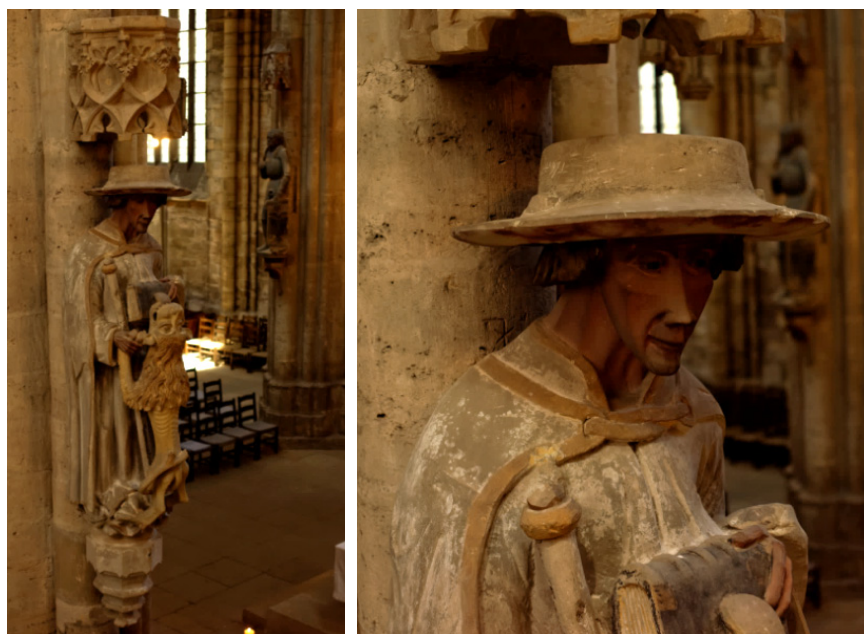
Figure 8: Image section of the original aerial photos of St. Hieronymus in Halberstadt Cathedral, Germany.

Sculptures or structural elements like the aesthetic gargoyles are very sensitive structural parts. The process of condition assessment is much more complex due to the special locations and the high sensitivity of those figures. The application of UAS based high detailed visual state determination and high accurate 3D reconstruction for maintenance or complex restorations was tested on the sculpture of St. Hieronymus in the Halberstadt Cathedral, shown in fig. 8. This sculpture hangs on an interior pier of the nave and was recorded in only one flight in 12 minutes by 180 images in a distance of less than 2 m. The photos were taken in different camera angles for an entire capture of the sculpture, though the critical light conditions (darkness) lead to a challenging data acquisition procedure.

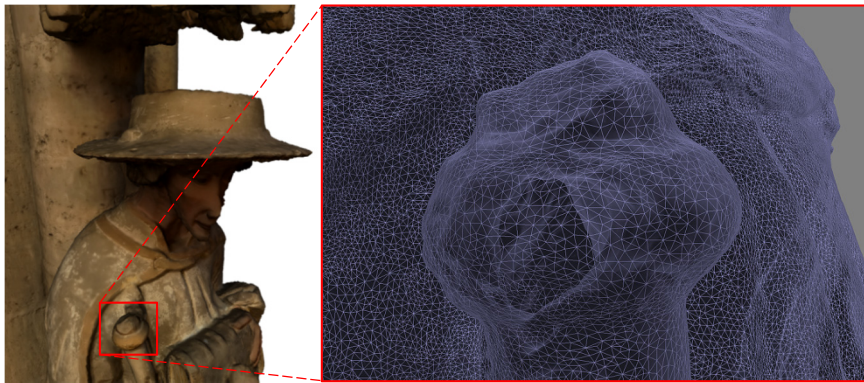
Figure 9: Left: colour fidelity dense 3D reconstruction of the sculpture (43 mio. points, 8.5 mio. faces), left: shaded polygonal meshed surface.

The 180 images with an object resolution of approx. 0.28 mm/pixel were used for a true scale and coloured fidelity 3D reconstruction using SfM methods explained in section 3.2. Based on the high resolution and a post flight quality enhancement of the RAW-images an ultra-dense RGB point cloud with more than 43 million measurement points could be generated. Using the dense point cloud for polygonal meshing the fine surface of the sculpture could be modelled highly accurately with approx. 8.5 million faces. For visualisation the high quality images were used for a textured 3D model. Fig. 9 shows a section of the reconstructed 3D model, left with the meshed and textured surface and right with the polygonal meshed surface. The achieved accuracy allows for detailed visual and geometrical analysis of the entire structure. That also leads to the concept of 3D modelling of missing, broken or damaged parts of the sculpture which could be renewed/reconstructed partial or all complete by 3D prints in original size.
