ARCHITECTURAL RENEWAL: A RISING DAWN IN ILE-IFE?

CORDELIA O. OSASONA

Department of Architecture, University of Ibadan, Nigeria

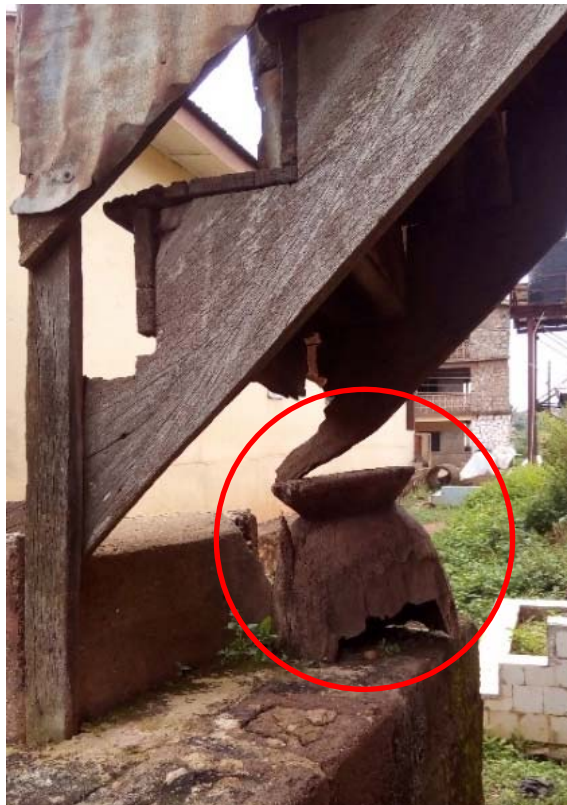
Some unique features of Lowa’s House include hardwood timber paneling of an enclosed veranda running around three sides of the first floor, linked to the ground by an external timber flanking staircase (Fig. 1). All masonry-work is of cob, with walls about 300 mm thick. This was plastered over with a layer (about 3” thick) of highly-granular cement-mortar (Fig. 2). The suspended floor is typical hardwood-timber planks on joists, spaced at about 75 cm centres, with another (internal) timber staircase linking it to the ground floor. Fenestration consists of an array of traditional windows, but mostly timber shutter panels, or slatted jalousies. All doors are wooden and paneled; the main ones are carved in ornate stylized floral-motif designs.

Figure 1: External staircase, supported by wooden mortar, at interface with plinth.

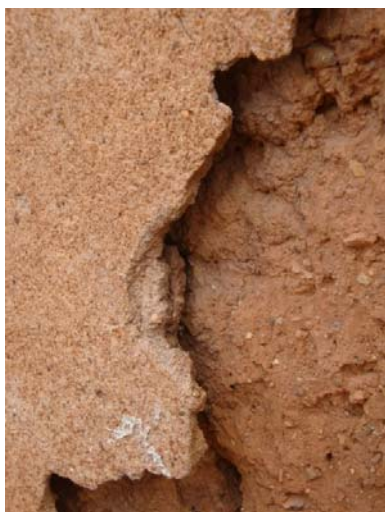
Figure 2: Deep crack in adobe wall, going into room beyond. Note extra-thick plaster-cover.

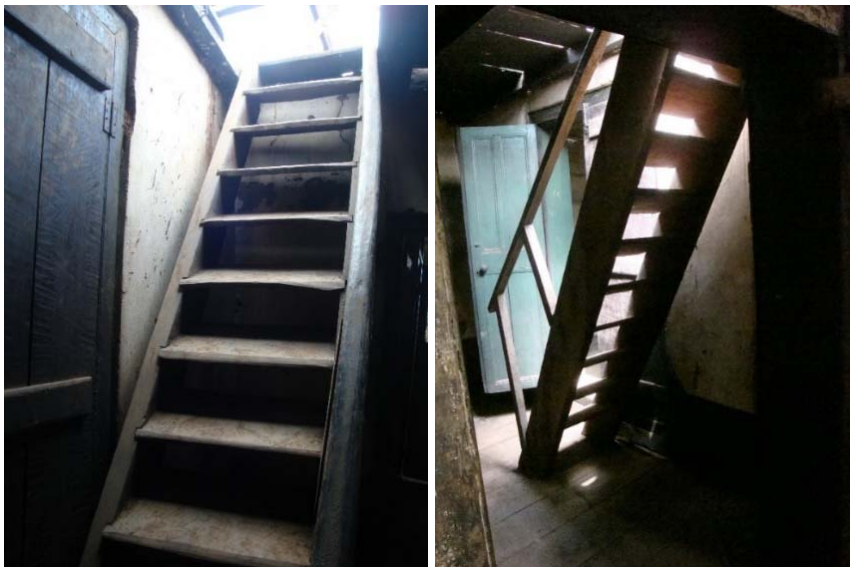
Figure 3: The attic staircase (from inside a bedroom).

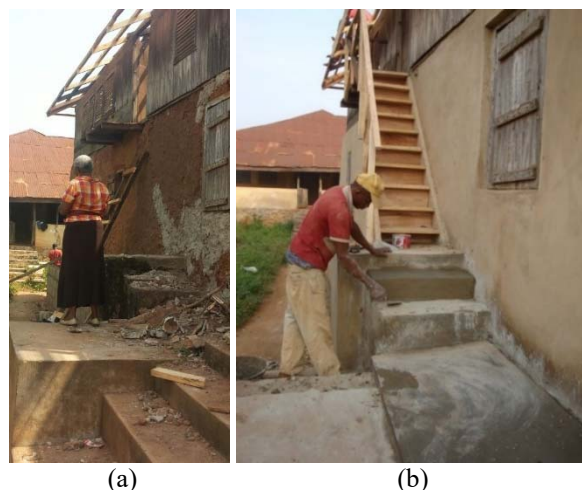
Figure 6: (a) Before re-creating the missing staircase; and (b) Ongoing replacement.

All structural defects (covering masonry-work, timber flooring, walls and staircases) have been rectified; even the missing rear staircase has been re-created; Fig. 6. The roof over the main house was overhauled, with the corrugated zinc sheets being replaced with granular-finished corrugated aluminium sheets. Windows and doors were repaired, as necessary. Attic windows were totally replaced (though maintaining the character of the previous ones).

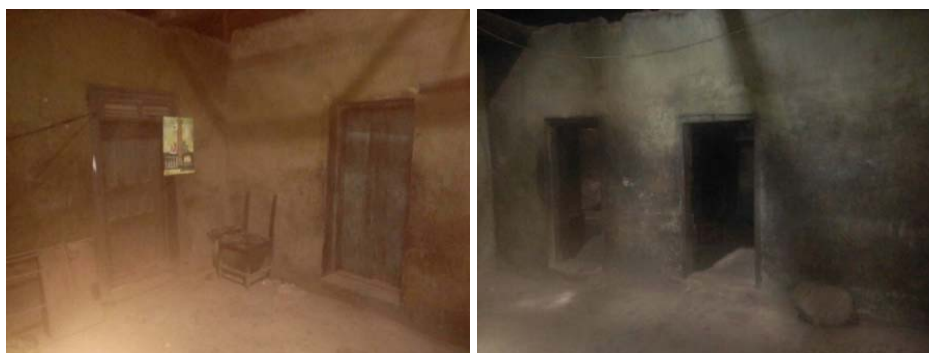
At first glance, it seemed the relatively large lobby (into which many of the surrounding spaces opened), could have been an impluvium-courtyard, once. However, at the onset of the exercise in July 2018, it was already roofed – and had been so for as long as memory served (according to Chief Odeyemi, key informant and sponsor of the intervention). Significantly, this central concourse was virtually devoid of daylighting; some light from a single Perspex sheet integrated into the roof-cladding, and through the front door (left open all day), gave weak illumination. As such, it presented a gloomy, unpleasant interior atmosphere. Fig. 7.

Figure 7: Interior views of the lobby, before the intervention.

Next to preserving interesting features of the Odeyemi House (e.g. doorframes featuring fanlights, historically significant domestic implements and paraphernalia, and artefacts related to religious observances), a major target of the exercise was to introduce an “outdoor daylight” ambient into the central lobby – without leaving it uncovered. To achieve this, early in conceptualization, it was resolved to raise the roof over this part, to service it with clerestory windows. Thus, rather than the single roof covering the spaces beneath, a two-roof system was to be introduced. This necessarily implied a complete overhaul of the roof.

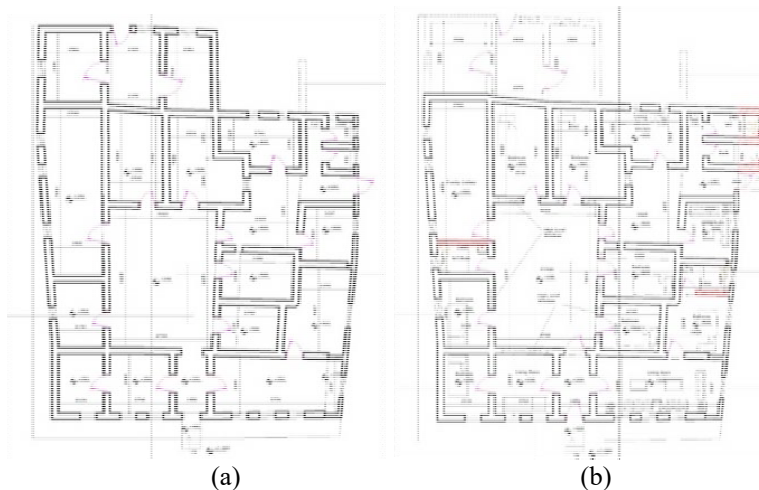
Figure 8: Floor plans of Odeyemi House. (a) Existing; and (b) Proposed amendments.

To fulfil the mandate to re-invigorate the building (and still maintain existing family relationships), partition walls were to be provided to create non-existent (or not properly articulated) in-house conveniences, and better define apartments. A functional kitchen was also to be integrated (negating traditional practices, where cooking is done outdoors, in ancillary shanty structures). See Fig. 8(b).

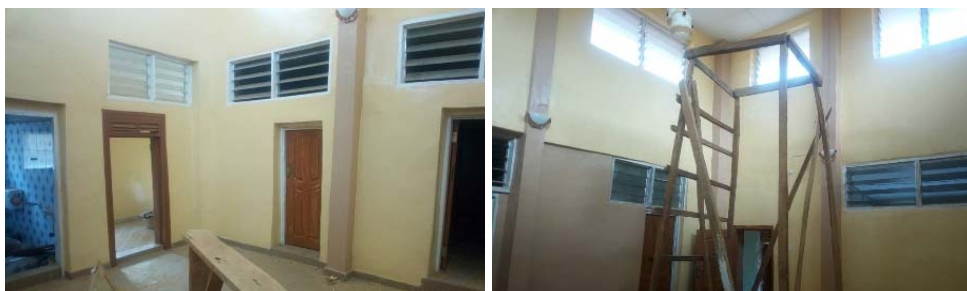
Figure 9: The well-lit, new-look atrium (lobby); work still ongoing.

The new-look Odeyemi House not only sports a two-roof configuration, it consists of a well-lit atrium (Fig. 9), bathrooms with WCs and shower-roses, a kitchen with a worktop and sink, a “gallery” (for family relics) and distinct bedrooms all tiled and painted. It was decided that, with people trooping in and out at will (and predisposed to running their hands along walls!), gloss paint should be used for walls, rather than the more conventional emulsion.

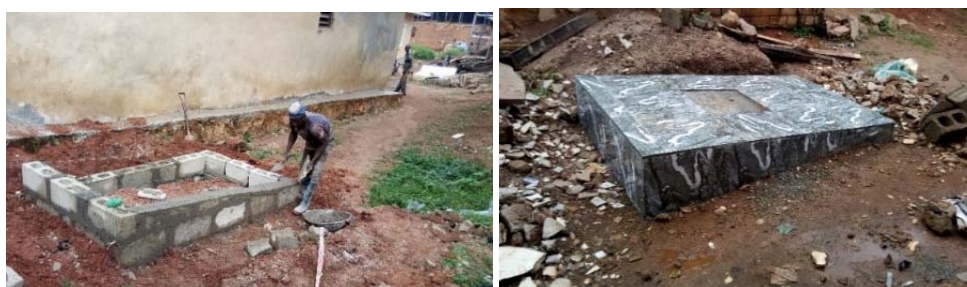
Figure 10: Ongoing refurbishing of graves of family members.

The exercise did not cover the rear apartment of the building, even though the two areas share a common wall; hence, the renewal intervention literally stopped at the interface. Also, a recent addition to the original mandate requested refurbishing of the two graves of family members adjacent to the house, to harmonise their appearance. See Fig. 10.

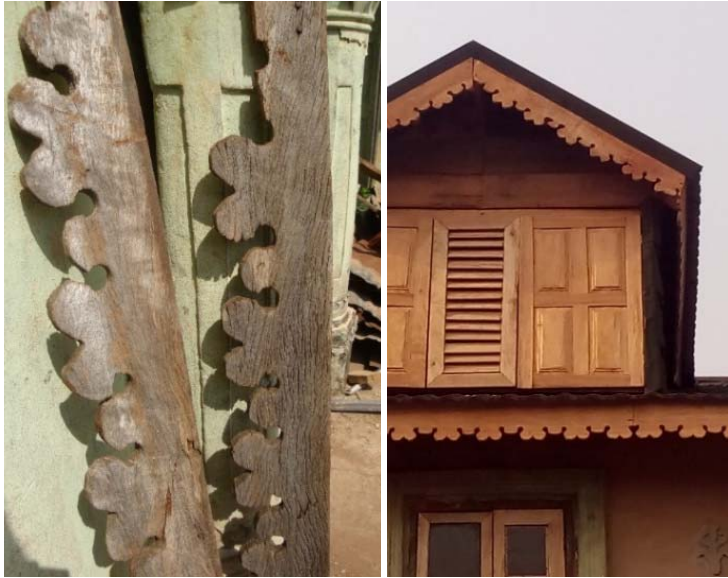
Figure 11: (a) Old (discarded); and (b) New fascias – note also, newly crafted attic shutters.

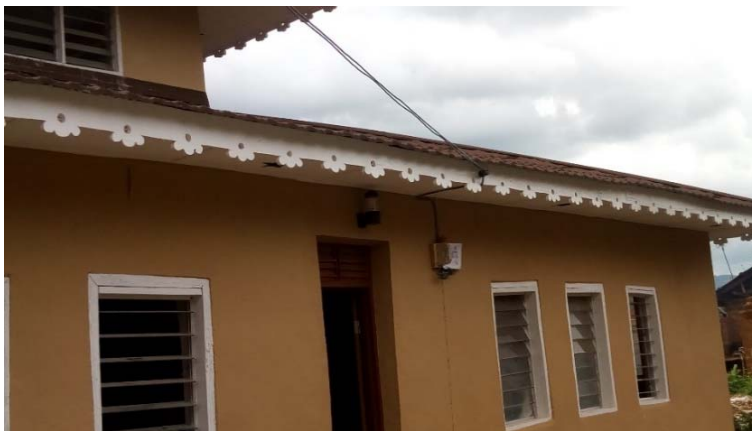
Figure 12: Fascia boards on Odeyemi House.

Certain issues were common to both projects. From a personal angle, given the fact that both schemes related to prominent Ife families (whose residences would normally be somewhat “elitist”, even in traditional times), it was an opportunity to implement some ongoing experiments in reviving the British colonially facilitated Saro and Brazilian carved fascia-board. For Lowa’s House, it was indicated, since the original roof had such fascias; some relics of this were found on the premises and, in the spirit of “restoration”, exact replicas were crafted (Fig. 11). The Odeyemi House has no such history; however, it has been provided, and has succeeded in greatly setting off the new roof configuration (Fig. 12).

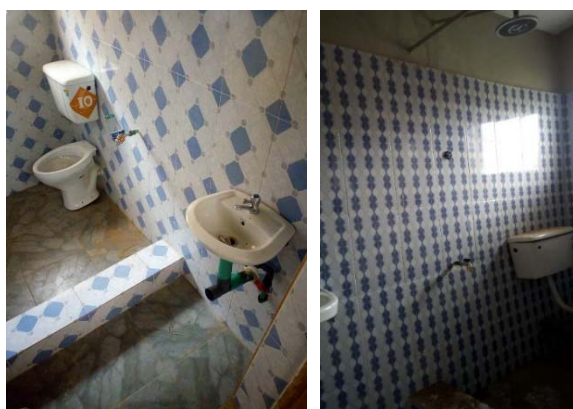
Regarding adaptations of space-use to provide in-house conveniences in Odeyemi House, there were anthropometric challenges. In two of the three provided, there was the problem of inadequate space (since the building could not be indefinitely extended). Hence, the design (to provide WC, shower and wash-hand basin) was not conventional (Fig. 13).

Figure 13: Two bathrooms, showing shower and WC in same enclosure, with wash-hand basin adjacent; plumbing works still ongoing.

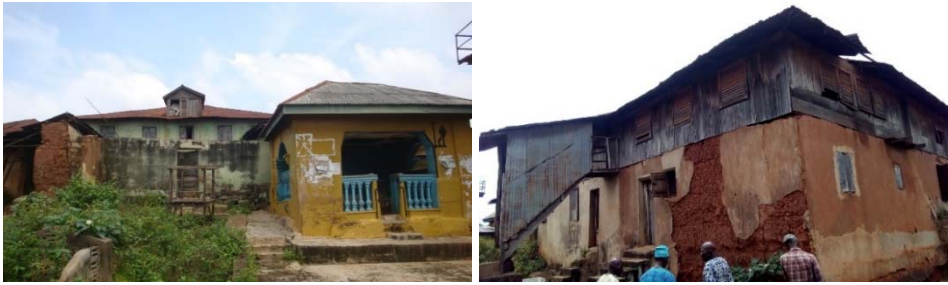
Figure 14: Lowa's (Omisore) House, at inception of project.

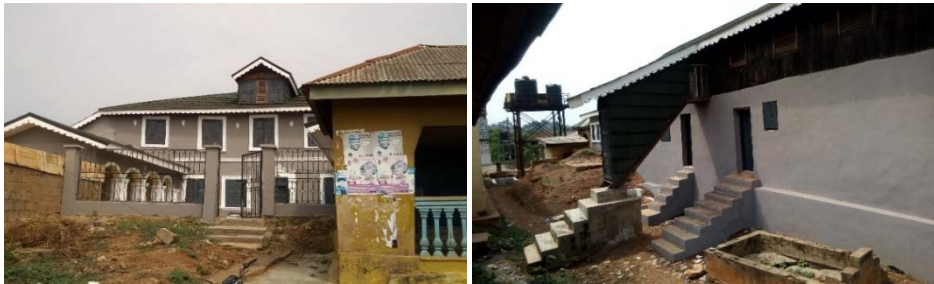
Figure 15: Lowa's (Omisore) House, close to completion.

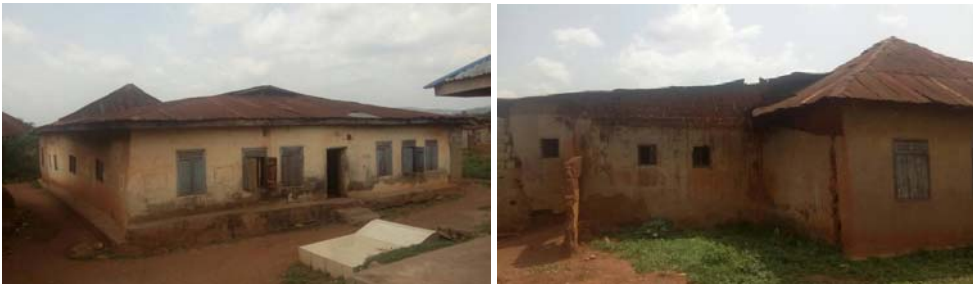
Figure 16: Approach and rear views of Odeyemi House, before the intervention.

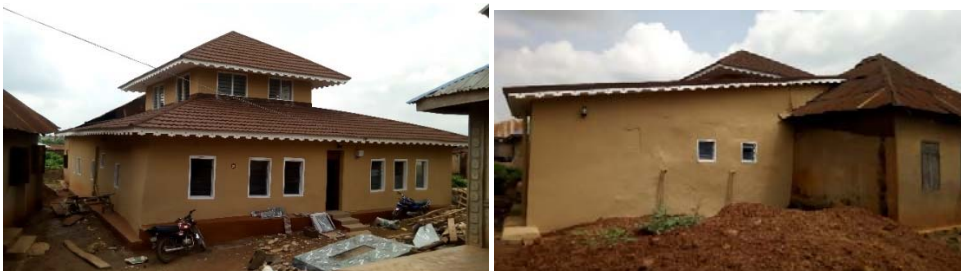
Figure 17: Approach and rear views of Odeyemi House, intervention nearing completion.

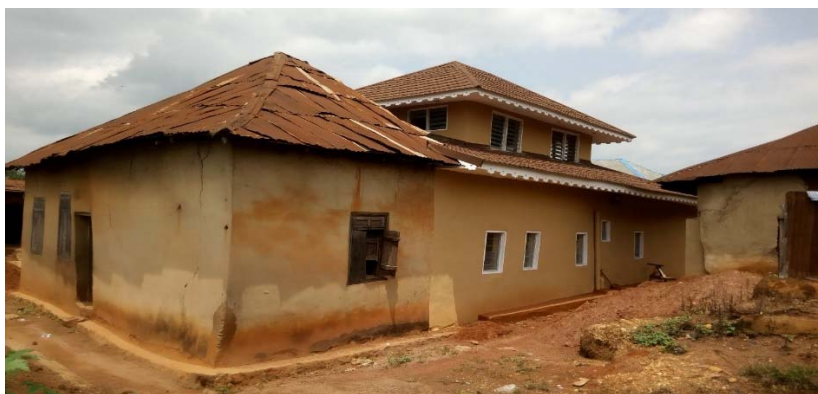
Figure 18: View of rear of Odeyemi House, showing clearly where the intervention stopped.
