MONUMENT OF LUDOVICO ARIOSTO IN FERRARA, ITALY: CONSERVATION OF ARCHITECTURAL SURFACES AND STRUCTURAL CONSOLIDATION

ABSTRACT

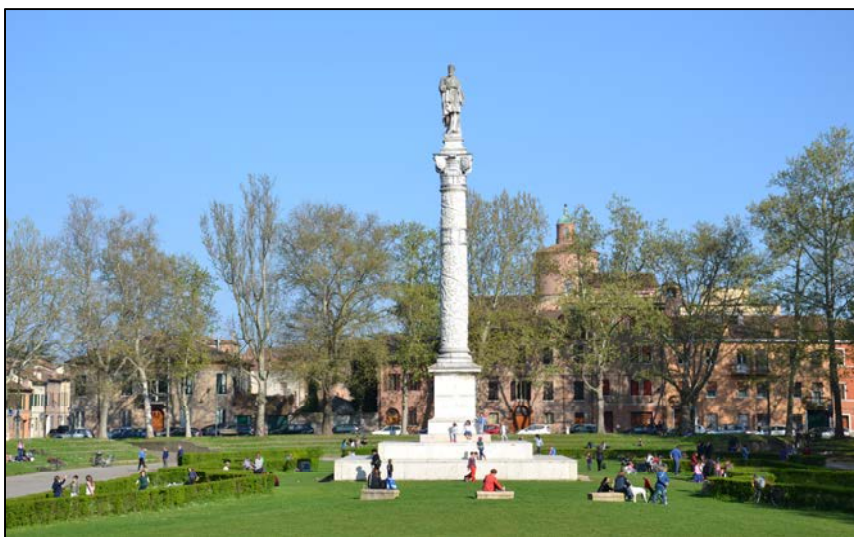
The Monument of Ludovico Ariosto, located in the centre of Piazza Ariostea in Ferrara, is composed of two large steps, a pedestal, a monolithic column and the statue of the poet placed on top, with a total height of 21.2 m (Fig. 1). The restoration project of this Monument, commissioned by the Municipality of Ferrara, involved the conservation of various stone surfaces and structural consolidation.

Figure 1: Monument of Ludovico Ariosto in Piazza Ariostea before the restoration works.

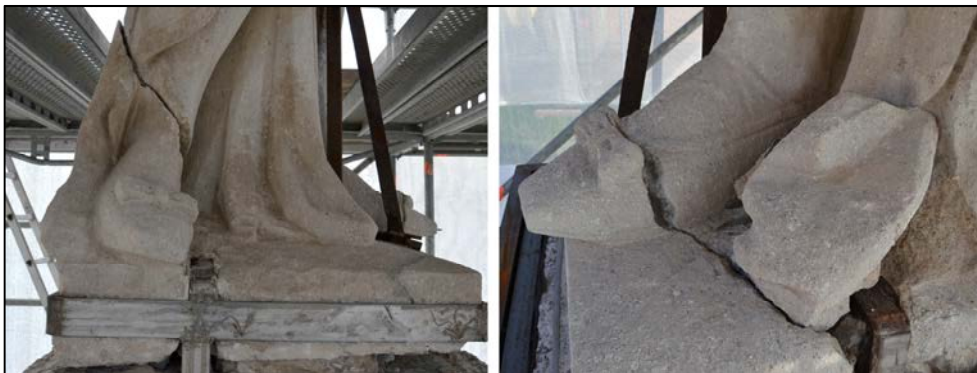
The statue of Ludovico Ariosto had particularly detached at the base due to the forward positioning of the bust. This problem had probably already been observed in the past considering the metal reinforcement to support the statue. However, today it appears to be ineffective and not well consolidated (Fig. 3).

Figure 3: Statue of Ariosto disconnected at the base after cleaning the stone and removing the cement mortars.

To be able to carry out this operation, it was necessary to lift the statue together with each stone element comprising the podium and the capital. This issue was the most complex one because of the lifted elements degradation and because, to prevent any loose of material, the lift framework was not inserted in the stone using a friction based application.

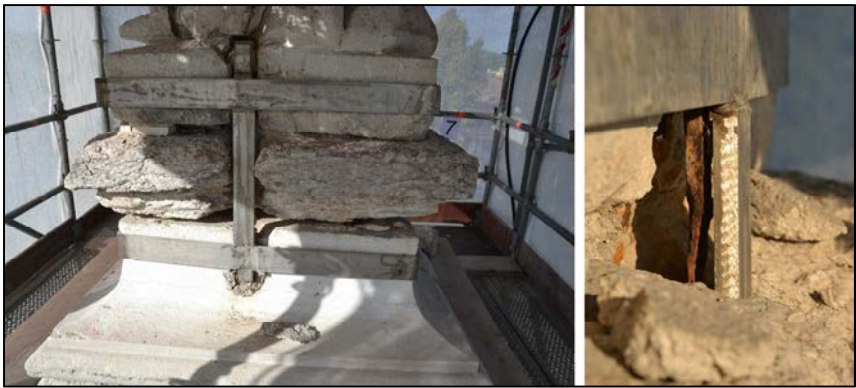
The area of the podium, between the statue and the capital, is composed of several elements that constitute a wall of square stone elements which, following the deterioration of the connectors, have gradually become disconnected. Probably with the aim of reinforcing the various elements, a modern external metal support ring in stainless steel had been inserted and welded to the internal metal elements, causing accelerated oxidation (Fig. 4). By analysing the cracks in the podium, an opening can be observed in the lesion, causing its upper part and the statue itself to incline. This phenomenon can be traced back to the jacking effect of the internally oxidised metal, particularly at the internal anchorage which has caused the discontinuity between the connectors to open up.

Figure 4: Podium of the statue. The external metal support ring in stainless steel has been welded to the damaged parts, accelerating oxidation.

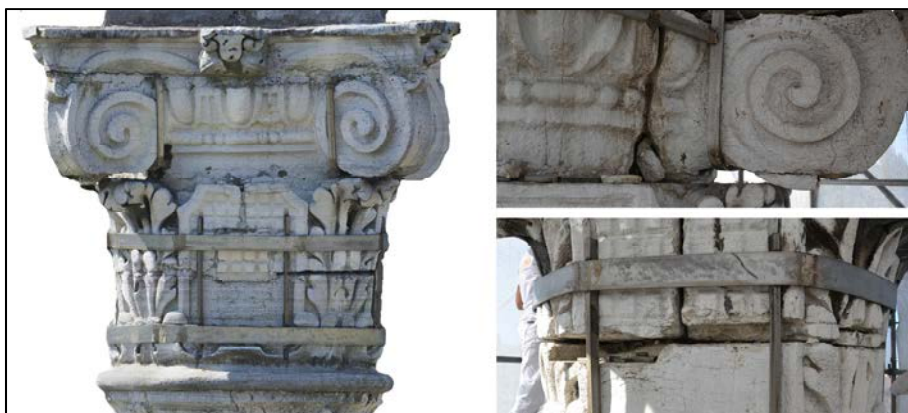
The capital of the Ariostea column is made up of a series of four elements placed on top of each other, each of which constitutes various stone elements, positioned on the monolithic shaft (Fig. 5). Each stone element had detached with cracks a few centimetres wide (Fig. 6) due to the stone jacking caused by the expanding metal inside (Fig. 7).

Figure 6: Capital of the column before the restoration works.

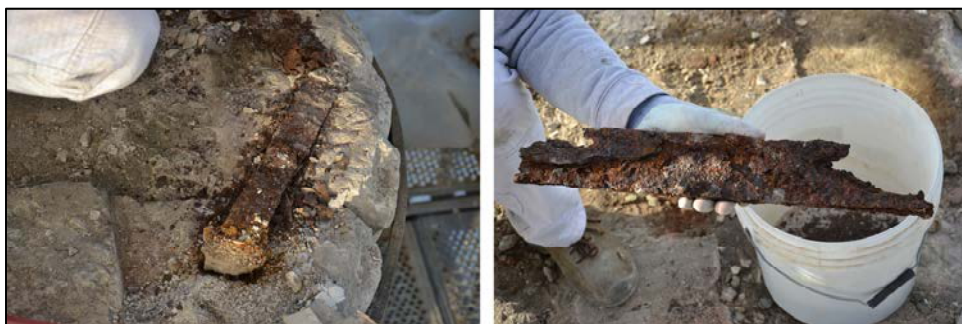
The site investigations were carried out during the planning phase and revealed that the metal parts had suffered the greatest deterioration due to corrosion effects. The corrosion produce a significant increase of volume [7] that could be between 3 and 6 times the original volume [8] and this led to cracking and movements of stone parts. Although without measurements or monitoring in time, the corrosion was evidently more severe where coupled between two steel types. Indeed, two types of metal were used for reinforcement: normal steel, adopted in the past, and stainless steel, used in interventions that are more recent. The connection between these steels caused a cathodic oxidation effect which had accelerated and amplified the erosion of the traditional steel. These damaging mechanisms, triggered by metal oxidation, constitute, from a structural point of view, the most significant problem encountered in the whole monument, with the most compromised parts being in the podium of the statue and in the capital. The high chemical force developed by oxidation causes many fractures and cracks in monolithic blocks and produced many deformations in structures.

Figure 7: Oxidation of the internal fixtures between the parts which define the individual stone elements of the capital.

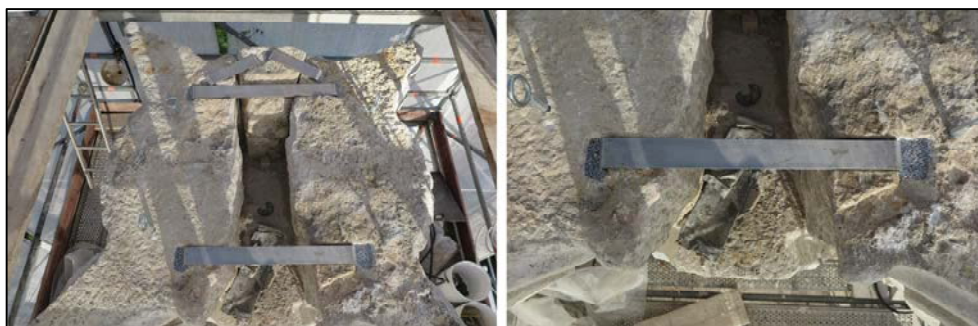
Figure 8: New cramps in duplex stainless steel connecting the various elements of the capital.

First ideas of interventions aimed at introducing substitutable metallic materials from outside because the substitution of such corroded elements in this work had been very expensive, it required the controlled disassembly and this might lead to damages on the structure, therefore, this substitution should be as much as possible avoided in the future. Those solutions were discarded because the loosening of the material was too relevant for a respectful restoration. In light of these observations, all the internal metal elements were replaced with new duplex stainless steel connectors of the same dimensions as the existing carbon steel ones and placed in the same positions (Fig. 8). The major initial cost of this special steel will be recovered in the major durability of the intervention moving forward the need for their substitution. Moreover, a consolidation with glass fibre reinforced bars was adopted to connect cracked blocks.

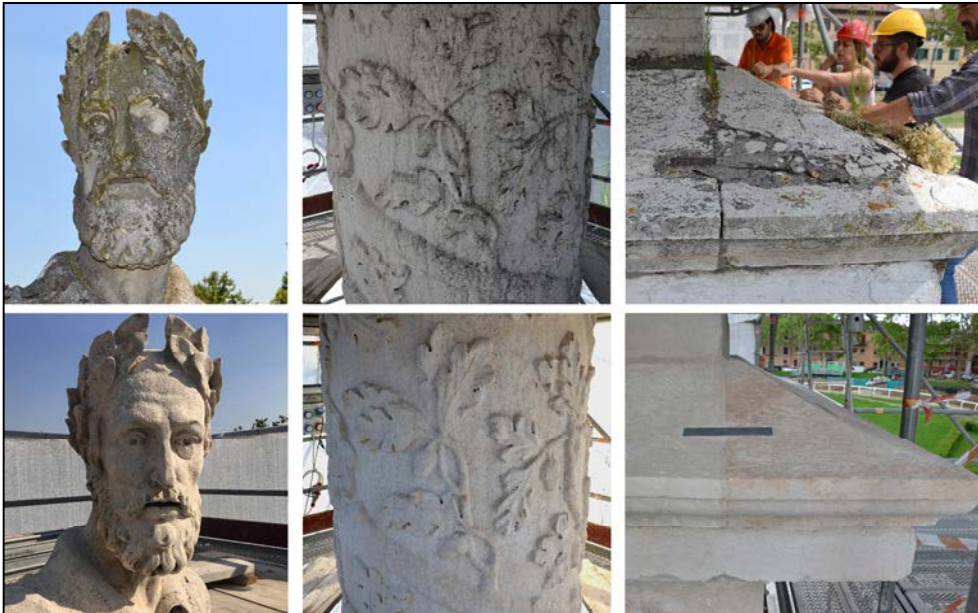
The monument presented widespread superficial deterioration caused by exposure to weather conditions and pollution. In particular, rainwater running from the top of the statue to the pedestal of the column had caused erosion, favouring the formation of biological patinas and the accretion of superficial deposits. There was a protective lead covering on the top of the capital, which was in such a poor condition that it had allowed rainwater to collect instead of letting it flow off the statue. In addition, the metal element, now oxidised and irregular, had altered the appearance of the top of the capital. The project involved removing the oxidised sheets and creating a more compatible system to allow rainwater to drain off the monument. A screed of breathable mortar was applied across the whole of the top of the capital with a slight inclination to help the rainwater run off and it was applied as thinly as possible so as not to alter the perception of the top of the capital. This was then covered in a sheet of lead.

Figure 10: Operations to clean the surfaces of the statue, shaft and pedestal.

The architectural surfaces were cleaned using biocides, clay poultices and manual techniques to remove superficial deposits, incrustations and the presence of biological staining. The incompatible elements were also removed (metal cramps and cement mortars) and the cracks and gaps were filled using special natural mortars mixed up on the site. They were then treated superficially with a thin coating (Fig. 10). As a final operation, the whole surface of the statue was treated with protective products, in particular to protect it against graffiti.

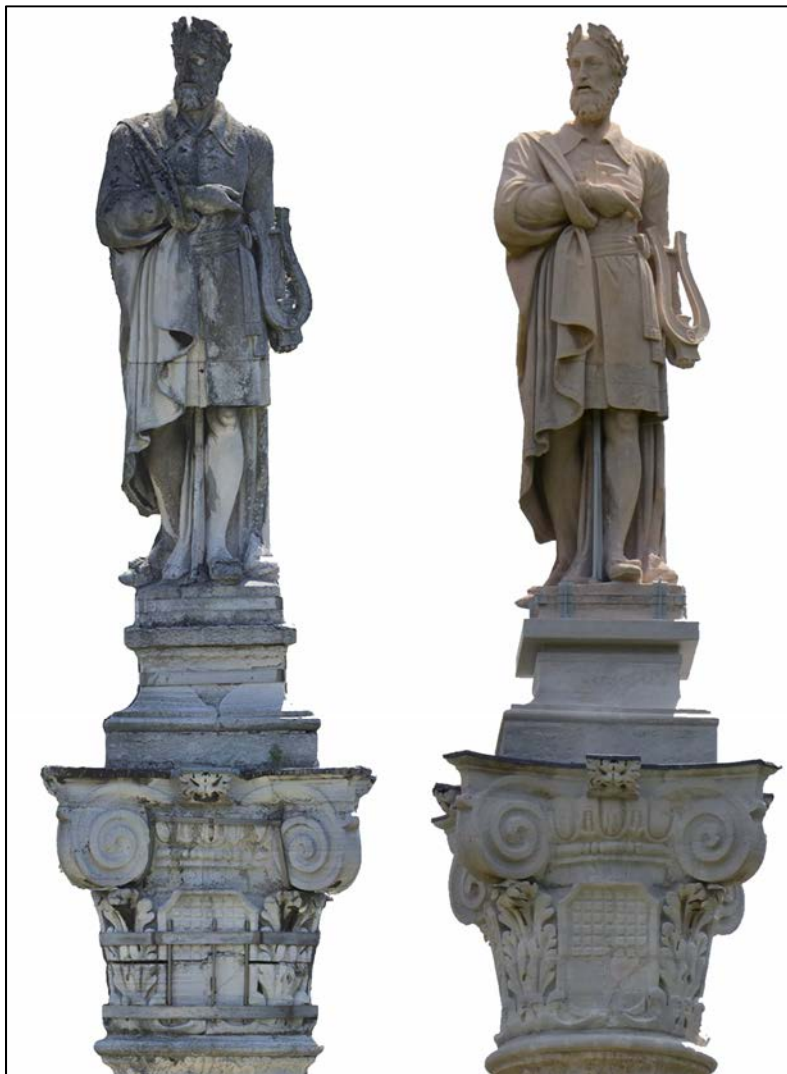
Figure 11: The capital, the podium and the statue before (left) of the restoration work and after (right).

The objective of returning the monument to the community, which required both structural and superficial restoration, was pursued through a circular process of understanding and conservation, and was fulfilled based on critically evaluated choices to recuperate the monument's visual unity and consequent capacity to reveal itself in each and every one of its elements: "la esigibilità del monumento" (Fig. 11).
