# TRACES AND SCARS: THE RECONSTRUCTION OF MADRID'S CIUDAD UNIVERSITARIA AFTER THE SPANISH CIVIL WAR

JARA MUÑOZ HERNÁNDEZ & JOSÉ LUIS GONZÁLEZ CASAS  
Universidad Politécnica de Madrid, Spain

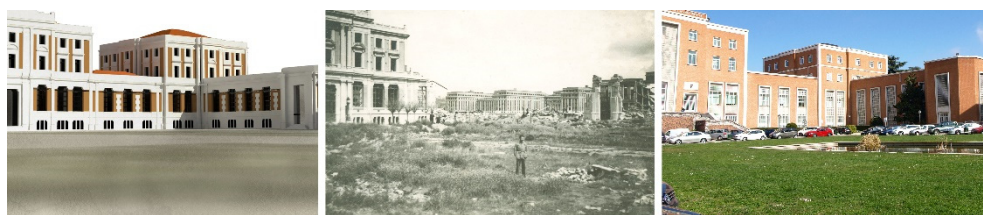
Figure 1: School of Agriculture Engineering in 1930, 1939, and 2015. (Source: Drawing: J. Muñoz. Old photography: Escuela Técnica Superior de Ingenieros Agrónomos. Current photography: J. L. González.)

Afterwards, a time comparison has been made for each building existing in the campus before the war, using drawing or photography – as explained above – depending on the case (Fig. 1). We have detected different ways of reconstruction according to which the buildings have been classified. Due to the limited length of this text, we offer here only some examples of each case. However, a summary table with every building is included at the end.

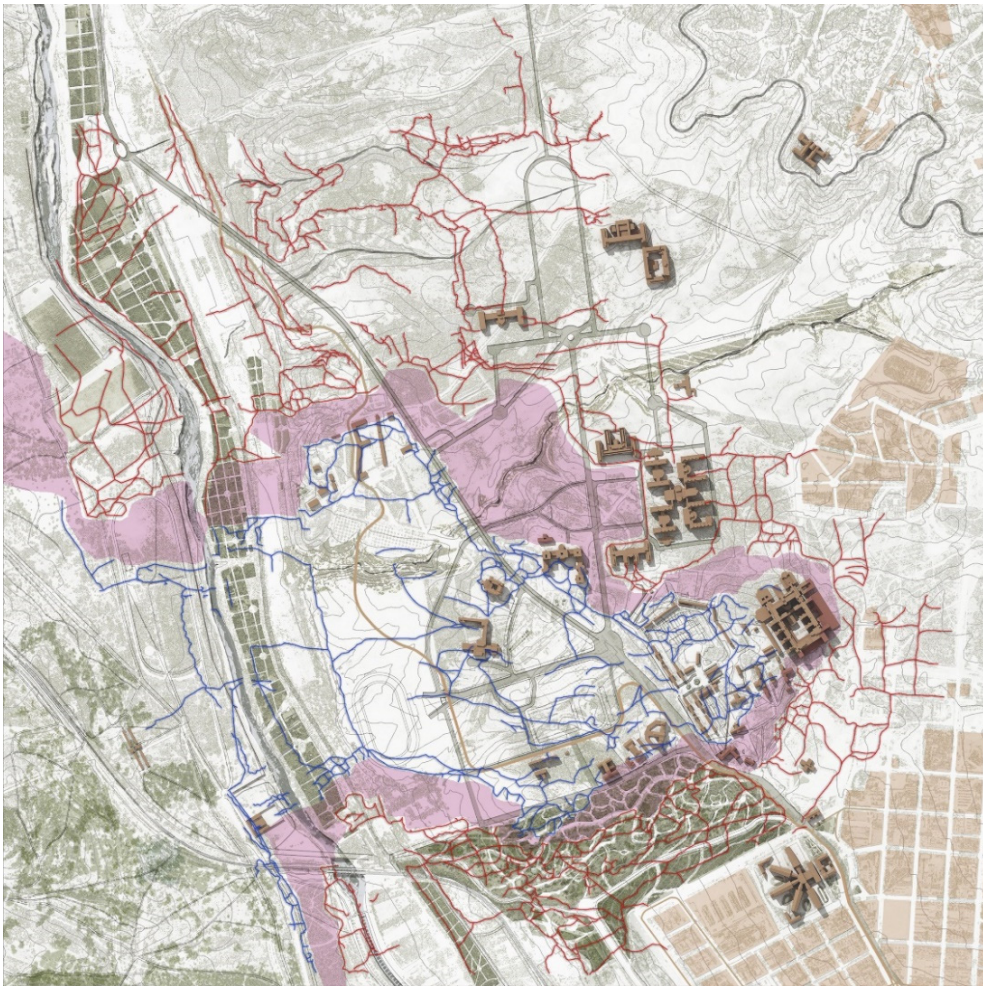
Figure 2: Location of the trenches within CU. In red are the trenches corresponding to the Republican army and in blue are those corresponding to the rebel army. In mauve, no-man's land. (Source: Drawing by the authors and L. Mauleón.)

The positions remained basically stable during the rest of the war. In the planimetry (Fig. 2) one can observe with great precision the Francoist regime's front – that set its headquarters in the School of Architecture – from which they connected with their positions in the School of Agricultural Engineering, La Moncloa Palace, Casa de Velázquez, the edge

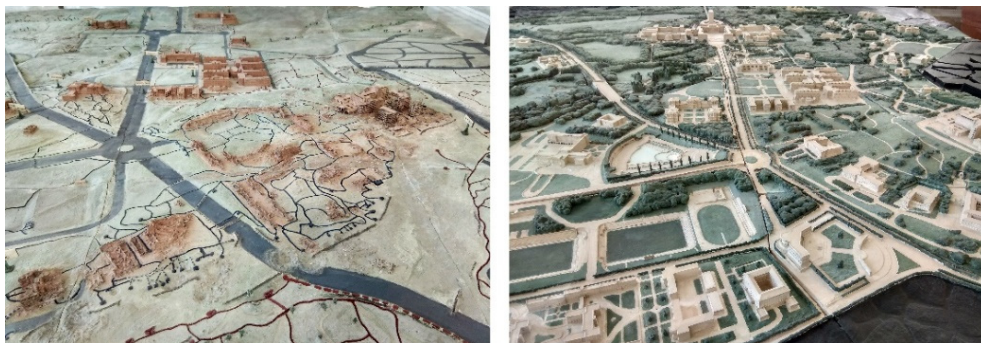
Figure 3: Left, CU's model at the end of the war, 1943. (Source: Army Museum. Ministry of Defence.) Right, CU's model with its ideal reconstruction plans, 1943. (Source: Universidad Complutense de Madrid.)

However, just to mention a last aspect regarding this debate, we may have a proof of that will to maintain that state of ruin in one of the two models that were carried out after the war to show the state in which the CU ended. The detailed materialization of this object 5.30 x 4.05 m big, was part of an evident propaganda manoeuvre since one could confront this one to the model of the reconstructed campus. Nevertheless, it could also well be an underlying intention of leaving, at least, a permanent reminder of those ruins at a smaller scale.

The other large model was built in 1943 for the inauguration event. This piece made out of plaster 5.4 x 5.1 m big, is an example of the symbolic value that the Francoist regime gave to the reconstruction of the campus. Even though at first it could seem to have been built after the other one, last evidence show that they have been carried out basically at the same time. This second model aimed to show how the new reconstructed CU would be. This way, whilst the first model shows an actual state of the campus at a certain moment, the second shows an ideal of what they wanted it to be more than what actually was finally built.

Today, these two models (Fig. 3) can be seen in the hall of the Faculty of Medicine within the campus of the Universidad Complutense in Madrid (UCM).

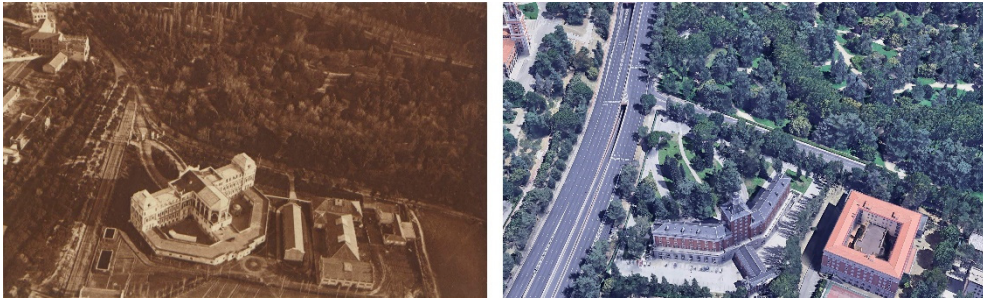
Figure 4: To the left, an aerial view of the Institute of Hygiene, 1936. (Source: *Nuevo Mundo. Biblioteca Nacional de España.*) To the right, a current aerial view. (Source: *Google Earth.*)

The best example of this is the Institute of Hygiene, on top of which the José Antonio Student’s Hall was erected, the rectorate at present (Fig. 4). It does not preserve the architectural style nor the use of its predecessor, but it is however located on top of the old building, probably making use of part of its foundations. That is why, after examining – in a very detailed way – the floor plan, we find that this plan holds great similarities with the back volume of the Institute of Hygiene with its “open arms”, something which we would have never thought about if we had only looked and compared the photographs of the buildings. The Del Amo Student’s Hall is another building which would disappear during the war since it was located really close to the front line. In the post-war period, a new student’s hall would be built on that same plot. This building would have very scarce similarities – stylistic or formal – with the preceding one. One last case which is definitely worth mentioning, is La Moncloa Palace, on top of which a completely new building was erected, the palace we all know today and where the Spanish Government Headquarters is located.

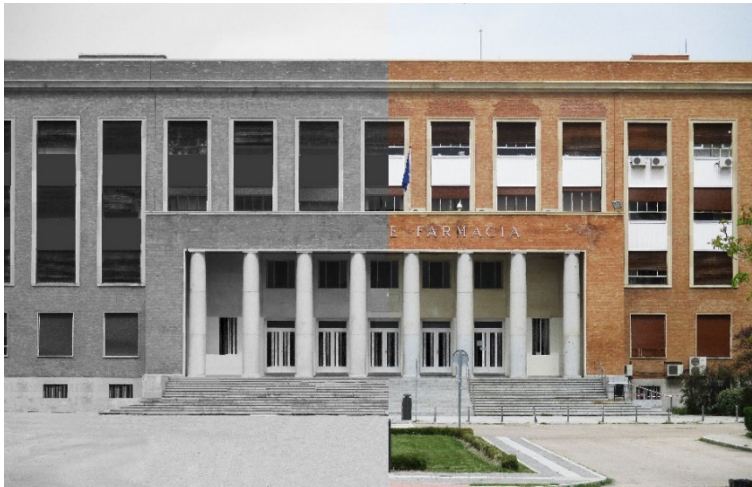
Figure 5: Façade of the Faculty of Pharmacy in 1936 and 2018. (Source: *Photographs by the authors.*)

These buildings were basically finished before the war. The medical campus was placed at the very front line during the war, reason why it suffered important damages which especially affected the Faculty of Odontology because of its forefront position. The other two faculties also suffered damages in their southern and eastern façades.

As a consequence of the repairs of the damaged areas, one of the main changes that can be observed in the façades is the use of a different sort of brick than that used in the initial project – with a different quality and a different tone – which generates a clear contrast at a glance, slightly altering the unity of the façade. In terms of use or interior distributions, there are no dramatic differences between the projects. Since a large part of the building was constructed prior to 1936, it was kept intact. Years later, the decision was made to paint white the metal elements located between the windows, breaking that sensation of verticality which those dark areas – joined with the glass openings – gave the façade and which contrasted with the strong horizontality of the complex, as can be seen in the edited picture (Fig. 5).

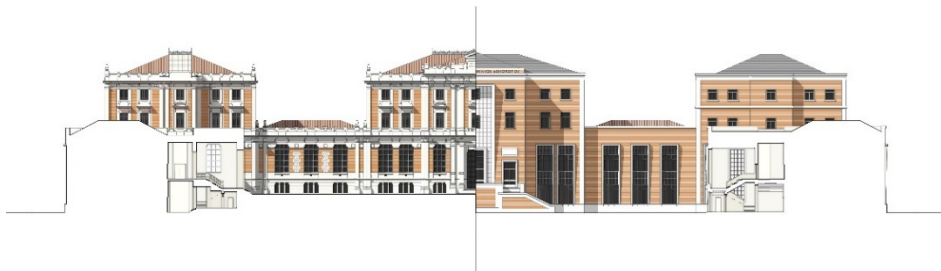
Figure 6: Façade of the School of Agricultural Engineering in 1936 and 2019. (*Source: Drawing by the authors and A. Bonet.*)

When the war was over, the original building of the School remained almost entirely in its central volume and western wing while the eastern wing had completely disappeared. When the faculty was reconstructed, the decision was to erect the original volume, but changing its façades, a decision however which was not apparently that clear from the beginning. This can be seen in the reconstruction model dating 1943, where the School of Agricultural Engineering is complete and both side wings are symmetric with their original façades. Also, the first repairs to be able to use the building again followed the original design (plans conserved in the Administration’s General Archive, 31-05500 and 31-05513).

Finally, the choice was to reconstruct the same project but changing its skin. Thus, the eastern wing was erected completely, the destroyed part of the central body of the building was reconstructed and the western wing was finished. The interventions carried out concerning the rest of the building included eliminating the orders of the columns of the façade, and also covering the façade with a new skin made out of brick. The size of the openings was also modified, and any type of ornamentation was eliminated (Fig. 6). Nevertheless, it is important to notice that the current building is not the same – if we take a look at the floor plan – than the original one as it is thought to be. Both side wings are shorter than they originally where. It is likely that as the La Coruña highway got wider, the direct consequence was that the building had to become smaller. However, it is also true that it could also have well been just a question of budget.

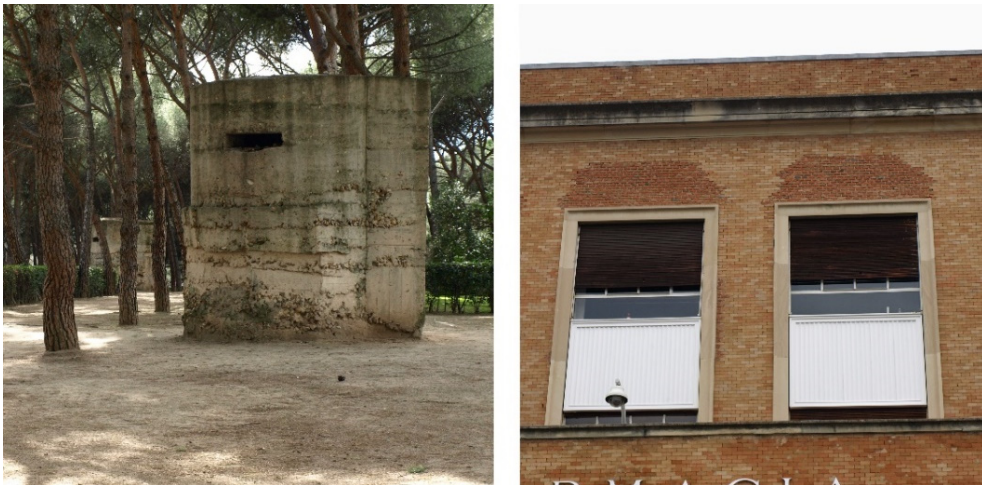
Figure 7: Bunkers in Parque del Oeste. Façade of the Faculty of Pharmacy. (Source: photographs by the authors.)

On the one hand, as a remain of constructed elements, we find the striking three bunkers located in the Parque del Oeste. They were carried out by the rebel troops during the last year of the war to consolidate the Frontline. Their quite good condition allows us to see the inscriptions done on them by the soldiers (Fig. 7). Although less visible, other constructed elements are the remains of the old trenches. In certain areas, what seems to be the natural topography of the place is actually the consequence of the digging of trenches. In the last years, some of them have been excavated, revealing abundant war material [8].

On the other hand, there are still many destruction signs in the damages caused by the impact of projectiles against various buildings and constructions. The ones which are most evident are those found in the granite plinths of the faculties of Philosophy, Medicine, Pharmacy and Odontology. The diameter and depth of the marks are a clear proof of the great variety of weapons used during the war. Also some of the reparations on the buildings do give us some clues. For example, the bricks with a more intense colour of the Faculty of Pharmacy are the evidence of the impacts which do not prevail (Fig. 7). Finally, the Faculty of Medicine is one of the few buildings where one can still see today impacts directly on the brick of the cornices. It is also very revealing that the western orientation is considerably more damaged than the rest of them, since it makes it clear that the enemy fire came from the School of Architecture.
