BUILDING RENEWAL: THE CENTRALITY OF EVENTUAL OCCUPANCY IN DESIGN DECISIONS

CORDELIA O. OSASONA

Department of Architecture, Obafemi Awolowo University, Nigeria

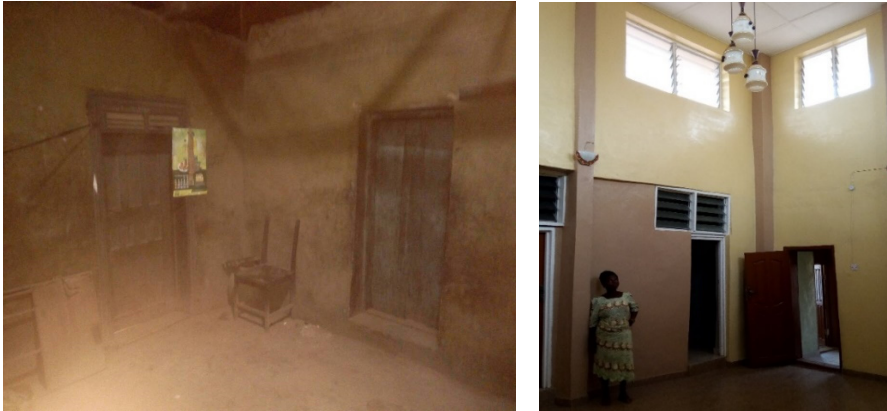
Figure 1: (a) Hall at Lokore house, before renewal; and (b) After renewal; lighting facilitated by clerestory.

Rather than clerestory windows (employed at Lokore, by creating a secondary roof-system), this mandate was realised by the use of a skylight. Fig. 6 shows its efficacy.

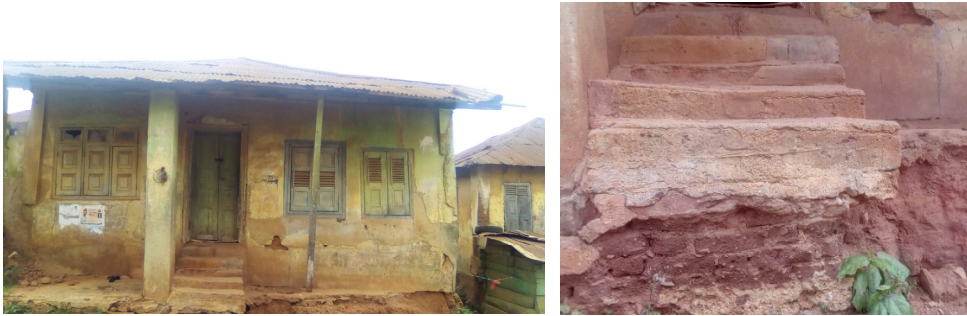
Figure 4: (a) Frontage of Agbedegbede House before renewal; and (b) Close-up of eroded plinth and steps leading into the building, 2020.

and according it due recognition. It was common practice for this slab to serve as a safer way to connect with the entrance stairway, much of the lower part of which had been eroded away over time. In addition, it served as a relaxation area for neighbourhood layabouts (who routinely brought plastic seats from a drinking “joint” across the road, and ensconced themselves there). Fig. 4(a) and 4(b) show the frontage of the Agbedegbede House before the renewal exercise. In addition to the public sewer, there is a lamp-post at the front of the house – broken and non-functioning.

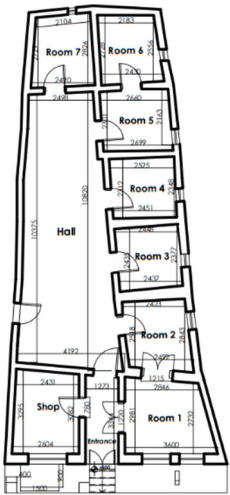
Figure 6: Existing floor layout.

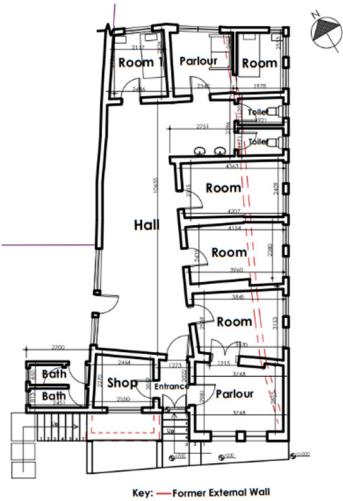
Figure 7: First proposal.

Figs 1, 2 and 4 show the progression in attempts at resolving this. Squaring off the right-hand side of the building from the frontage to the rear, automatically enlarged the rooms, six of the existing seven being in this wing. As such, this measure was immediately adopted in the (initial) design proposal. However, as soon as digging up the new foundations for this extension started, work was abruptly stopped by an extended family member. She claimed there were graves in the intervening space between this flank and the building adjacent to it – despite there being no visible evidence at ground level! This notwithstanding, the assertion was soon verified as being true. It resulted in this design being abandoned, and a return to the original constraining walls and undersized spaces. Nevertheless, alternative spaces were created, while some existing ones were re-assigned (see Fig. 4).

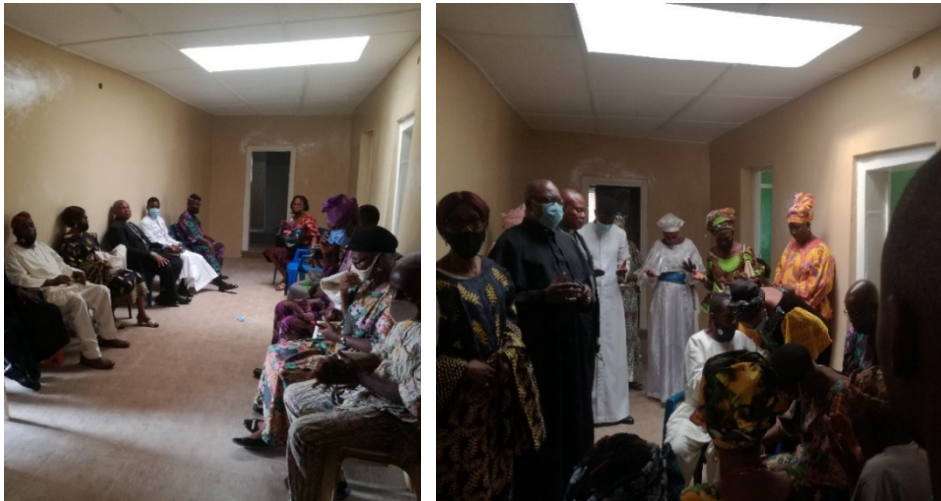
Figure 10: The hall at Agbedegbede, during the formal “opening ceremony”. (a) Waiting for the sponsor; note the effectiveness of the skylight; and (b) Special prayers by clergymen (Saturday, April 3, 2021, 3.30 pm).

In recognition of the sheer size of this hall needing to be naturally lit (and the fact that the area devoted to sky-lighting would necessarily be limited), the design sought to introduce additional day-lighting from alternative sources. High-level lighting (above the alternative door into the house) was integrated into the design. However, the major supplementary lighting was to be provided from the bathroom area – a new wing added to substantively provide this facility to the residents. To optimise the effectiveness of the fenestration here, doors (into the kitchen, and out from there into the showers) are totally eliminated. This was deemed acceptable as, from the viewpoint of tenants, there is no personal, sentimental attachment to the (communal) cooking area. This understanding also informed even the way shelving has been provided in the kitchen cabinet: nothing of any personal value will ever be actually stored in an all-comers facility.

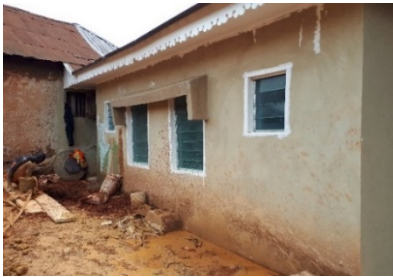
Figure 11: Unpainted north-western flank; ongoing well-works to the left.

With respect to the issue of providing mechanical services to the building, this restriction on all sides has proved a big challenge. The conventional septic-tank/soakaway-pit arrangement could not be invoked; even inspection-chambers had to be ingeniously situated and crafted. However, recourse was made to the use of a combined “well” septic-tank-soakaway pit. The provision of water is currently underway on the northwest flank, close to the alternative entrance to the house; a well is being dug – after successful overtures to hitherto hostile members of the extended family. Since there is no public water utility in the area, this will be a community benefit – just like the one at Lokore is currently being.

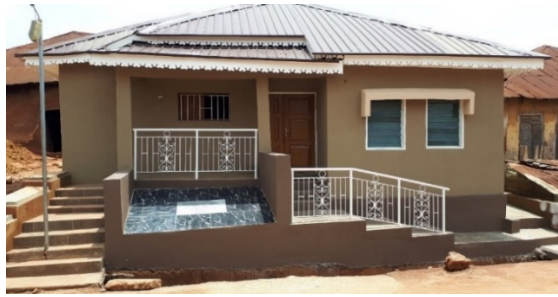
Figure 15: Front façade of Agbedegbede House, after renewal. The stairs to the left lead to the sales veranda; those on the right, lead to the main entrance of the building, April, 2021.

A shop had been part of the existing design. Strategically positioned at the frontage of the house, it had been a tailor’s shop; however, the entrance had been through a side wall – after essentially gaining access into the house, first. As part of the modern-day clear resolution of circulation pattern, this arrangement has been changed (more so as the retail trade is more identified with a home-base, today, than services). As such, prospective customers are restricted to the front of the shop, getting sales attention through a window provided for such, and being physically confined to the veranda from which they interact with the vendor, by a metal grille (see Fig. 11).
