# DIGITAL SURVEY AND PARAMETRIC 3D MODELLING FOR THE VULNERABILITY ASSESSMENT OF MASONRY HERITAGE: THE BASILICA OF SAN DOMENICO IN SIENA, ITALY

ANGELO MASSAFRA, CARLO COSTANTINO, DAVIDE PRATI,  
GIORGIA PREDARI & RICCARDO GULLI

Department of Architecture, Alma Mater Studiorum, University of Bologna, Italy

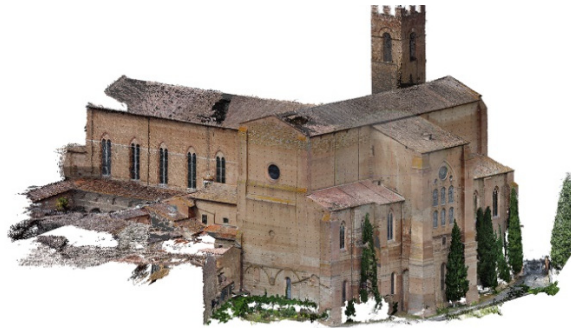
Figure 2: The photogrammetric mesh model of the exterior of the Basilica of San Domenico in Siena. (Source: Authors' graphic elaboration.)

The TLS and UAV photogrammetric survey campaign took five days. It was conducted employing a FARO CAM2 FOCUS 3D® and a DJI Mavic Mini, an open category UAV of C0-class identification label (MTOM < 250 g), using a targetless approach on both types of equipment. The photogrammetry needed, at least a 50% overlapping of the pictures with a proper resolution, to ensure an ideal outcome. These images were elaborated in Agisoft Metashape® 1.6.5 to make the photogrammetric 3D model and orthophotos of both the external and internal elevation (Fig. 2). Overall, the total airtime was about 8 h, allowing the shooting of 708 pictures.

The parametric modelling workflow was applied to each façade identified in Fig. 2, considering the reference system shown in the same figure. The x-axis is parallel to the nave with the positive direction towards the valley, the y-axis is parallel to the transept with the positive direction towards the bell tower, the z-axis is zenith with the positive direction towards the sky.

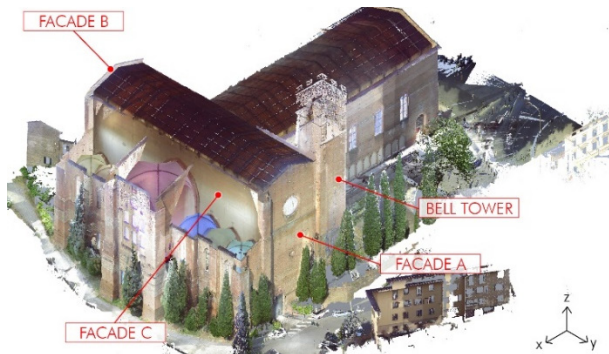
Figure 3: TLS point cloud of the Basilica of San Domenico in Siena: identification of the investigated masonry walls and the reference system. (Source: Authors' graphic elaboration.)

On the other hand, for the entire TLS survey of the building (Fig. 3), it was necessary to shoot 130 scans with a medium resolution of 7.67 mm/10 m and a quality filter of 3×. With a medium overlapping between the scans of 36%, despite the building complexity and size, it was possible to achieve an extremely accurate alignment, with an average 1.5 mm standard deviation between corresponding points and a maximum 2.6 mm deviation.
