# Natural frequencies of the colonnades of the Parthenon Athens at micro tremor level

## Abstract

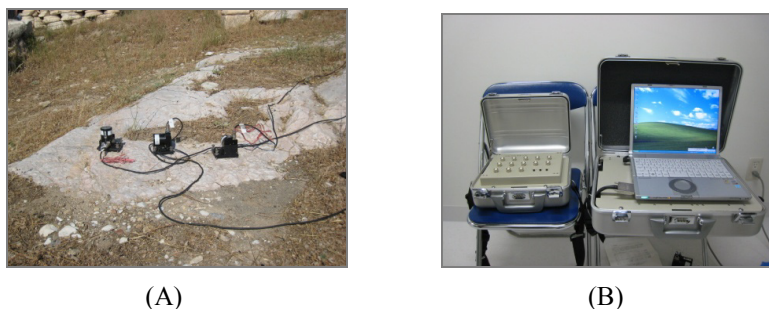
Measurements of microtremor were carried out using a total of 6 microtremor sensors, shown in Figure 1. Sampling duration was 60 seconds for each record with a sampling frequency of 100 Hz. A portable monitoring equipment of SPC-51A (Tokyo Sokushin Co., Ltd.) was used in the present research.

Figure 1: (A) Microtremor sensors and (B) recording unit.

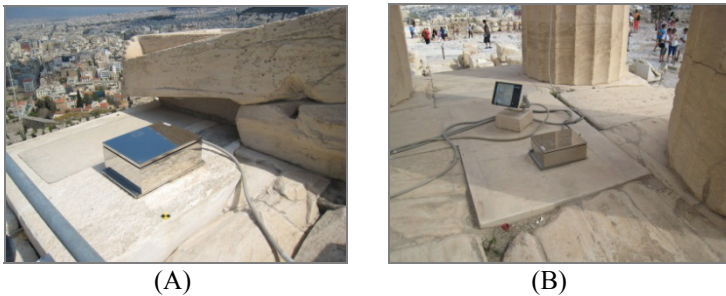
In September, 2008, two seismographs for earthquake monitoring were installed at the base (master sensor) and at the roof (slave sensor) of the north-east corner, shown in Figure 6.

Figure 6: Servo accelerographs, (A) master sensor and (B) slave sensor.

On 2<sup>nd</sup> September, 2010, a small earthquake was recorded at the base. The amplitude of that earthquake record was as small as 0.0007G. The predominant period was found in the response spectra at 0.5s. However, the topographical effect of Acropolis hill on the ground motions still remains as a subject to be studied.
