The blast performance of real-scale reinforced concrete specimens with varying fiber types and content

M. Kovar, M. Foglar & R. Hajek

*Faculty of Civil Engineering, Czech Technical University in Prague,
Czech Republic*

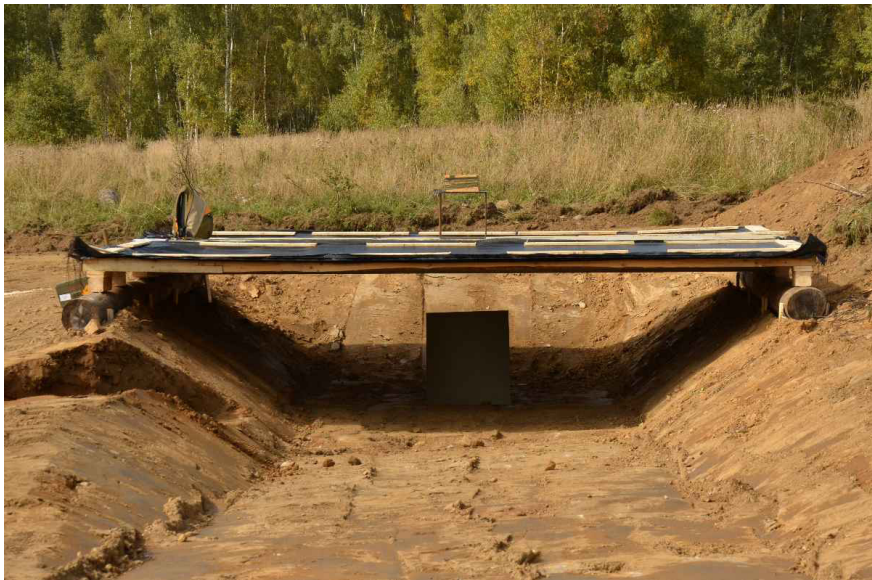
Figure 1: Layout of the experiment.

The layout of the experiment was practically the same as experiments from years 2010 and 2011.

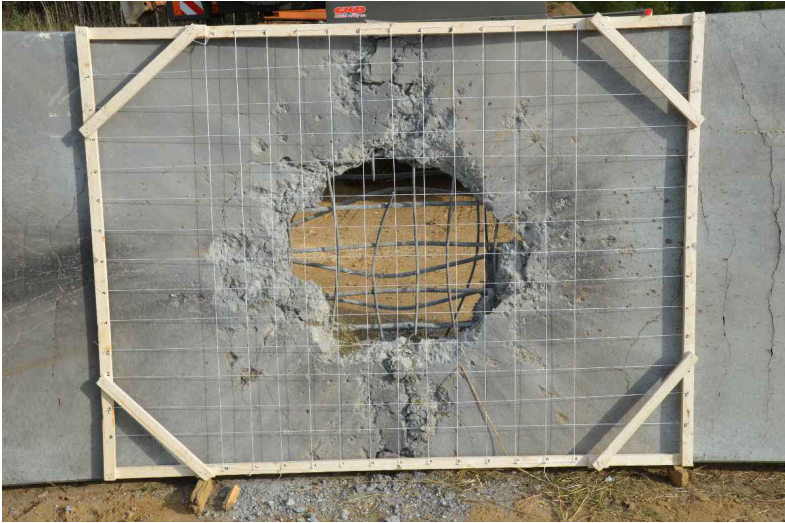
The timber frame with string grid of 100mm was used to measure area and depth of concrete spalling and puncture. The method of data evaluation can be seen in Figure 2.

Figure 2: Timber frame with string grid to experiment data evaluation.

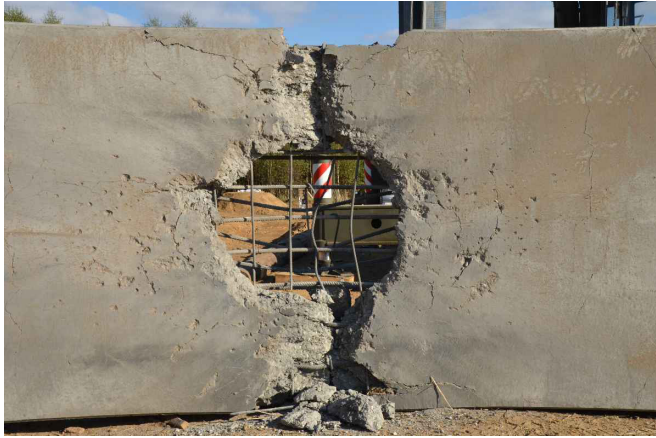
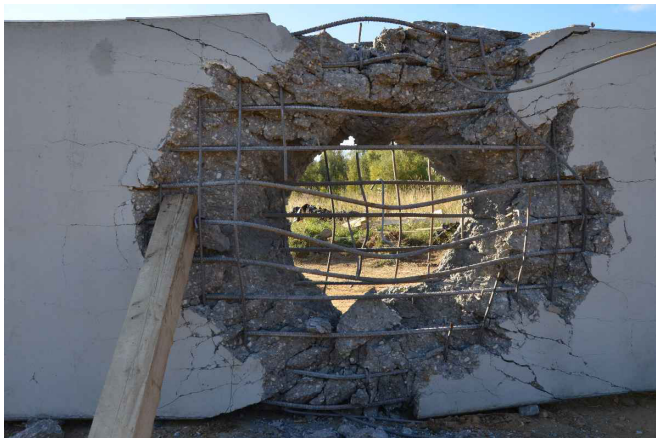
The specimen No. 11, C55/67, 40 kg/m³ FE fibers, was approximately equally damaged. The area of the puncture is 0.36 m², volume 0.11 m³, which represents 4% of the total volume of the specimen. Total volume of the damaged concrete (puncture + spalling) is 0.27 m³, which represents 10% of the total volume of the specimen. The area of puncture was reduced by 16% in comparison to specimen No. 1, total volume of damaged concrete was increased by 17% in comparison to specimen No. 1. The damage of the left side of specimen No. 10 was reduced by more than 80%, the damage of the right side was reduced by more than 65%. The deflection was 320 mm. The shape of deflection was similar to deflection from point loading in the mid-span of the specimen. The deflection was increased by 3% in comparison to specimen No. 1.

Figure 3: Damaged specimen No. 11 after blast – top view.

Figure 4: Damaged specimen No. 11 after blast – bottom view.

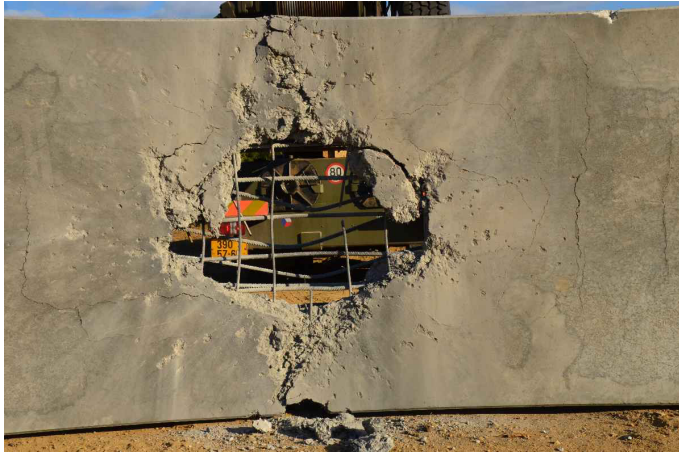
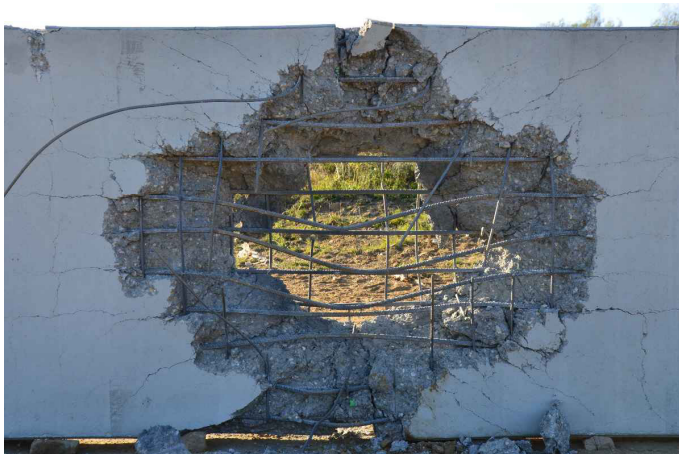
The specimen No. 10, C30/37, 80kg/m³ FE fibers, was approximately equally damaged. The area of the puncture is 0.36 m², volume 0.11 m³, which represents 4% of the total volume of the specimen. Total volume of the damaged concrete (puncture + spalling) is 0.24 m³, which represents 8.9% of the total volume of the specimen. The area of puncture was reduced by 16% in comparison to specimen No. 1, total volume of damaged concrete was increased by 9% in comparison to specimen No. 1. The damage of the left side of specimen No. 10 was reduced by more than 85%, the damage of the right side was reduced by more than 75%. The deflection was 450 mm. The shape of deflection was similar to deflection from point loading in the mid-span of the specimen. The deflection was increased by 45% in comparison to specimen No. 1.

Figure 5: Damaged specimen No. 10 after blast – top view.

Figure 6: Damaged specimen No. 10 after blast – bottom view.

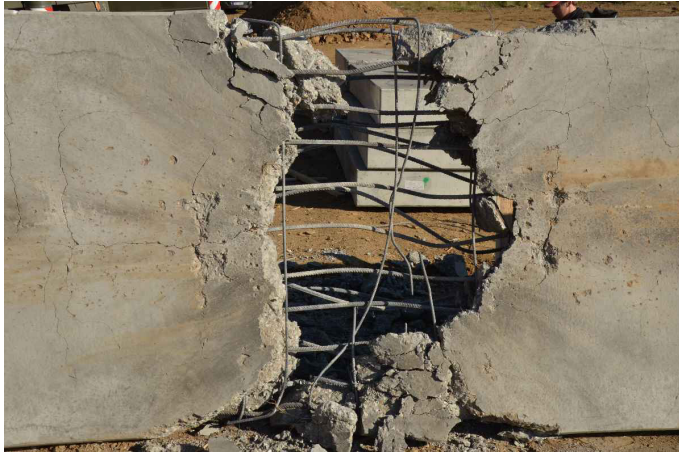
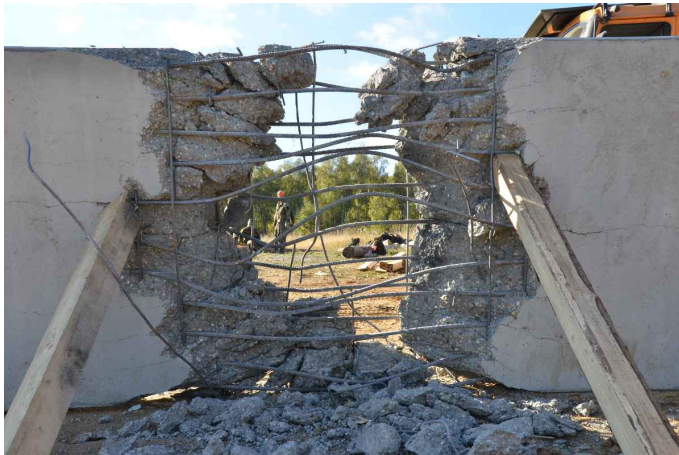
The specimen No. 9, C30/37, 40 kg/m³ FE fibers, was completely damaged. The specimen No. 9 after blast can be seen in Fig. 1. The area of the puncture is 1.02 m², volume 0.31 m³, which represents 11.3% of the total volume of the specimen. Total volume of the damaged concrete (puncture + spalling) is 0.45 m³, which represents 16.7% of the total volume of the specimen. The area of puncture was increased by 131% in comparison to specimen No. 1, total volume of damaged concrete was increased by 95% in comparison to specimen No. 1. The damage to the sides was 100% because area of puncture intervened over the whole width of slab. Cross-section of slab in mid-span was represented by steel reinforcement only.

Figure 7: Damaged specimen No. 9 after blast – top view.

Figure 8: Damaged specimen No. 9 after blast – bottom view.

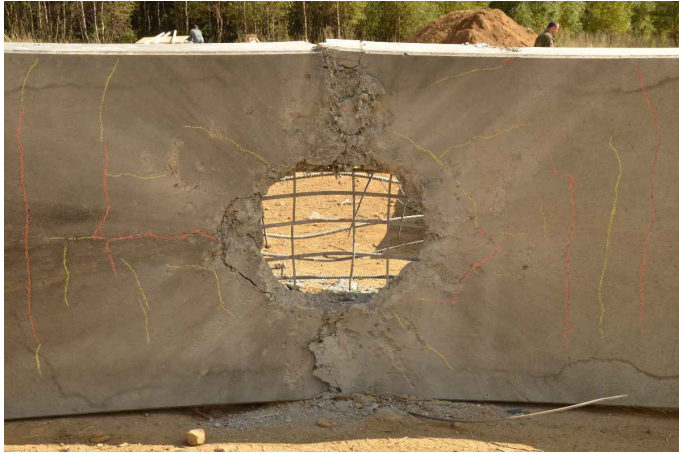
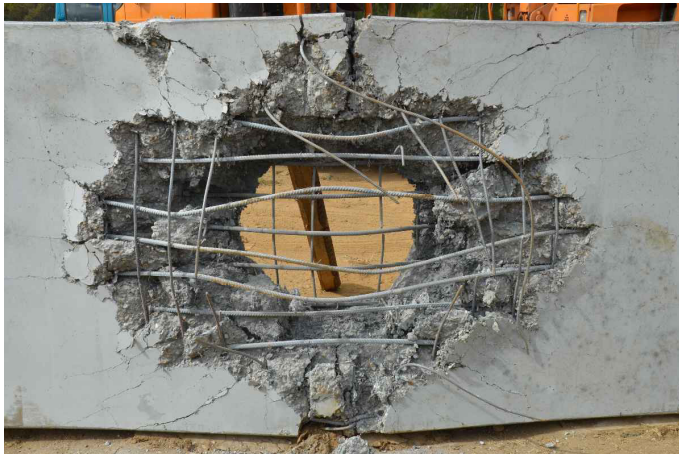
The specimen No. 8, C30/37, 40 kg/m³ FE + 4.5 kg/m³ PP fibers, was approximately equally damaged. The area of the puncture is 0.30 m², volume 0.09 m³, which represents 3.3% of the total volume of the specimen. Total volume of the damaged concrete (puncture + spalling) is 0.26 m³, which represents 9.6% of the total volume of the specimen. The area of puncture was reduced by 31% in comparison to specimen No. 1, total volume of damaged concrete was increased by 10% in comparison to specimen No. 1. The damage to the sides was completely reduced by 95%. The deflection was 450 mm. The shape of deflection was similar to deflection from point loading in the mid-span of the specimen. The deflection was increased by 45% in comparison to specimen No. 1.

Figure 9: Damaged specimen No. 8 after blast – top view.

Figure 10: Damaged specimen No. 8 after blast – bottom view.

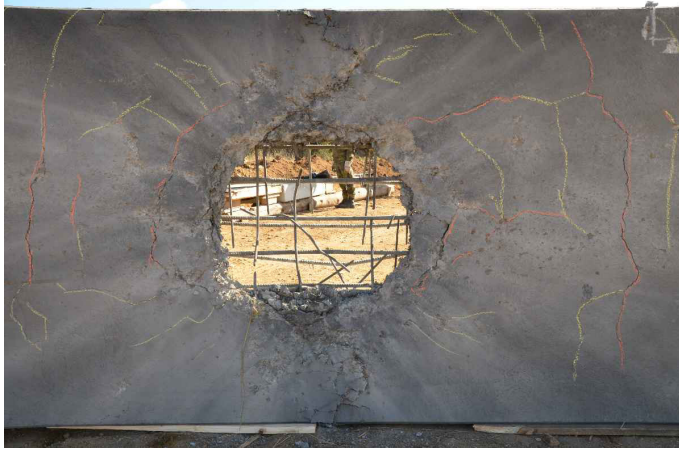
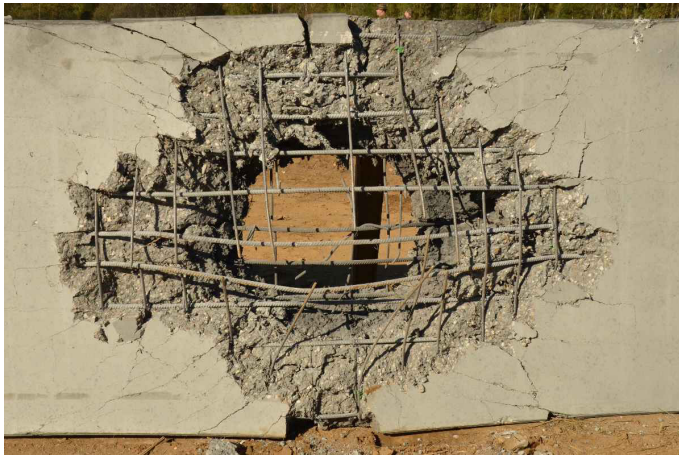
The specimen No. 7, C55/67, 40 kg/m³ FE + 4.5 kg/m³ PP fibers was approximately equally damaged. The area of the puncture is 0.30 m², volume 0.09 m³, which represents 3.3% of the total volume of the specimen. Total volume of the damaged concrete (puncture + spalling) is 0.25 m³, which represents 9.3% of the total volume of the specimen. The area of puncture was reduced by 31% in comparison to specimen No. 1, total volume of damaged concrete was increased by 9% in comparison to specimen No. 1. The damage to the sides was reduced by 85%. The deflection was 300 mm. The shape of deflection was similar to deflection from point loading in the mid-span of the specimen. The deflection was reduced by 3% in comparison to specimen No. 1.

Figure 11: Damaged specimen No. 7 after blast – top view.

Figure 12: Damaged specimen No. 7 after blast – bottom view.

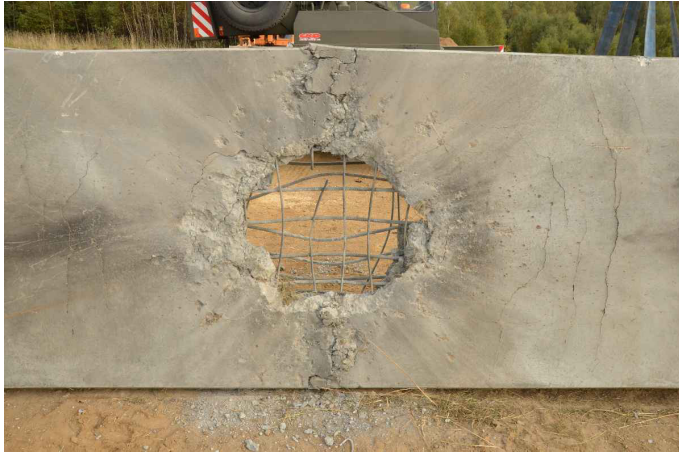
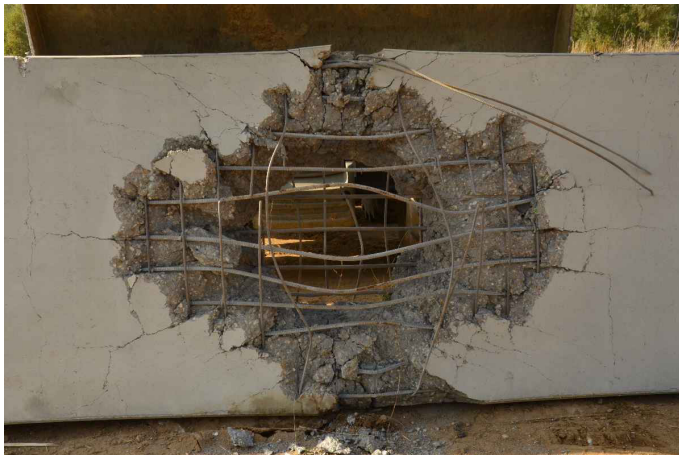
The specimen No. 6, C55/67, 80 kg/m³ FE fibers was less damaged. The area of the puncture is 0.31 m², volume 0.09 m³, which represents 3.4% of the total volume of the specimen. Total volume of the damaged concrete (puncture + spalling) is 0.20 m³, which represents 7.4% of the total volume of the specimen. The area of puncture was reduced by 28% in comparison to specimen No. 1, the total volume of damaged concrete was reduced by 13% in comparison to specimen No. 1. The damage of the left side of specimen No. 6 was reduced by more than 80%, the damage of the right side was reduced by more than 50%. The deflection was 310 mm. The shape of deflection was similar to deflection from point loading in the mid-span of the specimen. The deflection was the same in comparison to specimen No. 1.

Figure 13: Damaged specimen No. 6 after blast – top view.

Figure 14: Damaged specimen No. 6 after blast – bottom view.
