# The structural response of a reinforced concrete specimen subjected to adjacent blast loading

## Abstract

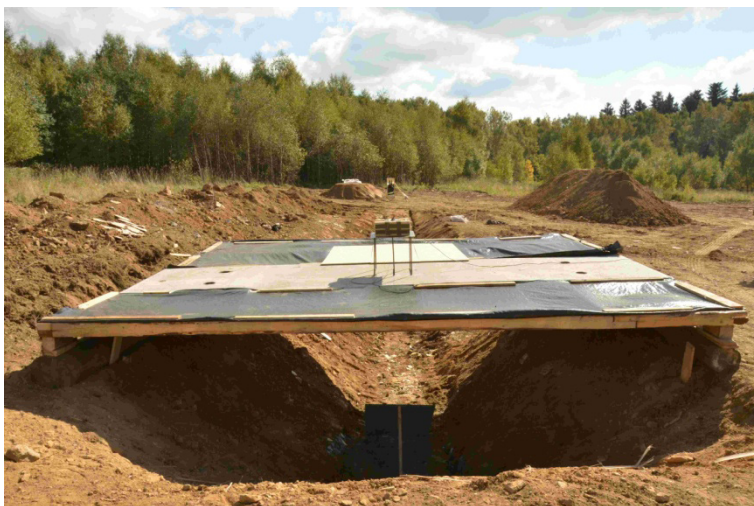
Figure 1: Layout of the experiment.

The 25 kg TNT charges were built up using standard military 200 g TNT charges. The charges were placed on steel holders in the middle of the slabs. The holders provided a 450 mm stand-off distance from the slab for better simulation of real in-situ conditions. This value was chosen as the most usual height of a car trunk. The setup of the experiment is shown in Figure 1.

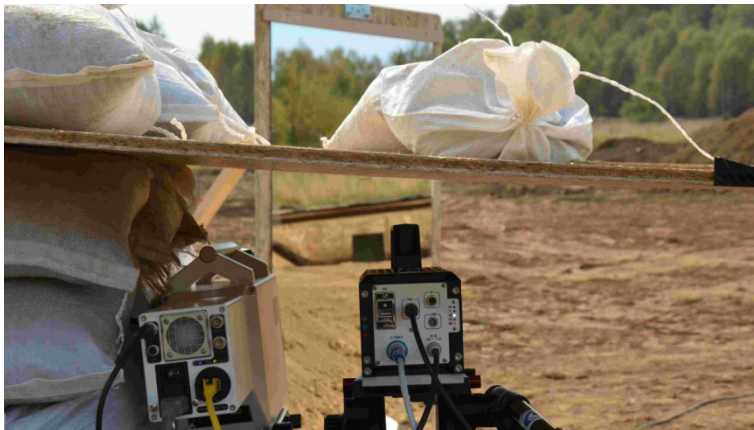
Figure 2: The camera view.

The early stages of spall formation were observed on the soffit using angled mirrors which were placed under the concrete specimens. Another mirror was placed in front of the cameras in order to allow indirect observation without the risk of camera damage by fragments. The experiments were captured using a NAC Memrecam GX3 high speed movie camera and IVV UHSi 12/24 ultra-high speed framing camera, the former being intended for expected spall formation while the latter for crack growth observations. Sigma 70–300 mm f/4–5.6, Samyang 800 mm f/8, and Samyang 85 mm f/1.4 lenses were mounted on the cameras. The aperture and gain were set to maximum values. The frame rates, single frame exposure times, and lens types are shown in Table 1. The view of the cameras can be seen in Figure 2.

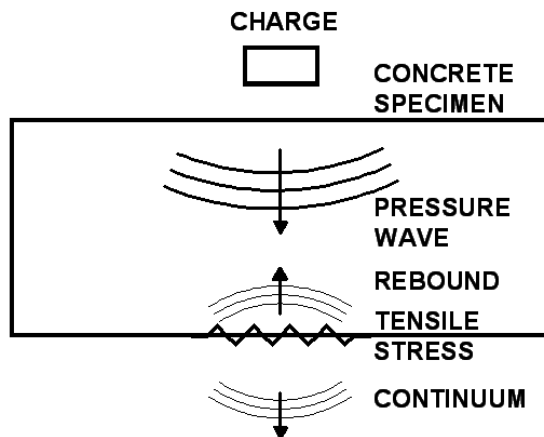
Figure 3: Scheme of the spall formation.

The process of blast loading of concrete has the following time schedule. The detonation of the main charge generates an expanding cloud of gases led by a strong shock wave which approaches the concrete specimen. The shock wave partially reflects back from the specimen surface. The compressive stress at the top surface of the specimen can cause local crushing of concrete or a shear failure of the specimen (puncture by shear-punching behaviour). The other part of the shock wave passes through to the bottom side of the specimen, where it reflects again, interfering with the release part itself. In this time, cracks develop on the soffit and the spall begins to form (as described in [2] and can be seen in Figure 3). Part of the shockwave again passes through the interface, creating an air shock wave under the specimen. This air shock wave is combined with a shock wave which overflows the test specimen from the side. The air shock wave is later followed by flying spall debris.

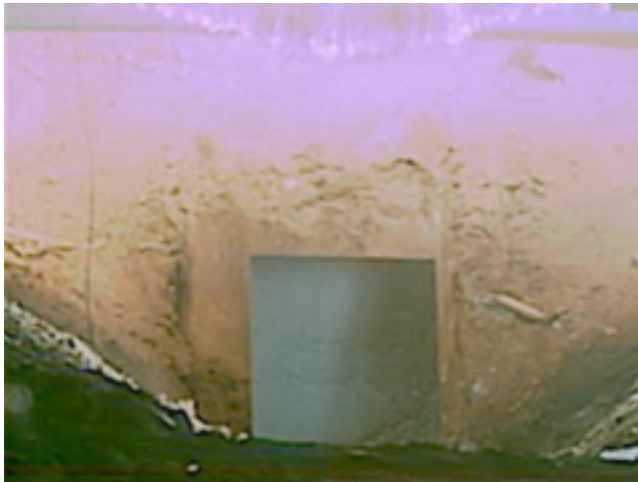
Figure 4: Spalling just started on the soffit (test 5,  $t = 0.67$  ms).

Results of monitoring the blast wave propagation, which were obtained from the Memrecam records, can be seen in Table 2 and Figures 4–7. The first cracks are visible on the soffit at about 0.3 ms after the main charge detonation according to test 4, but they probably formed earlier. The average spall debris velocity was  $120 \text{ m.s}^{-1}$ . In test 1, the air shock wave velocity under the specimen as determined from the movie reached  $1150 \text{ m.s}^{-1}$  while it was only  $480 \text{ m.s}^{-1}$  and  $600 \text{ m.s}^{-1}$  in tests 2 and 5, respectively.

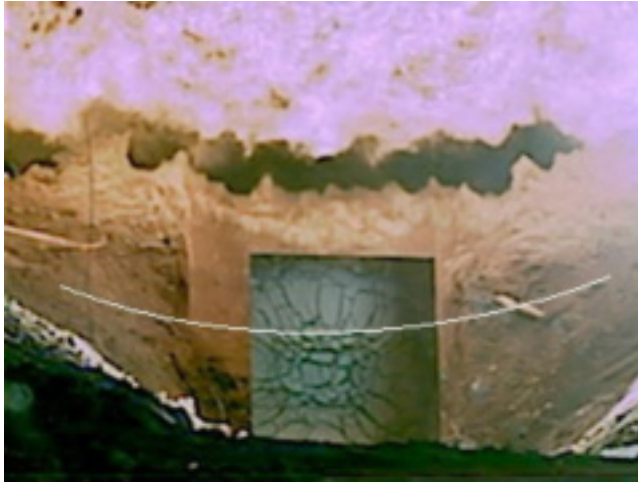
Figure 5: Air shock wave passes along the mirror (highlighted by the white line, test 5;  $t = 2.8$  ms).

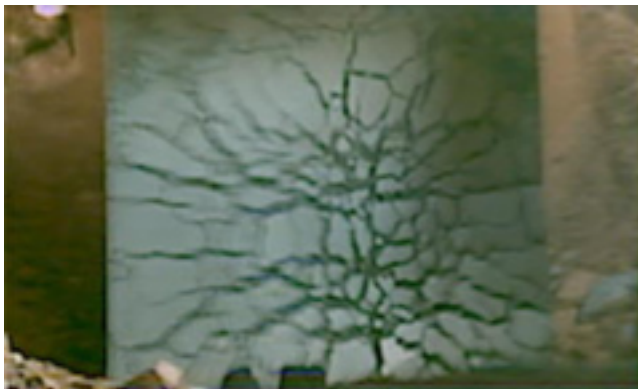
Figure 6: Extended damage of the soffit (test 4;  $t = 2.85$  ms).

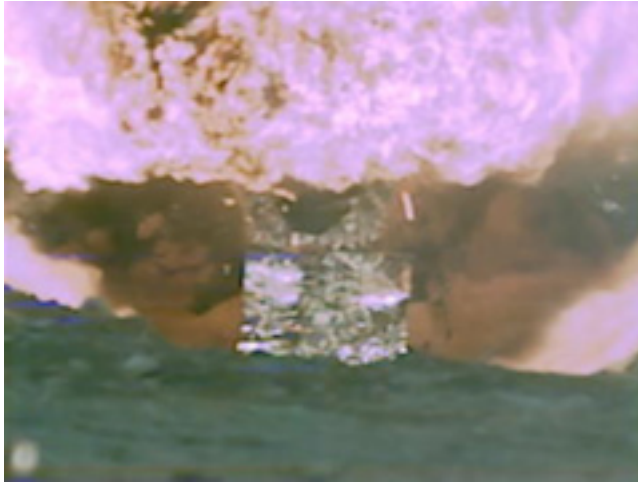
Figure 7: The flying spall debris reach the upper edge of the mirror (test 2;  $t = 10$  ms).

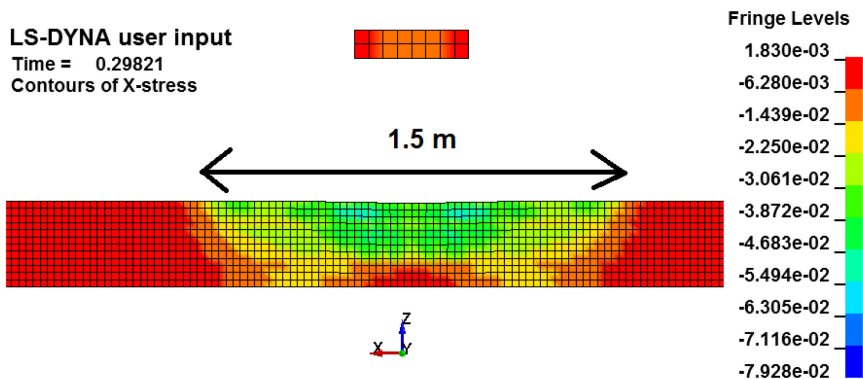
Figure 8: Normal stress –  $t=0.3$ ms.

The camera instrumentation confirmed some numerical model expectations. The overpressure wave arrived at the top surface of the specimen at  $t = 0.2$  ms in the numerical model. After the rebound of the overpressure wave from the soffit of the specimen, the first elements started to erode ( $t = 0.4$  ms). Figure 8 shows

the contours of normal stress in time  $t = 0.3 \text{ ms}$ . Figure 9 shows the contours of normal stress in time  $t = 0.5 \text{ ms}$  – eroded elements on the soffit.

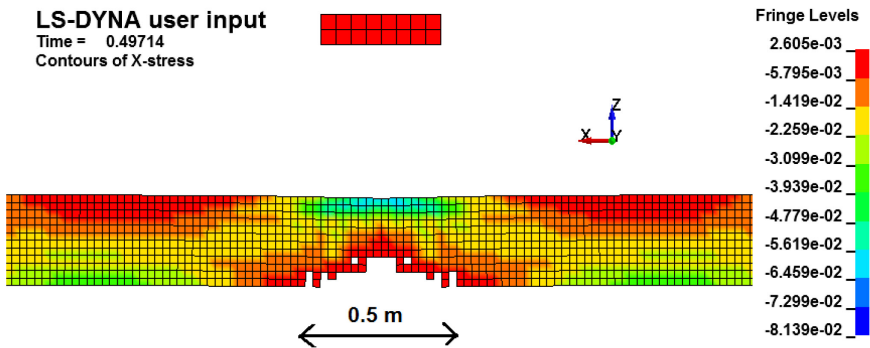
Figure 9: Normal stress –  $t=0.5\text{ms}$ , eroded elements on the soffit.

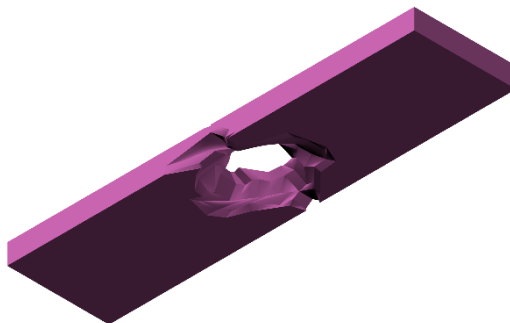
Figure 10: A 3D model of damaged specimen.

For detailed concrete loss of weight research, the 3D models of concrete slabs were created. The crack, puncture and spalling patterns were made in every concrete layer in accordance to a known depth. The connection of separated layer patterns brought the 3D model of the concrete slab (Figure 10).
