EXPERIMENTAL TESTING OF REINFORCED CONCRETE SLABS RETROFITTED WITH CFRP AND MECHANICAL ANCHORS

GENEVIEVE PEZZOLA & LAUREN STEWART

School of Civil and Environmental Engineering, Georgia Institute of Technology, USA

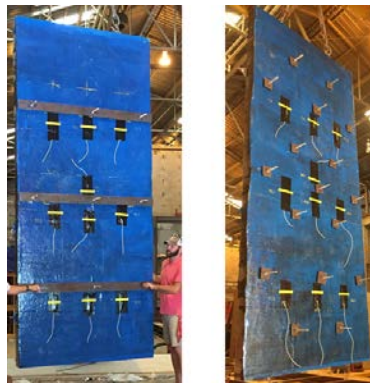
Figure 1: Finished strap anchorage retrofit (FT1 – left) and finished plate anchorage retrofit (FT2 – right).

The mechanical anchors were applied after the CFRP cured. For both anchorage systems, the edges of the steel were rounded with a grinder to prevent any sharp edges coming into contact with the CFRP. For the steel plate anchorage system, a thin piece of rubber (0.32 cm (1/8 in) thick) was installed in between the CFRP and steel disc. The rubber was installed to allow a gentler transfer of forces between the CFRP and steel plate. Fig. 1 shows the finished retrofit for both specimen (the specimen with the strap anchorage system is shown on the left and the specimen with the plate anchorage system is shown on the right).

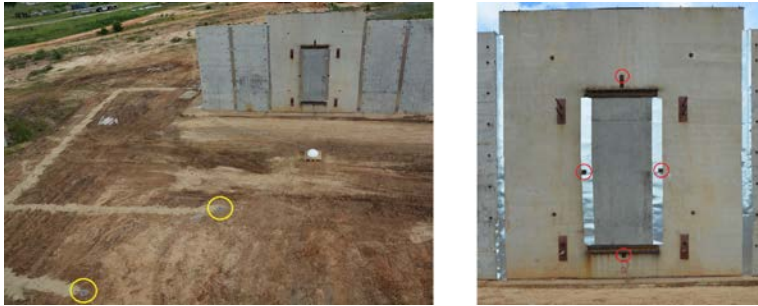
Figure 3: The two installed free field pressure gauges (left) and the layout of the four reflective pressure gauges (right).

Six HKS pressure gauges were used to obtain free-field and reflected pressures. Two free-field gauges were installed in concrete cylinders topped with aluminum discs that were buried underground so that the gauge would be flush and level with the ground surface. One free-field gauge was placed one standoff away from the charge (rated for 1.72 MPa (250 psi)) and the other free-field gauge was placed two standoffs away from the charge (rated for 0.689 MPa (100 psi)). Four reflected pressure gauges (each rated for 13.79 MPa (2,000 psi)) were mounted into the front slab of the reaction structure surrounding the specimen. One pressure gauge was mounted below the specimen at the centerline, two pressure gauges were mounted at either side of the specimen at the mid-height, and the other pressure gauge was mounted above the specimen at the centerline. The layout of the free field pressure gauges and reflective pressure gauges is shown in Fig. 3.

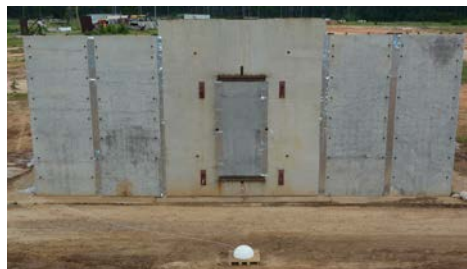
Figure 4: Finalized test setup before the blasting cap was installed.

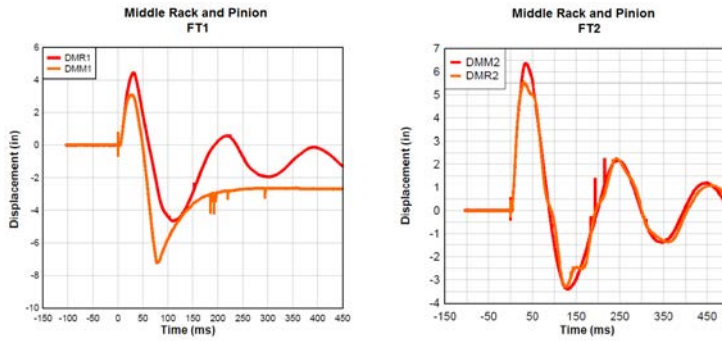
Figure 5: Displacement-time histories from the mid-height rack and pinions for FT1 (left) and FT2 (right).

The maximum displacement of the midpoint for FT1 was approximately 11.4 cm (4.48 in), while the maximum displacement of the midpoint for FT2 was approximately 16.3 cm (6.4 in), measured using the rack and pinions. Fig. 5 shows the displacement-time histories for the midpoints of FT1 and FT2, where “DMR” and “DMM” refer to the rack and pinions placed on the right side of the slab and middle of the slab, respectively, for each test. The peak reflected pressures and impulses for both FT1 and FT2 are shown in Table 1, where the peak reflected pressures were obtained directly from the reflected pressure gauges and the peak reflected impulses were calculated by integrating the pressure-time histories from the reflected pressure gauges. Fig. 6 shows the pressure-time histories for each pressure gauge for both FT1 and FT2, where “RPB”, “RPL”, “RPR”, and “RPT” refer to the bottom, left, right, and top pressure gauge for each test.

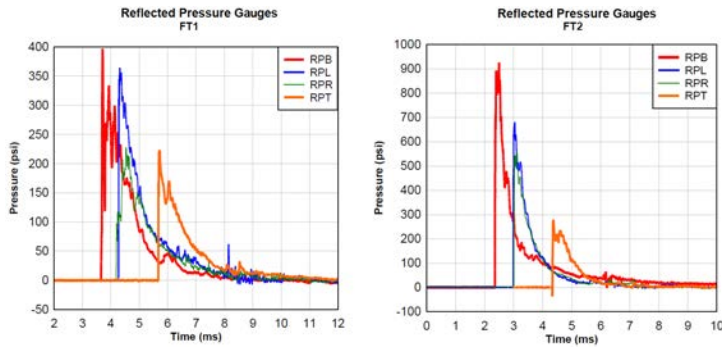
Figure 6: Pressure-time histories for each reflective pressure gauge for FT1 (left) and FT2 (right).

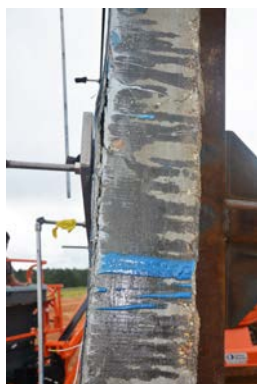
Figure 7: Concrete failure and debonding in FT1.

Both the FT1 and FT2 specimen exhibited damage in the concrete and CFRP. In the FT1 specimen, most of the concrete damage was located on the non-blast side of the specimen, with greater concrete damage located close to the location of the straps. There was also a significant amount of CFRP tearing located near the straps that spanned the width of the straps. This tearing was the greatest at the middle strap. Debonding occurred near the middle straps, similar to a previously reported failure mode, “plate-end debonding” [8], but this

particular failure mode had never been reported before this test series. A small layer of concrete and even aggregate were still attached to the CFRP, indicating that no adhesive failure occurred. Fig. 7 is a post-test photo of the side of FT1, where the debonding and concrete failure near the middle strap can be seen.

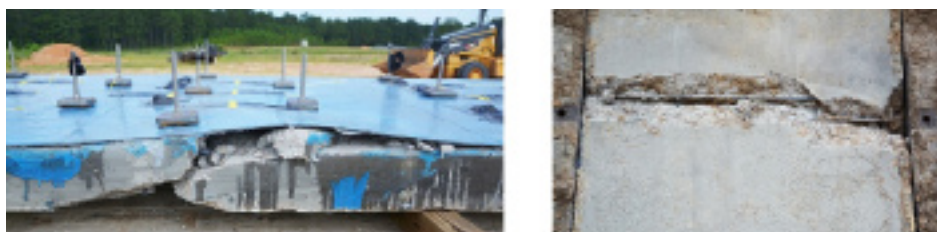
Figure 8: Intermediate crack-induced debonding (left) and concrete crushing (right) in the FT2 field test specimen.

In the FT2 specimen, similar to the FT1 specimen, most of the concrete damage occurred on the non-blast side of the specimen, but concrete crushing on the compressive side was also observed. Large flexural and flexural shear cracks were observed in the specimen. The location at which these cracks widened is the point at which debonding initiated in the retrofit. This debonding failure mode has been previously classified as “intermediate flexural and flexural shear crack-induced debonding” [8]. Despite the amount of damage in the FT2 specimen, widespread delamination was prevented as the smaller, more evenly distributed anchors allowed for a more even distribution of stresses. Small tears in the CFRP were observed near the anchors, but were not long in length, which indicates that using smaller anchors allows for less stress localizations to be induced in the specimen, as opposed to straps that span the width which caused much longer tearing in the CFRP. Fig. 8 shows two post-test photo of FT2, major flexural shear cracks and debonding (left), and concrete crushing (right).

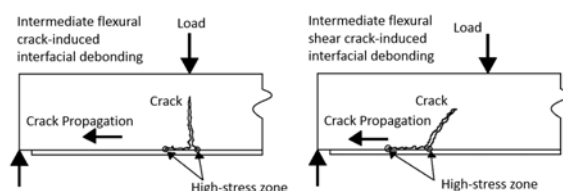
Figure 10: Schematic of intermediate flexural and flexural-shear crack-induced interfacial debonding.

In FT2 large flexural and flexural-shear cracks were formed, indicating that the failure mode in this slab was “intermediate flexural and flexural-shear crack-induced interfacial debonding”, mixed with a compressive failure mode in the concrete due to the large cracks in the front face of the specimen. Intermediate flexural and flexural-shear crack-induced interfacial debonding occurs when a flexural or flexural-shear crack occurs far from a plate end and initiates the point of debonding of the CFRP and concrete. This debonding then propagates away from the initial point. This failure does not occur in the adhesive, but initiates in the concrete. A schematic of this failure is shown in Fig. 10.
