MANAGEMENT OF SIDEWALK MAINTENANCE TO IMPROVE WALKING COMFORT FOR SENIOR CITIZENS

MARIA VITTORIA CORAZZA, PAOLA DI MASCIO & LAURA MORETTI

Sapienza University of Rome, Department of Civil, Building and Environmental Engineering, Rome, Italy

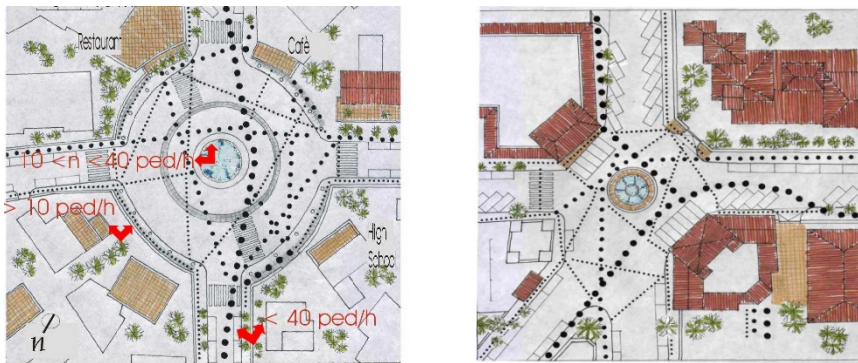
Figure 2: Pedestrians routes at two squares in the study area [9].

Although some functions and businesses changed in the surveyed areas in the last decade (a high school closed permanently in one square, a redesign program was carried out in the other, with sidewalks slightly broadened, and a number of new supermarkets opened nearby both), a recent survey confirmed the habits and the features already observed. Sidewalks maintenance was still poor and due to the same problems, pedestrians still favoured carriageways instead of sidewalks, traffic and pedestrian flows did not markedly change, drivers were still compliant with the speed limits. An element of variation was the increased amount of elderly pedestrians, especially in the morning hours. For this specific category, recurring activities observed were walking with shopping trolleys (35% of the surveyed flows) and pets (25%) and strolling (30%). Needless to say, the majority of them (around 65%) performed such duties jaywalking, detouring from sidewalks or walking directly on the carriageways. Some recurring habits were also observed among the “great elderly” pedestrians: they walk preferably on the sunny side of the streets (the survey took place on average working days in wintertime, and probably the shadowed side would be favored in summertime); when carrying shopping bags or walking pets, they tend to avoid areas perceived as too narrow or crowded (due to furniture, trees, etc.), even when actually there is plenty of room; once left the sidewalk for any of the reason above mentioned, they continue to walk on the carriageways until they have to cross again the street. Often, they stop on the carriageway to talk or rest and then resume walking.

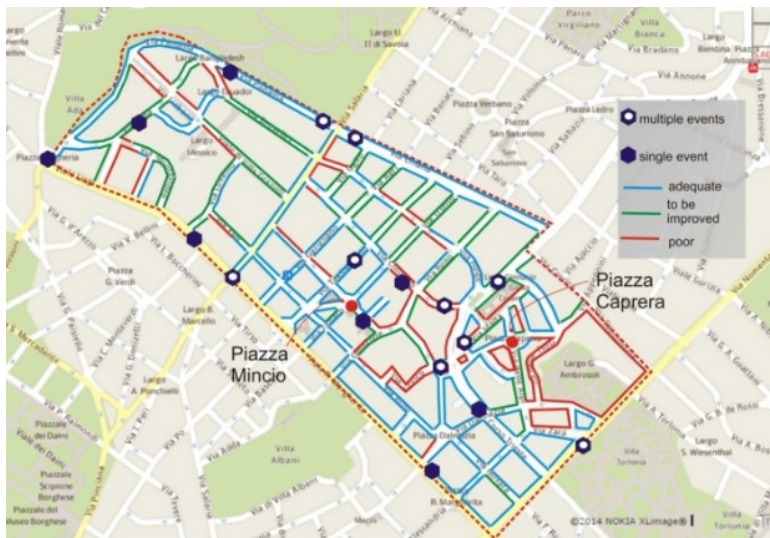
Figure 3: The TTF.

At the end of this process one area resulted more appropriate than the others due to the additional higher recurrence of accidents involving elderly pedestrians (Fig. 3). In this 5500 m² area, called the Trieste Test Field (TTF), the whole pedestrian pavements network was analysed, with exclusion of the private access areas, where sidewalks are interrupted (for example by driveways), as further described.

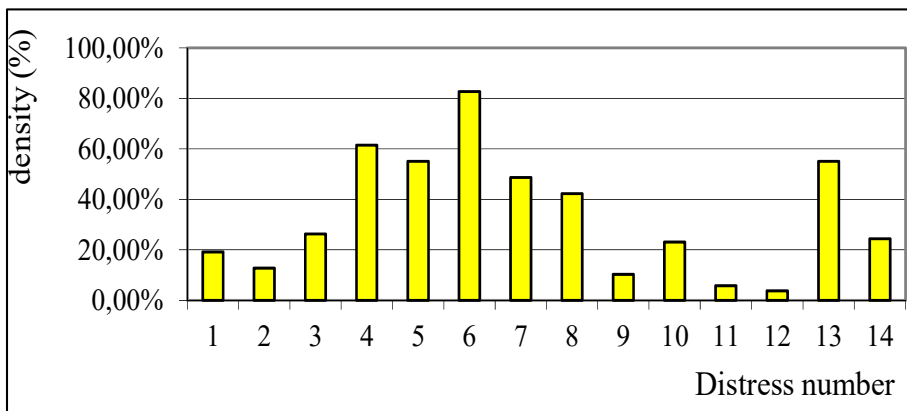
Fig. 5 shows the density of the recorded distresses in the TTF. Highest density (more than 50%) is associated to: patching (4), potholes (5), corrugations (6) and depressions (13).

Figure 5: Distress density on the TTF sidewalks.

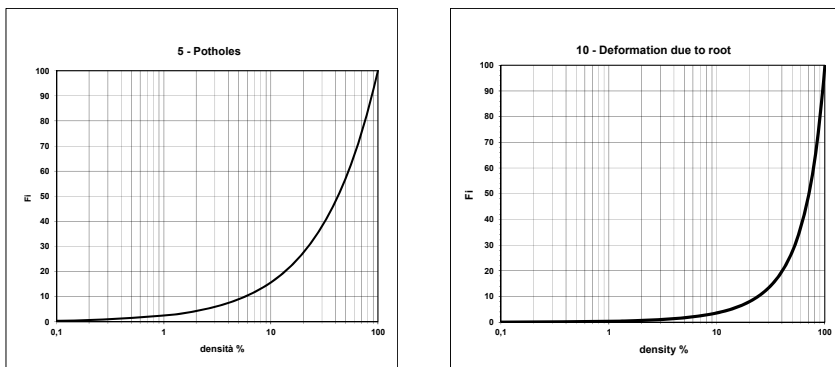
where DV_{ij} is the deduct value and F_i is the value resulting from the per cent density $d\%$, for the distress *i*, by curves like those in Fig. 6. These curves were calculated by a proportion assigning the maximum value, equal to 100, to the maximum density. The deduction curves derive by interpolating these values and the recorded density, and restraining the curve to pass in the points (0, 0) and (100, 100). The curves are one for each distress and they are exponential. Fig. 6 shows those related to the distresses in Fig. 4. Interviews to pedestrians who walked the TTF allowed defining a weight, p_{ij} . The panel of interviewees was representative of the average pedestrian population of the TTF, thus included also elderly and physically challenged pedestrians.

Figure 6: Distress density on sidewalks in the TTF.
