A calamity of a severe nature: case study – Chennai, India

S. Esther & M. D. Devadas
Anna University, India

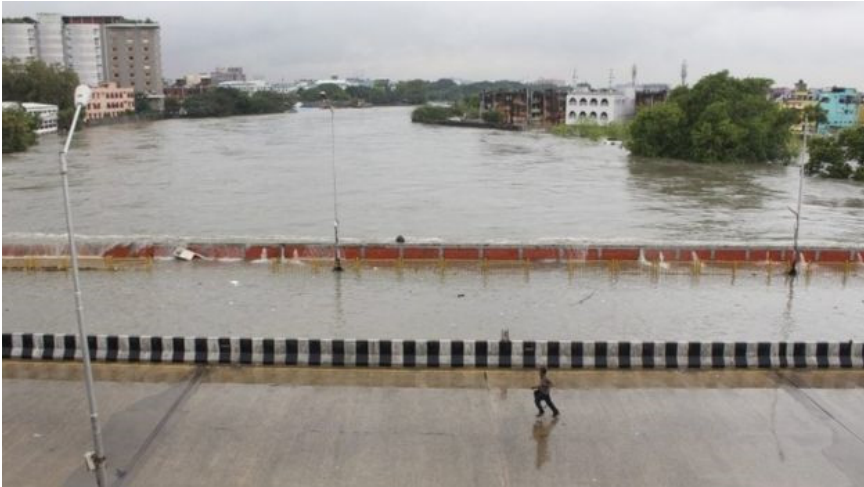
Figure 1: The Adyar river flowing through Chennai rose and broke through bridges in the city (source: <http://www.bbc.com/news/world-asia-india-34992004>).

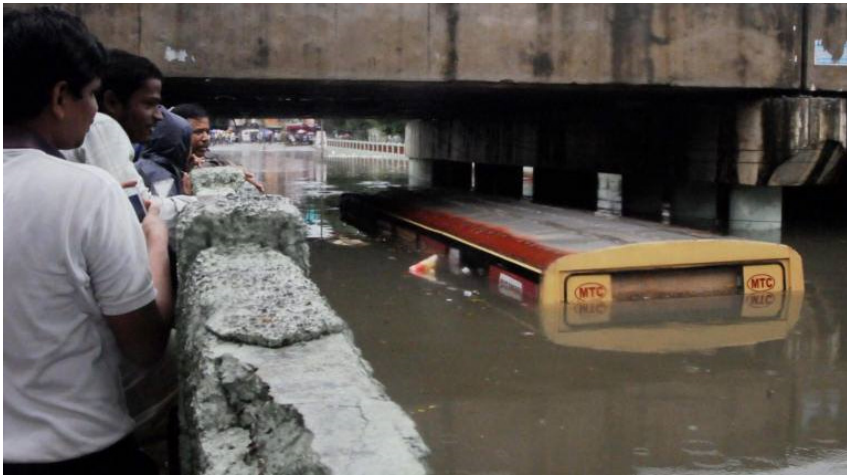
Figure 2: A public transport bus submerged in a flooded subway (source: Daily).

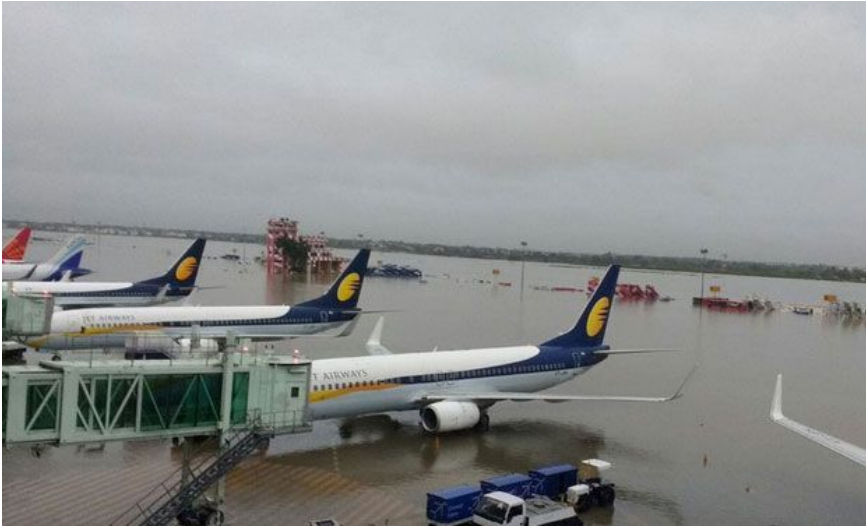
Figure 3: The scene at Chennai airport that was flooded (source: Daily).

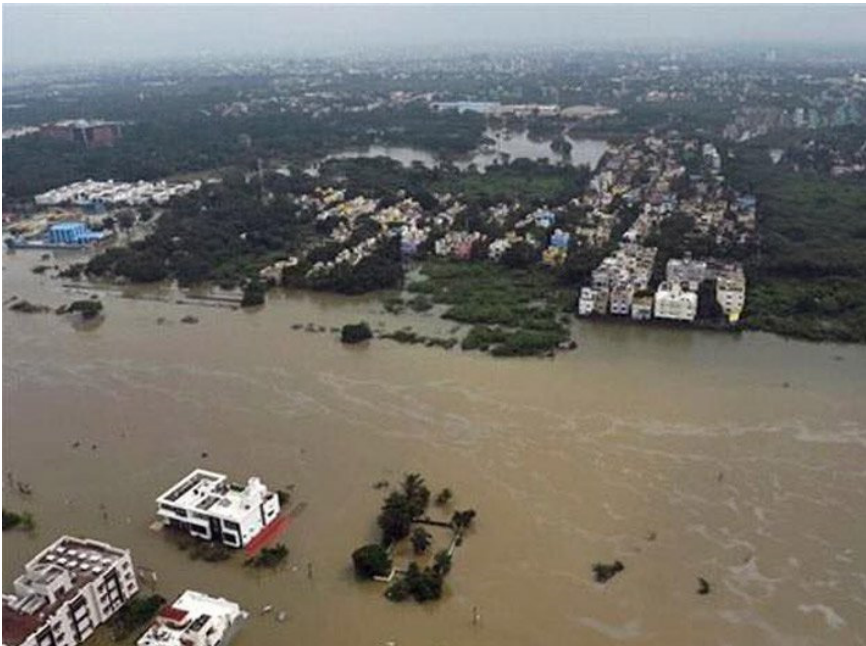
Figure 4: Developments built along the course of water channels reclaimed by water (source: <http://www.governancenow.com/news/blogs/surviving-chennai-floods-came-back-my-apartment-19-days>).

Around 1.5 lakh illegal structures have come up over the past few years, especially along the water bodies and the dry channels of rivers. They were overlooked by the local authorities for various reasons. However, the monsoon brought to light the severity of such an act. Since they were in the natural path of the water, the floodwaters took their course and these were some of the worst areas affected. Areas such as Manapakkam in Chennai experienced water as high as 15 ft.

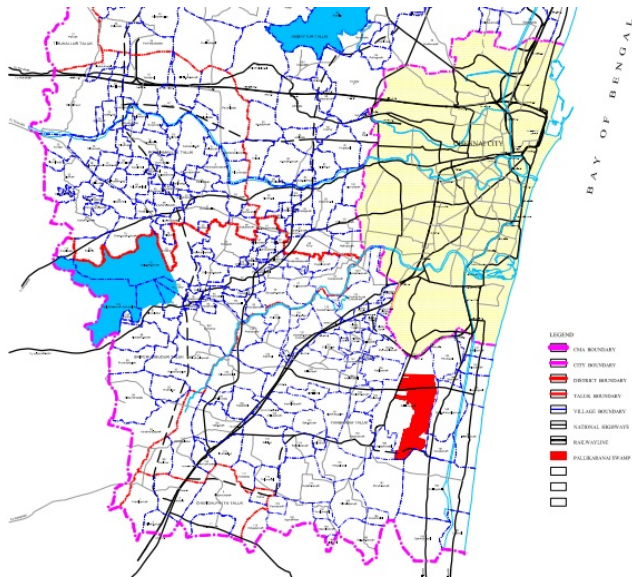
Prior to urbanisation Chennai had a very effective natural drainage system via southern marshlands. With every new master plan the city receives, that regulates the development within its extents it is observed that the percentage of open areas such as forests, swamps and wetlands have been drastically reduced (fig. 6). The change in land use for the city has faced quite a change. At present, developments have taken over around 90% of the open swamps. The previous 650 water bodies in Chennai have reduced to a meagre 27. By nature's design, the water naturally drains towards these basins (fig. 7). Had they been retained, areas such as

Figure 6: Map of Chennai showing water bodies in blue and marshlands in red (source: Chennai Metropolitan Development Authority, 2008).
