# Use of geophysical methods in investigating PRBs employing non-conductive reactive materials

Y. S. Kim, J. J. Kim, G. H. Lee & J. B. Park  
*School of Civil, Urban and Geosystem Engineering,  
Seoul National University, Korea*

Resistivity survey and ground penetrating radar (GPR) were used for investigating a full-scale permeable reactive barrier (PRB) installed nearby abandoned mines of the Go-sung area, located on the south coast of the Korean peninsula. The aims of the testing program included evaluating the applicability of geophysical methods in: 1) locating PRB installations, 2) investigating the movement of groundwater through the PRB and 3) qualitatively identifying the extent of contaminant removal on the PRB. The results indicated that both resistivity and GPR surveys were applicable in giving exact locations of PRB installation based on given information on the reactive material properties, including particle size, composition and electrical characteristics. The resistivity survey was also successful in evaluating the movement of groundwater at different locations nearby the PRB installation. On this basis, results and discussion of the testing program provides evide

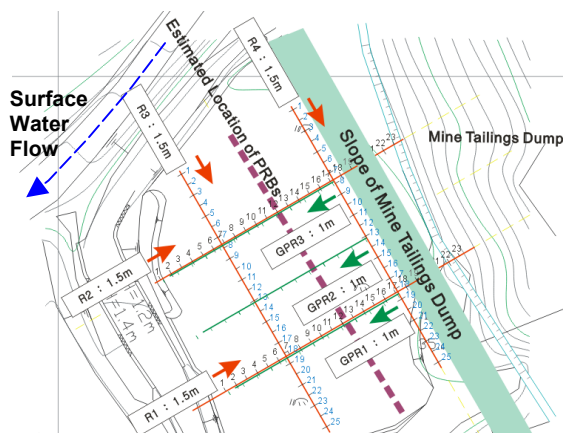
Figure 1: Schematic diagram showing grid lines of geophysical surveys conducted at the study site.

Resistivity survey and ground penetrating radar (GPR) were used for investigating the study site. Prior to conducting geophysical surveys, GPS was employed to aid in marking exact locations of the grid lines. The GPR survey was conducted in an effort to locate the pile-type PRB installations. Therefore a total of 3 grid lines were directed perpendicular to the estimated direction of the PRB installation, as shown in figure 1. The survey was conducted using a 100 MHz Pulse EKKO transmitter and receiver antennae pair. Although the depth of penetration may dependent on the dielectric properties of the underlying soil, it was considered to be sufficient since the pile-type PRBs were designed to be buried at a depth of 1 to 2 m from the surface.

A total of 4 grid lines were selected for resistivity survey. Since the resistivity survey was conducted in an effort to investigate the subsurface conditions and movement of groundwater in addition to locating PRB installation and identifying the extent of contaminant removal, grid lines were directed both

parallel and perpendicular to the pile-type PRBs (refer to figure 1). Wenner arrays were employed by placing electrodes 1.5 m apart, which gives a penetration depth of 7.5 m ( $\approx 5$  times the electrode spacing). Since the surface of the study site contained a significant amount of large gravels and rocks, salt water was discharged in order to increase the contact resistance between the subsurface and stainless steel electrodes.

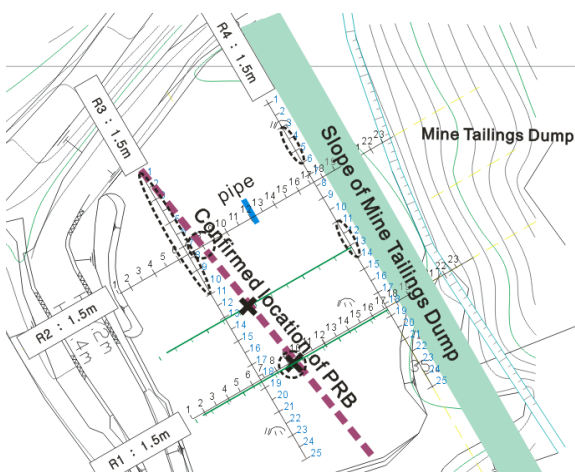
Figure 5: Schematic diagram showing the confirmed location of the PRBs from excavation. Dotted circles represent areas of low resistivity and black x symbols indicate of anomalies in GPR images.

interpretation of the results of geophysical surveys were highly reliable. As shown in figure 5, the pile-type PRB was approximately 12 to 15 m away from, and not completely parallel to the slope of mine tailings dump. Use of geophysical surveys to locate PRBs employing non-conductive reactive materials is highly effective, since it can substitute or minimize site excavation (based on design plan), which is a destructive method and may cause costly damage. Figure 5 is a schematic diagram giving a summary of interpretations made based on geophysical surveys.
